Construction problems on the karstified limestone tuffs of Condeixa, central Portugal: a case study

Abstract. During the excavations for the foundations of a three storey building on the limestone tuffs of Condeixa, Central Portugal, a large dissolution fissure and smaller dissolution voids were found. Since the area has never been the subject of engineering geology investigation, it was decided to evaluate the risk associated with the construction of the building. These limestone tuffs were formed in a continental environment by the precipitation of calcite carried by the water coming from the large limestone body in the east. The precipitated calcite mixed with the terrigenous materials and around trunks and leaves of plants, originating a very heterogeneous and porous ground, which is characteristic of limestone tuffs. The study started with a detailed geological survey followed by a large number of destructive drillings, located essentially under the pad foundations. The results revealed several karstic cavities with serious problems for the building foundations and the structure, and many smaller dissolution cavities, often filled with clayey soils. The ground treatment solut

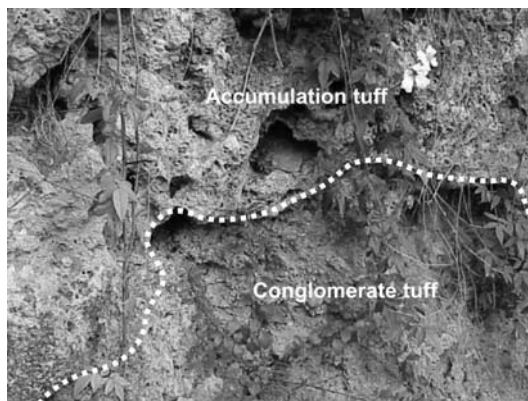
Figure 2. Aspect of the accumulation tuff and conglomerate tuff in an old cut, close to the site. The large voids on the accumulation tuff correspond to the trunks of plants surround by precipitated calcite. The erosive action of the water removed the clay usually filling the voids before exposure.

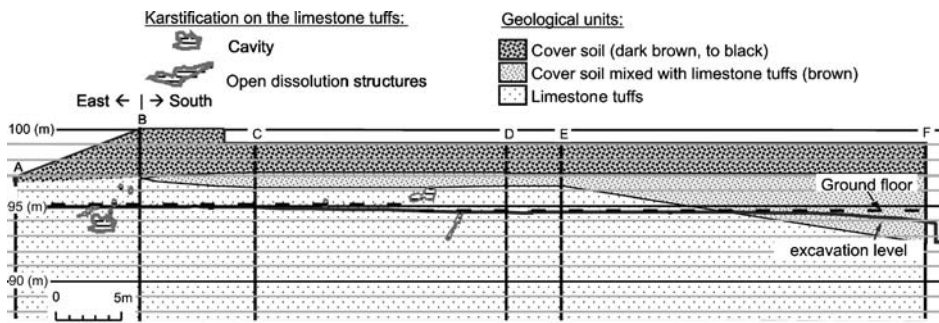
cover soil (0.4–3.3 m thick); cover soils mixed with limestone tuffs (up to 4.6 m thick); limestone tuff (around 30.0 m thick). In Figure 3 the distribution of the three units identified on site are shown to be represented along the east and south surface walls of the excavation. The levels intended for the ground floor and the bottom of the excavation are also indicated.

Figure 3. Distribution of the three units identified along the east and south faces of the excavation. The level intended for the ground floor, the bottom of the excavation and the karstic structures identified during the first phase of investigation are presented.

On the south face of the excavation several dissolution cavities were identified above the foundation level of the building. The most important was 0.5 m high by 1.2 m wide, had a very irregular shape and was in continuity with PDS 1. It is represented in Figure 3.

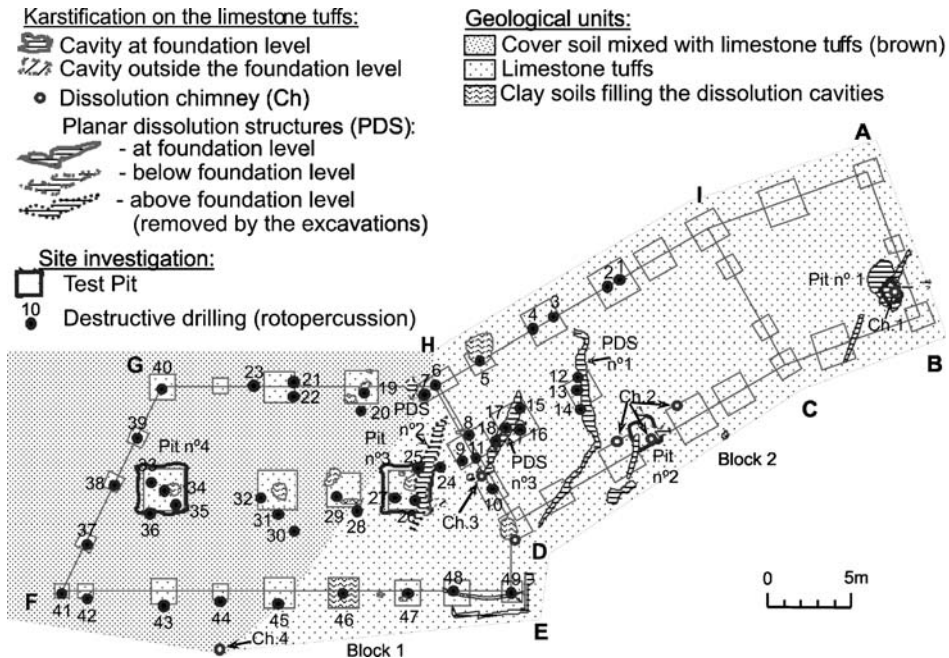
Figure 4. Location of the destructive drillings and of the karstic structures identified close to the level of foundation.

A few more chimneys were identified during the site investigation. It was observed that the chimney 3 was directly connected to the large planar dissolution structure no. 3. For chimney 4 we did not investigate its continuity because it was outside the construction area (Figure 4).

The planar dissolution structures (PDS) have an important development, and are sub-vertical, slightly inclined to east, being illustrative the three structures named PDS 1, 2 and 3 (Figure 4). The walls of these planar structures were covered by karstic features resulting from the precipitation of calcite. We consider that these planar structures are the result of fractures that were enlarged by dissolution and that had posterior precipitation of calcite in the walls.

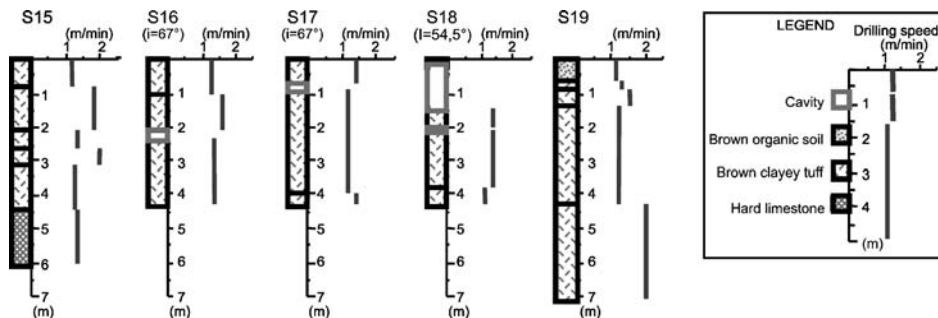
Figure 5. Example of a few simplified logs of the destructive drillings.

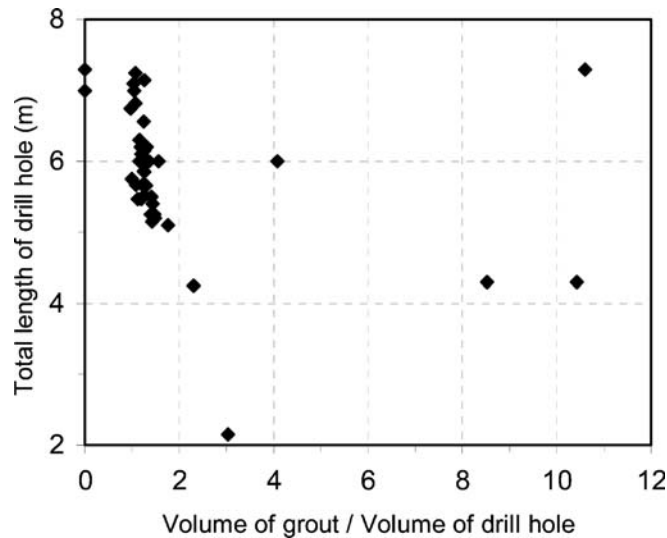
Most of the drill-holes were filled with cement grout. Figure 6 shows the relationship between the total length of the drill-hole and the ratio between the volume of the grout necessary to fill the drill-hole and the theoretical volume of the drill-hole. In most of the drill-holes the ratio is around 1, or slightly higher, while a few show much higher ratios, indicating the presence of cavities that were intersected by the drill-holes. The records of the parameters of the drilling, mainly the drilling speed, allowed to identify the depth at what the cavities intersected, and are reported in Table 1.

Figure 6. Relationship between the total length of the drill hole and the ratio: volume of grout poured to fill the drill hole / volume of drill hole.

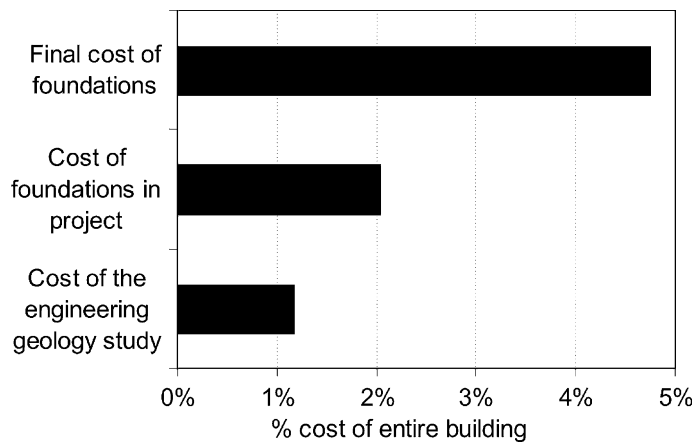
Figure 7. Percentage of cost of the foundation and engineering geology study, related with the cost of the building.

Considering the cost of the foundations in relation to the total cost of the building, it increased from the 2% predicted in the original design, to 4.8% after construction (Figure 7). The total costs for the construction of the building was €870 000.
