Natural and man made causes for the “Elísio de Moura” earth flow in Coimbra, Portugal.

MÁRIO QUINTA-FERREIRA

Department of Earth Sciences, University of Coimbra Portugal. mqf@dct.uc.pt

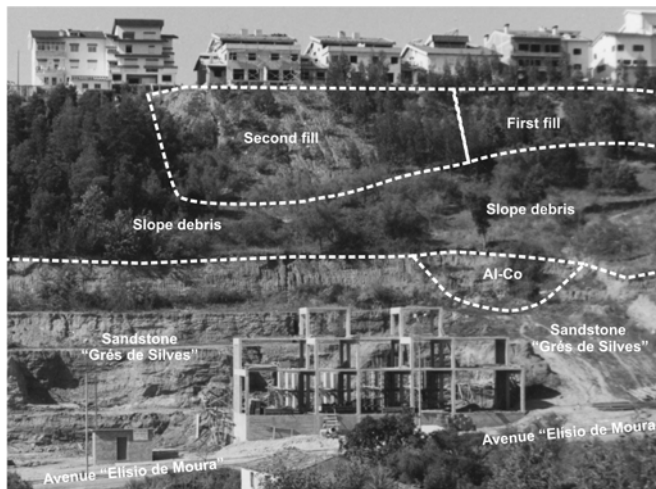
The urban expansion that occurred in the 1970s started with the construction of the “Elísio de Moura” avenue, named after a philanthropist doctor. By the end of the 1970s several platforms had been excavated on the west side of the avenue, stepped into the base of the hill (Fig. 1). These platforms, created in order to construct residential buildings, parking areas and garages, were excavated into both the slope debris and the underlying sandstone. The materials excavated from the north west of the “Elísio de Moura” avenue were transported to the top of the hill and dumped there, creating a wide platform. As a consequence, the angle of the hill slope was increased from the original 18° to 38° in the fills. Subsequently the platform formed by the fill at the top of the hill was used for the construction of several villas, seen in the upper part of Fig. 1.

Based on field observations, the distribution of the fills, information from residents and photographs dated from the spring of 1983, it is concluded that the dumping of the fill was done in two phases. The first filled area was completed in the middle of the 1970s. With a thickness of less than 7 m, the material was dumped essentially north of the failure area (Fig. 1). The second fill was completed at the beginning of the 1980s and had a thickness of up to 14 m. As seen in Fig. 1, small eucalyptus trees grew on this slope and erosion gullies had developed in the loose materials.

Figure 1 –Slope geology superimposed on a 1983 photograph indicating the fills placed at the top of the hill and the platforms excavated in the sandstone of the Grés de Silves (Photo of F. Gomes da Silva).

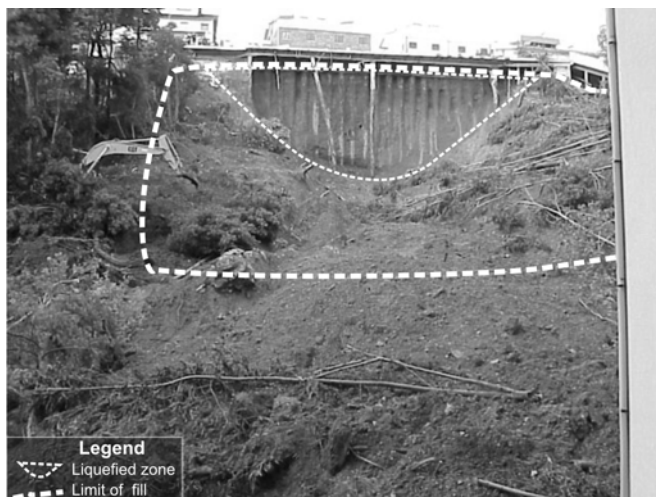
The following morning, it was possible to observe that a large volume of soils had moved downhill from below the line of piles (Figure 2). Before the failure, the concrete slab was less than 3 m above the fill while after the mass movement of

material downslope, the slab was as much as 13 m above the ground in the hollow. The soils which accumulated at the toe of the slope destroyed and buried two blocks of garages belonging to the building of the Elísio de Moura avenue and destroyed the three upslope pillars of a building at the first and second floor levels, leaving the remaining twelve floors suspended (Fig. 3). In addition, Lemos, et al. (2001) record the destruction of 27 garages and 31 cars. Fortunately no lives were lost.

The fieldwork allowed the local conditions to be determined, in particular the geomorphology, the geology and the characteristics of the disturbed area. The movement of the ground ranged from large "flow" movements in the central area to limited displacements at the sides (Fig. 4). Within the affected area, approximately 75m wide by 100m long (7,500m²), the main hollow seen in Fig. 2 had an area of some 1,400m².

The anchored piles constructed in 1998 significantly reduced the mass movement (Fig. 2), limiting the volume that failed and thus the damage, both at the top (close to the villas) and at the bottom of the slope. The volume of soil that remained unaffected above the anchored piles was some 15,000m³ (Fig. 6).

Figure 2 - General view of the earth flow, taken from the building at the bottom of the slope, showing the limit of the original fill. The maximum height of the piles exposed during the earth flow is 13m.

Following this site investigation, a programme of remedial works was prepared which included the placement of 33 piles. As these were required to penetrate into the sandstone bedrock, they had lengths of some 20 m. In order to provide sufficient lateral restraint, the piles were 0.8 m in diameter and placed at 1.5 m intervals. They were linked by a crest beam anchored into the bedrock beneath the villas, using sixteen 600 kN anchors at 3 m spacings, inclined at 45° (Macedo, 1998). These remedial works began on 3 August 1998 and have been described by

As noted above, the development of two cracks in 1998 resulted in the residents of the villas reinforcing the fill material by the placement of a number of piles. This decision proved to be extremely important. It not only saved the lives of the residents who were on the concrete slab at the moment of failure but also prevented the destruction of the villas at the top of the hill. Further, by limiting

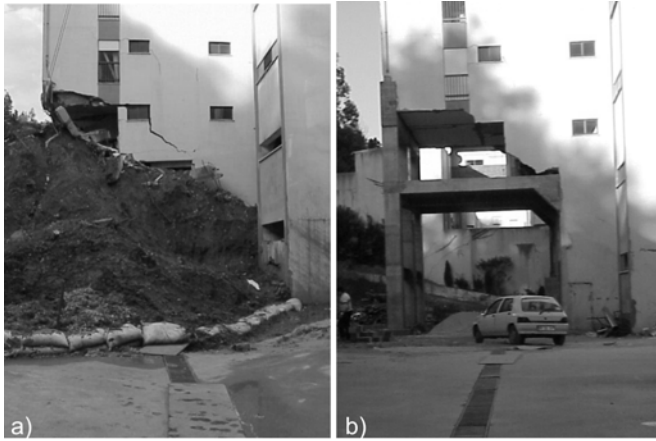
Figure 3 - Accumulation of soils against the building at the foot of the earth flow, which destroyed two floors, leaving the remaining twelve floors suspended. a) After the failure; b) One year later, after repairing the affected concrete structure.

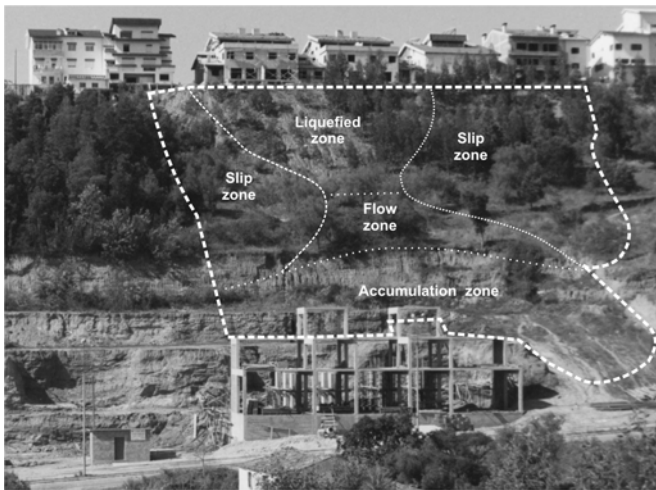
induced the liquefaction of about 10,000m³ of saturated soils where the fill was thickest. The liquefied “mud like” material ran downhill through a bottle-neck shape (Figs. 4 and 5), hitting the garages and apartment block at the base of the hill.

Figure 4 – Zoning of the earth flow superimposed on a 1983 photograph.

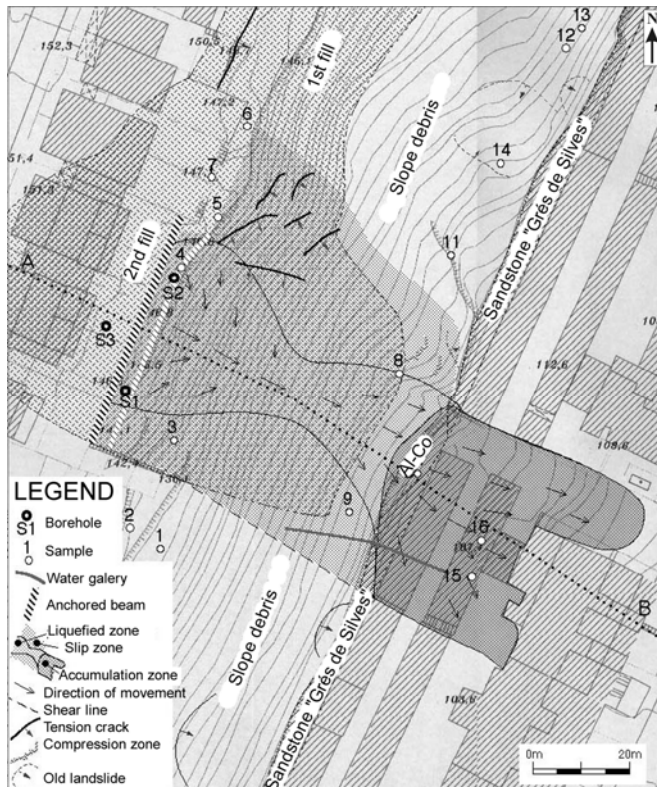
modified Proctor and direct shear. The direct shear test was undertaken on two samples, one from the fill and one from the slope debris. Figure 5 indicates the sampling locations and a summary of the test results is given in Table 3.

Figure 5 – Geological map and limits of the earth flow (modified from Lemos & Quinta-Ferreira, 2004).

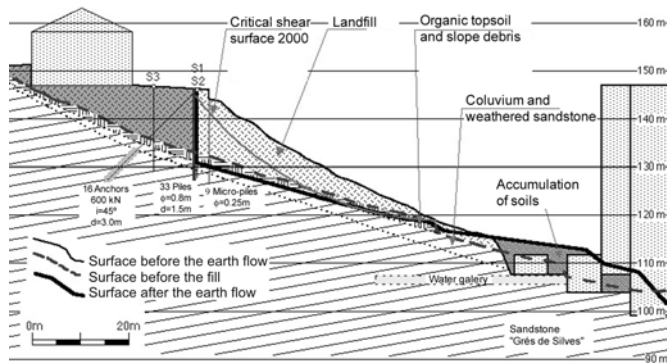
As discussed above, the main earth flow had a valley-type profile with the material to the sides of the hollow experiencing little movement. From the information obtained during the investigation, the likely rupture surface is indicated in Fig. 6. This shows the failure is likely to have taken place through the debris veneer present before the fill was placed which had a lower shear strength.

Figure 6 – Cross section along the earth flow (line AB of Fig. 5); modified from Lemos & Quinta-Ferreira, 2004.

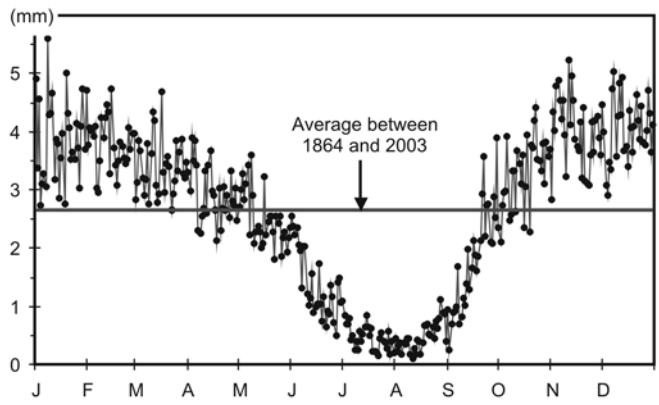
Based on the precipitation data from 1864 to 2003, the daily average rainfall distribution in Coimbra is shown in Fig. 7. From Fig. 7 and Table 2, the annual rainfall pattern can be seen to involve seven months (October to April) with average daily rainfalls above 2.65mm and five months (May to September) with lower rainfall values. The lowest values for daily average rainfall are found between the middle of July and the middle of August, with minimum values of less than 0.1mm.

Figure 7 – Distribution of daily average rainfall, and average between 1864 and 2003.

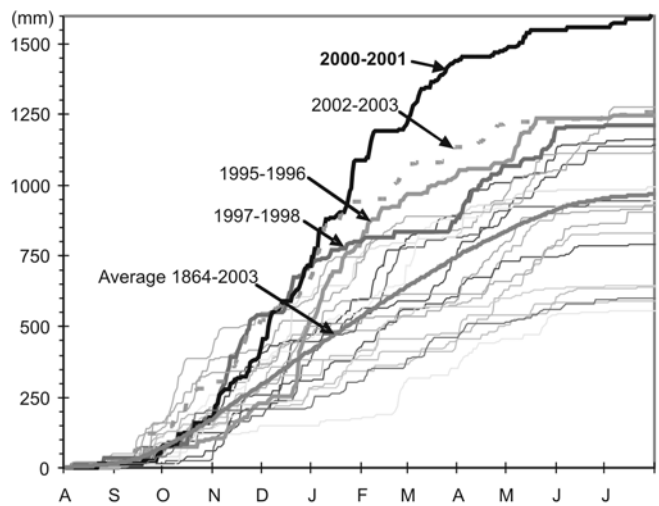
Analysis of the rainfall between 1864 and 2003 indicates that the wettest year was in 1935/36 with 1716 mm and the driest year 1952/53 with only 468mm. Table 2 gives the precipitation characteristics of the area on a monthly basis, indicating the maximum and minimum monthly rainfall and highlighting the year in which the maximum rainfall occurred. It also provides the maximum, minimum and average daily rainfall for each month and when the maximum rainfall in a single day occurred, giving the day, month and year. Figure 8 shows the accumulated rainfall in each of the years from 1982/83 to 2002/03. It can be seen that the year 2000/01 was unusually wet, with 1612mm of rainfall compared with the average of 968mm. In the 139 years of records, there are only four years with precipitation above 1600mm, indicating a mathematical re-occurrence interval of 30 years.

Figure 8 – Accumulated rainfall for the years 1982/83 to 2002/03 and accumulated average from 1864 to 2003. A few relevant years are identified.

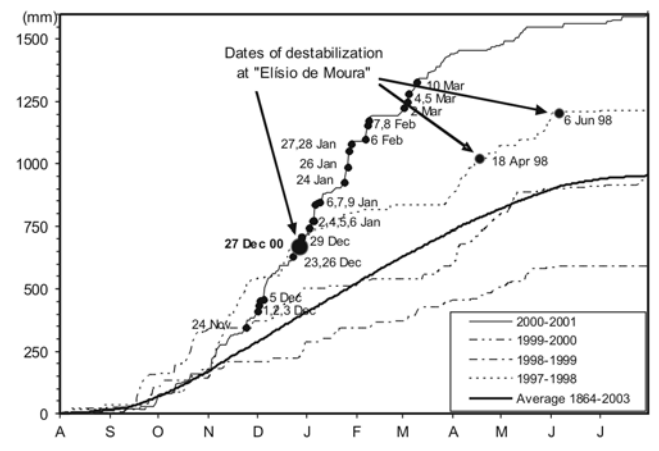
Figure 9 shows the accumulated rainfall for the year 2000/01, starting at 1 August. The Elísio de Moura earth flow on 27 December 2000 and the problems of April and June 1998 are highlighted. As discussed above, the total rainfall in 2000/01 was significantly in excess of that recorded in other years and in November and December when there were only 11 days without rain. As a consequence, at the time of the Elísio de Moura earth flow (27 December 2000) the fill and slope debris were saturated. In November 2000, the accumulated rainfall was 231mm, compared with the average of 120mm (an increase of 193%) while in December (until the date of the failure), the accumulated rainfall was 272 mm, 217% above the average for the whole month of December. Thus, the total rainfall during November and December was 503mm, which corresponds to more than half of the annual average rainfall (968 mm).

Figure 9 – Accumulated rainfall for the years 1997/98 to 2000/01, accumulated average from 1864 to 2003 and dates of occurrence of landslides in the area of Coimbra.
