**EXPERIMENTAL AND NUMERICAL
THERMOMECHANICAL CHARACTERIZATION
OF REFRACTORY MASONRIES**

**Tese no âmbito do Doutoramento em Engenharia de Segurança ao
Incêndio orientada pelo Professor Doutor João Paulo Correia
Rodrigues da Universidade de Coimbra e pelo Doutor João Miguel
Pereira da Universidade do Minho e apresentada ao
Departamento de Engenharia Civil da Faculdade de Ciência e
Tecnologia da Universidade de Coimbra.**

Abril de 2022

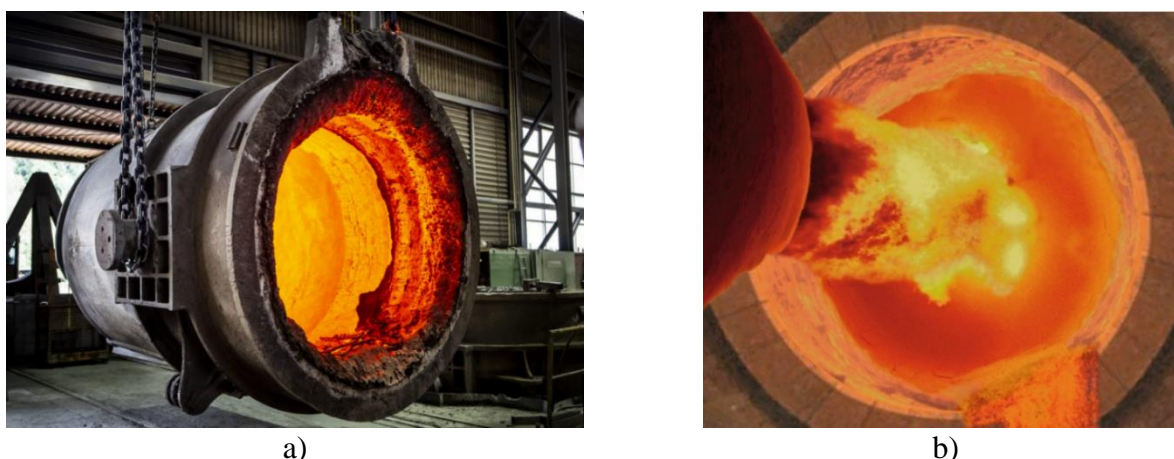
Figure 1-1 – Refractory linings: a) steel ladle (Seven Refractories, 2021); b) rotary cement kiln (ZKG, 2021)

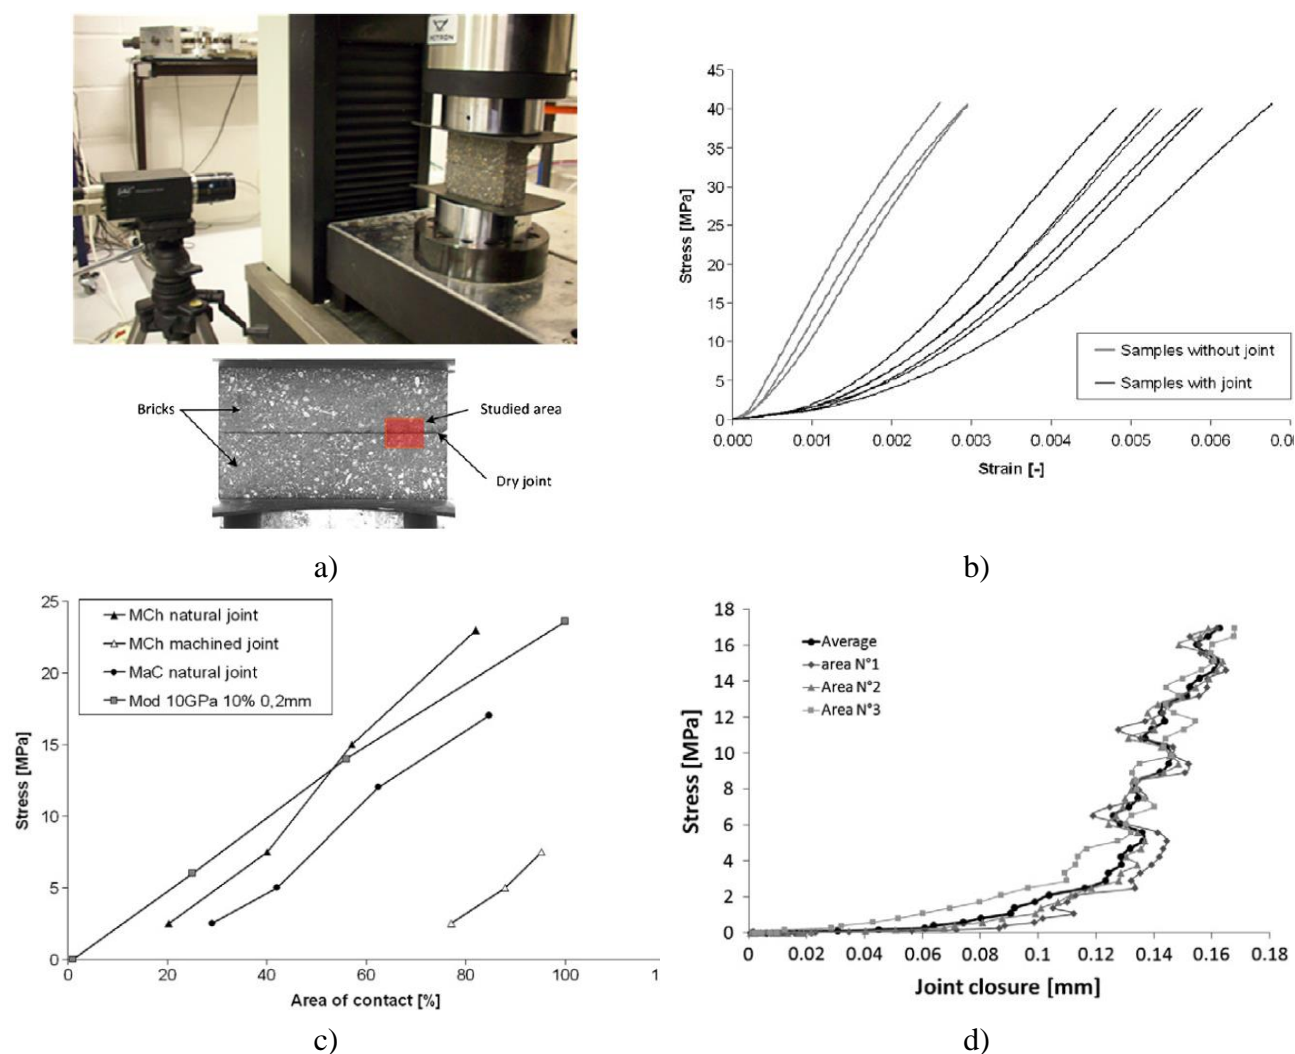
Figure 2-13 – Experimental research: a) Experimental set-up, b) Effects of joints in the materials behaviour; c) Increasing of contact area with load; d) Scattering in joint closure. Reprinted from (Andreev *et al*, 2012)

Andreev *et al* (2012) also characterized the compressive behaviour of dry joints in refractory masonries using the aid of the Digital Image Correlation (DIC) technique. The authors performed compressive tests in prisms formed by magnesia-carbon and magnesia-chromite bricks in a wide temperature range (**Figure 2-13a**). They highlighted that the exponential form of the joint closure curve is a result of the gradual crushing of initially non-parallel surfaces (**Figure 2-13b**). The tests have shown that the temperature influences the joint closure by changing the stiffness of the material and reducing the initial gap by thermal elongation. The contact area between the bricks was found to be proportional to the applied stress (**Figure 2-13c**). The authors observed that the joint thickness is not constant along the joint due to surface roughness, bricks' shape variations and non-parallelism of faces (**Figure 2-13d**).

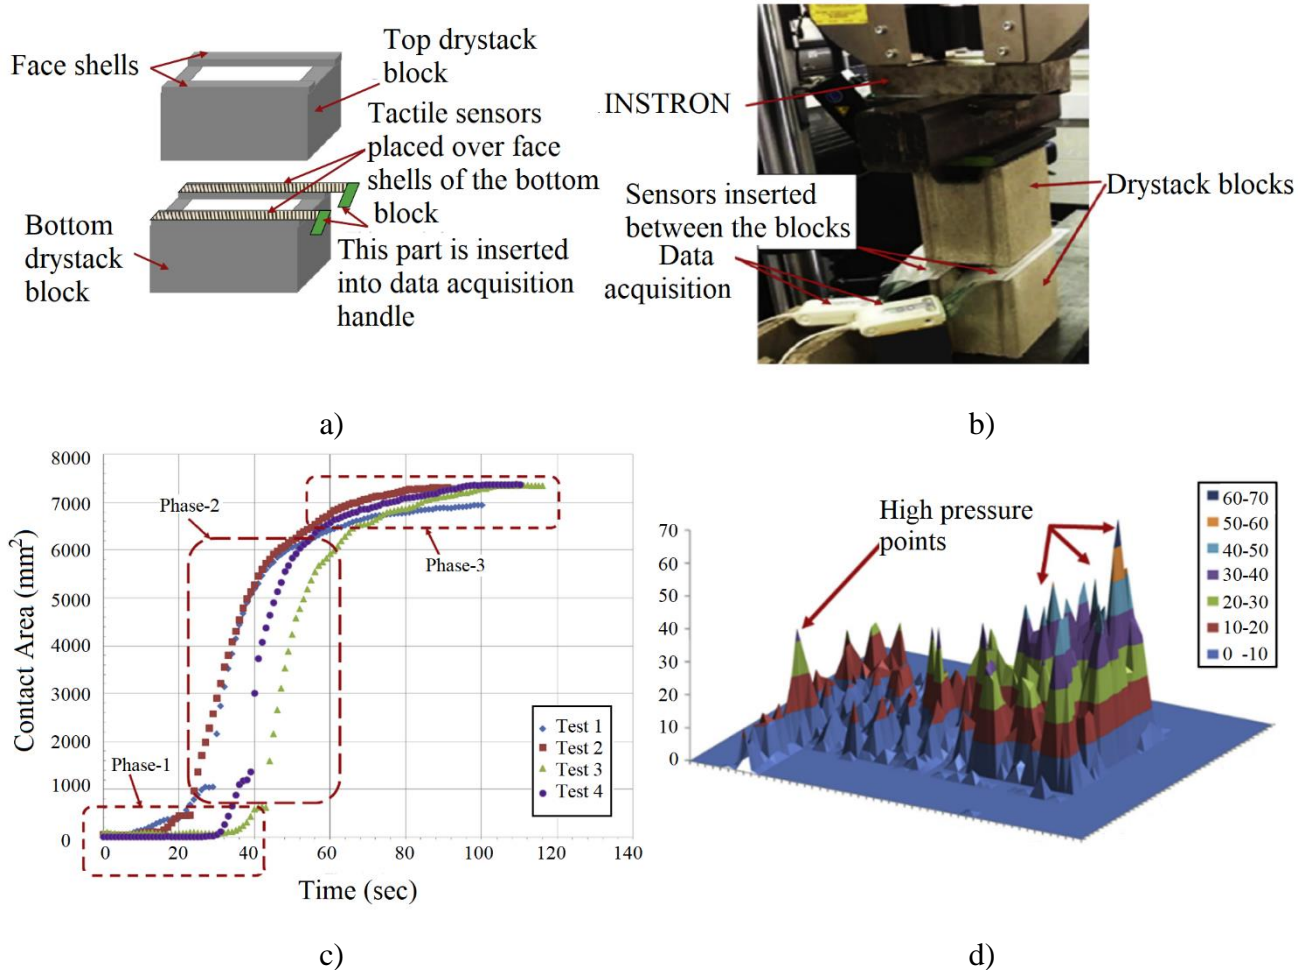
Figure 2-15 – Experimental research: a) Experimental set-up; b) Scattering of results; c) strain fields at the joints; d) displacement fields at the joint. Reprinted from (Zahra and Dhanasekar, 2018)

are observed even for higher loads, most likely caused by high strength coarse aggregates that are not crushing during the test (**Figure 2-15d**). The authors proposed techniques to mitigate the unevenness contact conditions, however, these techniques seem less interesting in the case of refractory masonries due to the high temperatures in service.

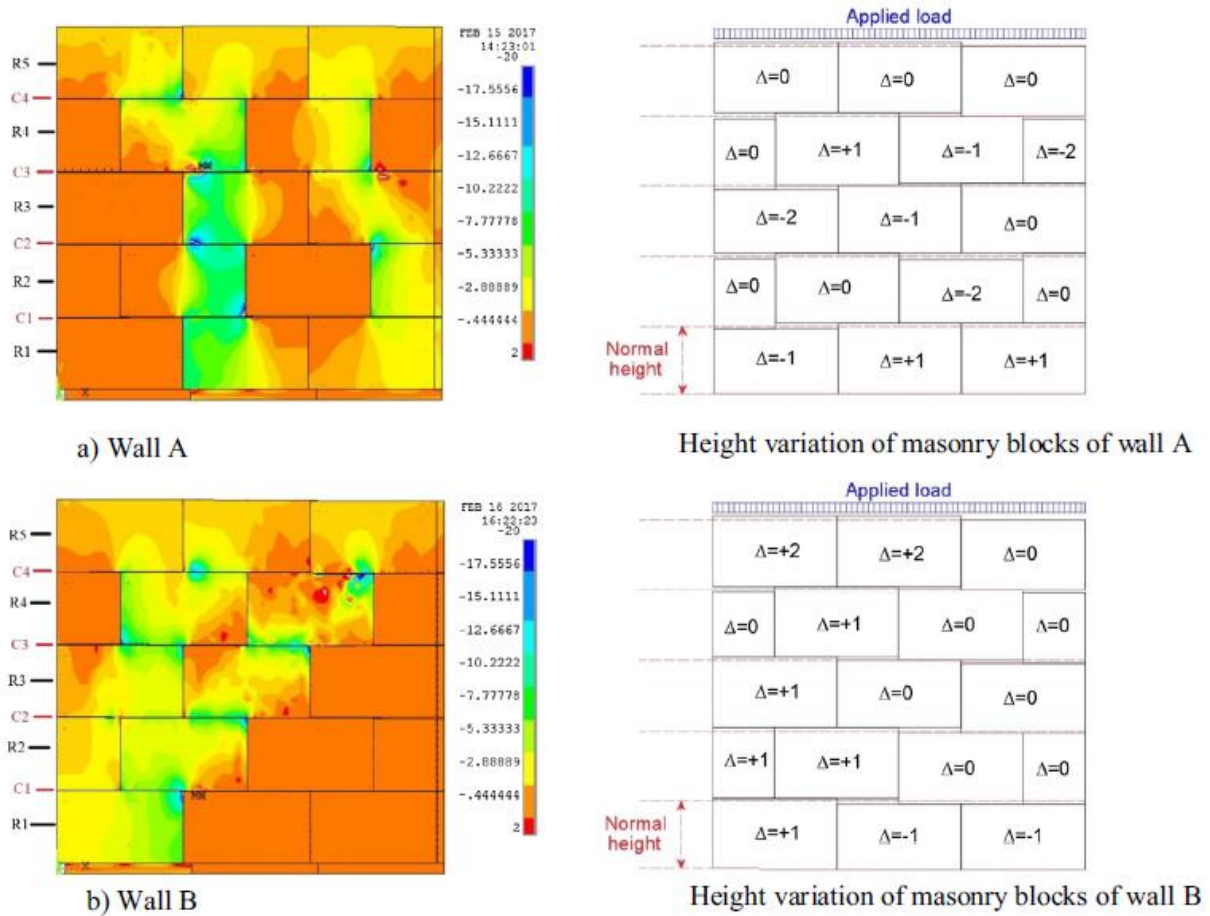
Figure 2-17 – Numerical study: a) Stress distribution [MPa] in wall A; b) Stress distribution [MPa] in wall B (Ngapeya *et al*, 2018)

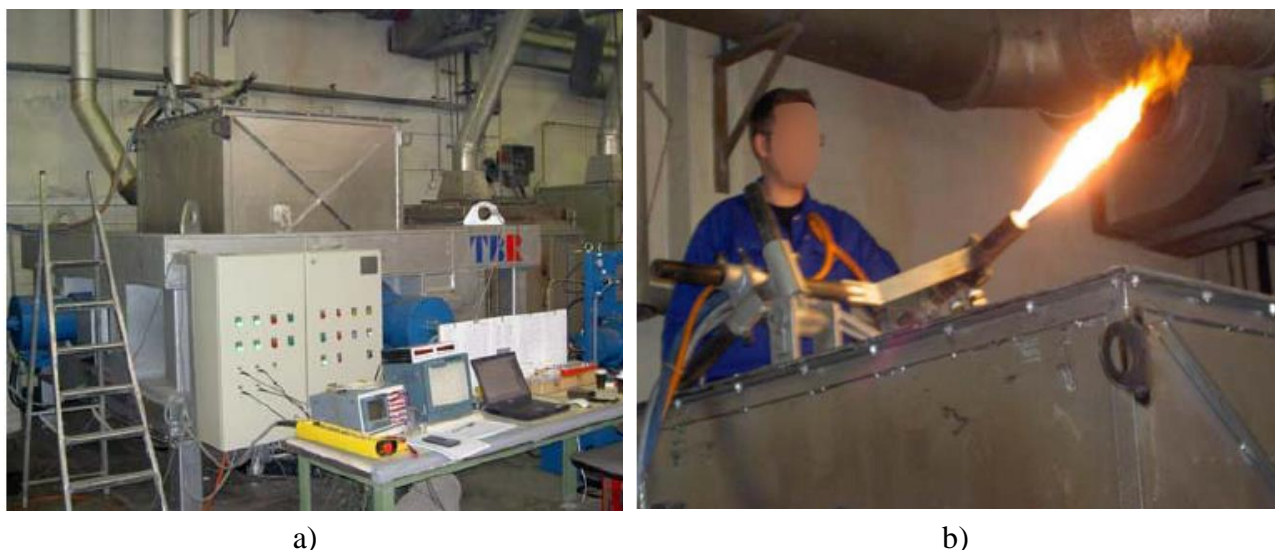
A heating hood was used in the tests performed at high temperatures (**Figure 2-21a**). The hood was designed to withstand up to 1400°C, thus it was built by a 8 mm steel shell and a 200 mm thick ceramic wool lining was used for thermal insulation. A gas burner was used to heat the specimen (**Figure 2-21b**). The experimental setup used by Prietl (2006) was enhanced and improved in the scope of this doctoral research, as detailed in Chapter 5.

Figure 2-21 – Biaxial press: a) Experimental setup; b) Gas burner (Prietl, 2006)

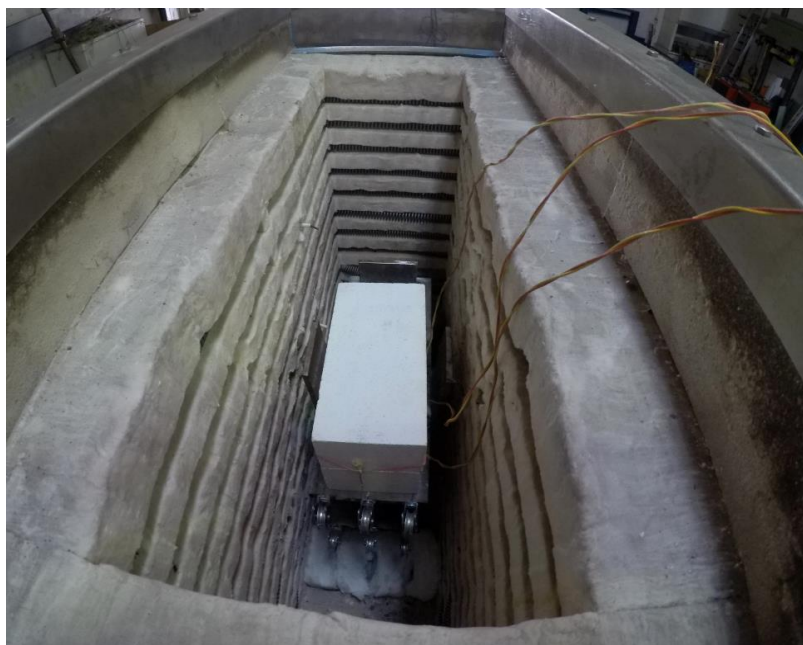
The specimens consisted of two stacked bricks of type *B* (250×124×76 mm), therefore the final dimensions of the prism were 250×124×152 mm (Oliveira *et al*, 2019). The prism can be seen in **Figure 3-31**.

Figure 3-31 – Prism composed by two stacked bricks inside the furnace chamber

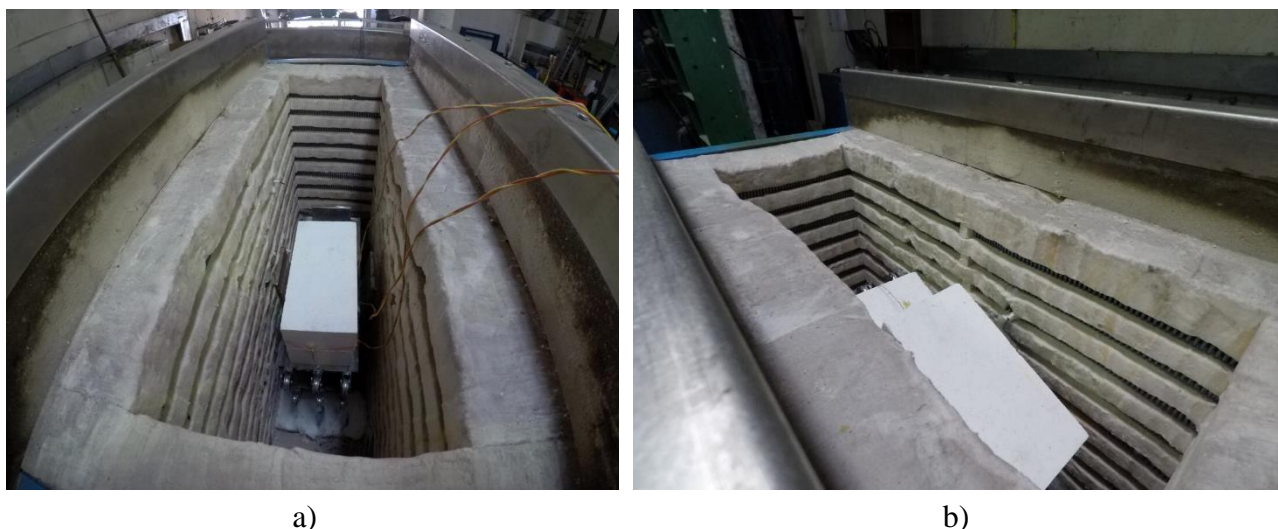
The configuration of the specimens before and after the tests are shown in **Figure 3-35**. The slipping of the bricks occurred aligned as expected, the bricks did not touch the lateral steel pieces used to protect the resistances of the furnace.

a) b)
Figure 3-35 – Slip test specimens: a) Beginning of the test; b) After slipping

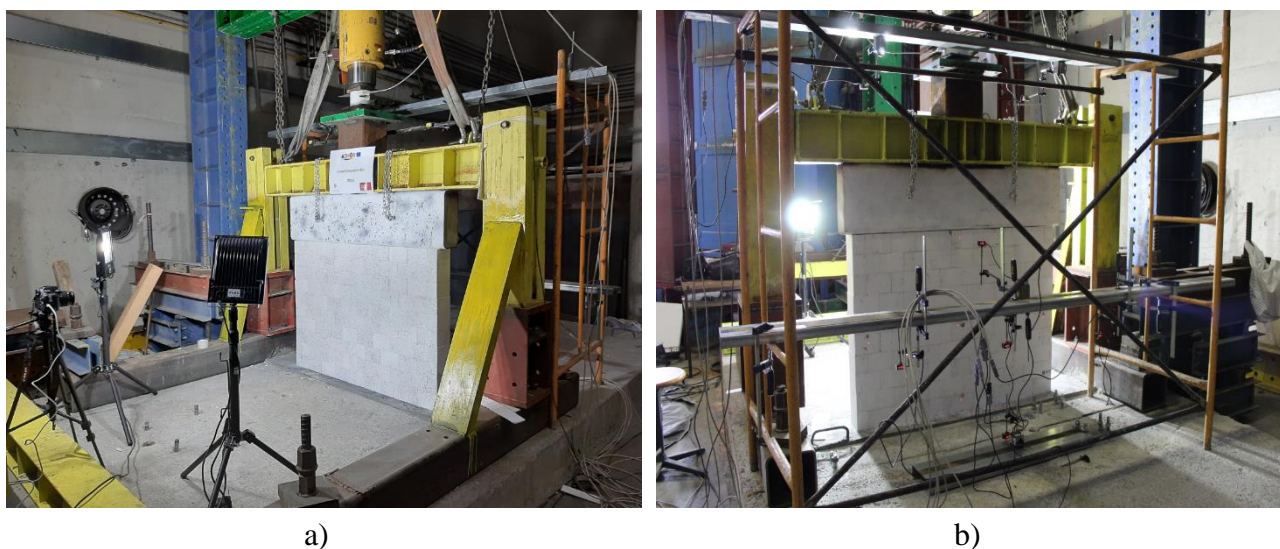
The test set-up consisted of one reaction frame composed by two HEB500 columns and two overlapping HEB600 beams (4500 mm span). The hydraulic jack had the capacity of 3000 kN and the load cell used to measure the applied load had the capacity of 5000 kN. For the experiments performed at high temperatures one modular electric furnace (45 kVA) was used to heat the specimens. The hydraulic jack applied the load in the plane of the wall by two load beams. The top one was a HEB240 steel beam with web stiffeners and the bottom one was a composite beam (tubular steel section filled with concrete). The verticality of the load application was ensured by two lateral steel frames working as guides. The hydraulic jack was controlled by a servo hydraulic central unit W+B NSPA700/DIG2000. Aiming to limit the heat losses, two masonry columns were built at the edges of the specimens, the gap between the masonry wallet and columns (15 mm) was filled with rockwool, therefore, there was no mechanical restraint at the sides of the specimen.

The reaction frame was bolted to the laboratory slab by eight steel anchors ($\phi 40$ mm). The specimens were built in the reaction slab over a 10 mm grout layer. Rockwool was used for the thermal insulation of the reaction slab and to fill the gap between the specimens and the lateral masonry columns. The pictures of the experimental set-up are presented in **Figure 4-2** and **Figure 4-3** for the tests at ambient and high temperatures, respectively.

Figure 4-2 – Test set-up at ambient temperatures: a) Front view; b) Back view

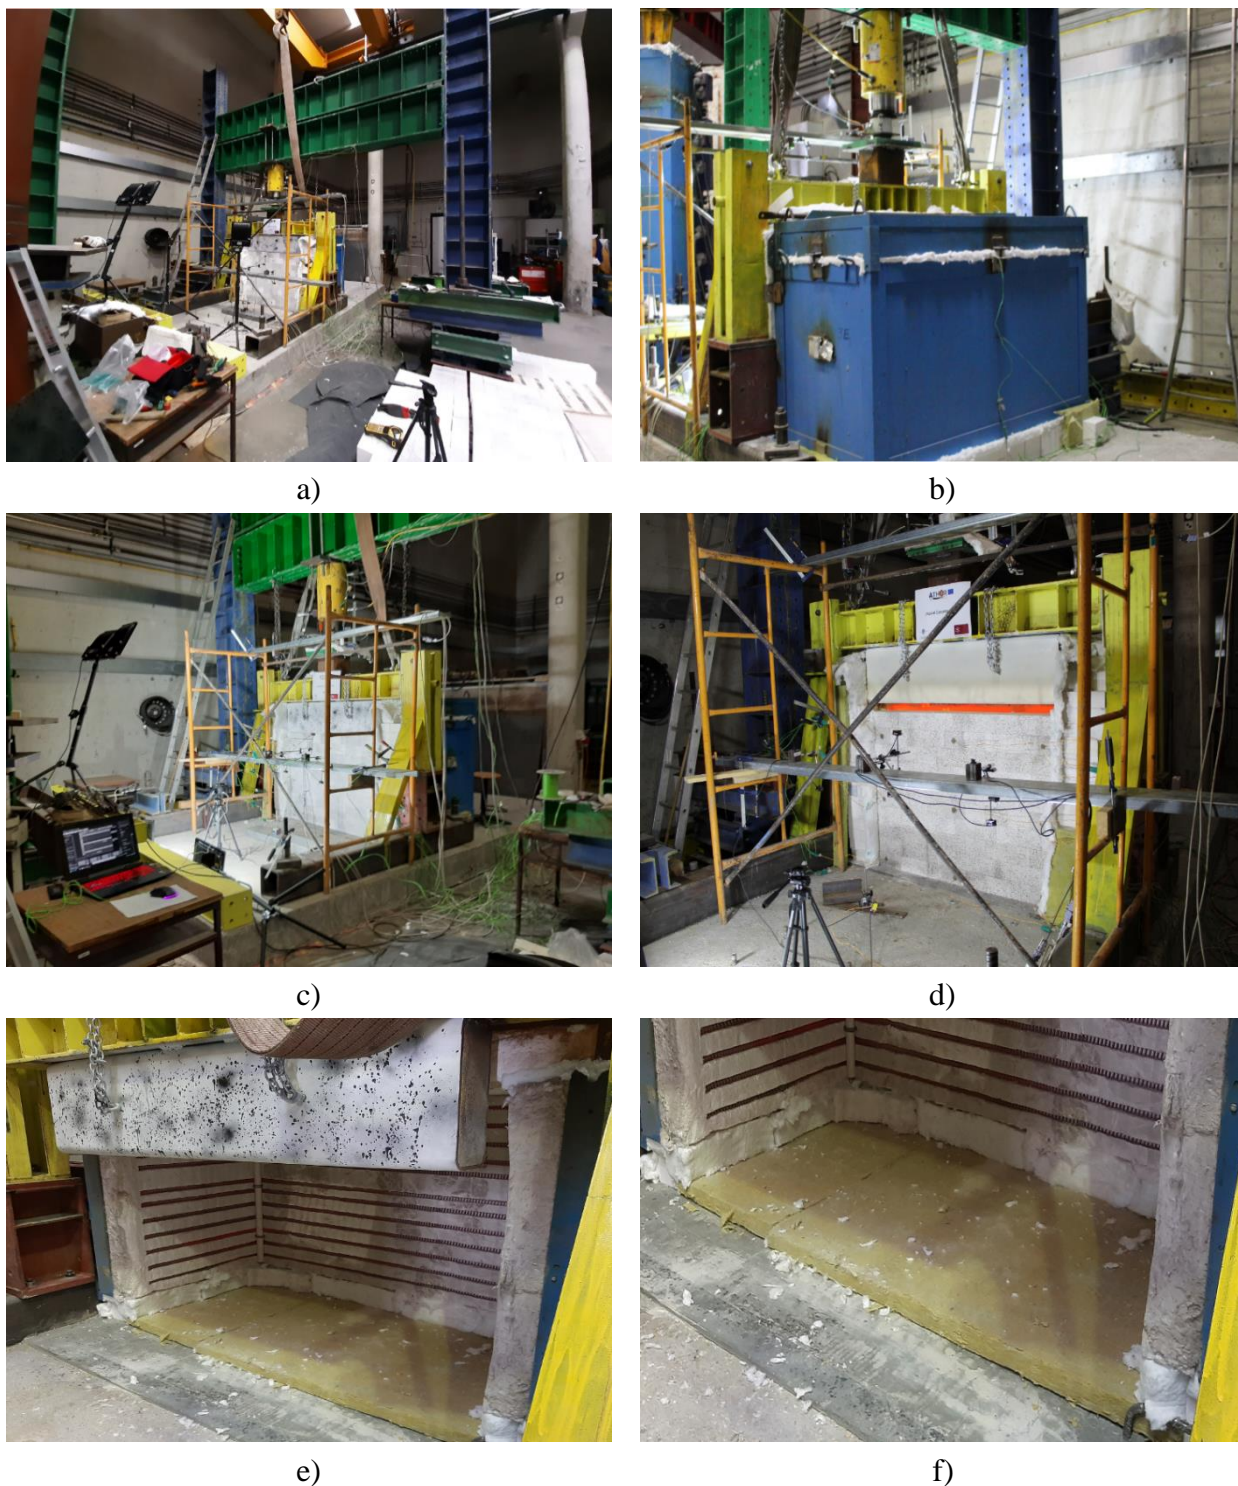
Figure 4-3 – Test set-up at high temperatures: a) General overview of the test setup; b) Back view; c) Specimen in position for testing; d) End of the test; e) Resistances of the furnace; f) Bottom insulation

The temperatures in the first course of the bricks (bottom of the wall), measured by TC-07, TC-08 and TC-09, were lower than the average temperatures of the wall. This was caused in part by the furnace’s internal arrangement of the resistances, making this area less exposed to radiation (**Figure 4-3e**), due to heat losses through the reaction slab (**Figure 4-3f**), and due to the air convective currents inside the furnace.

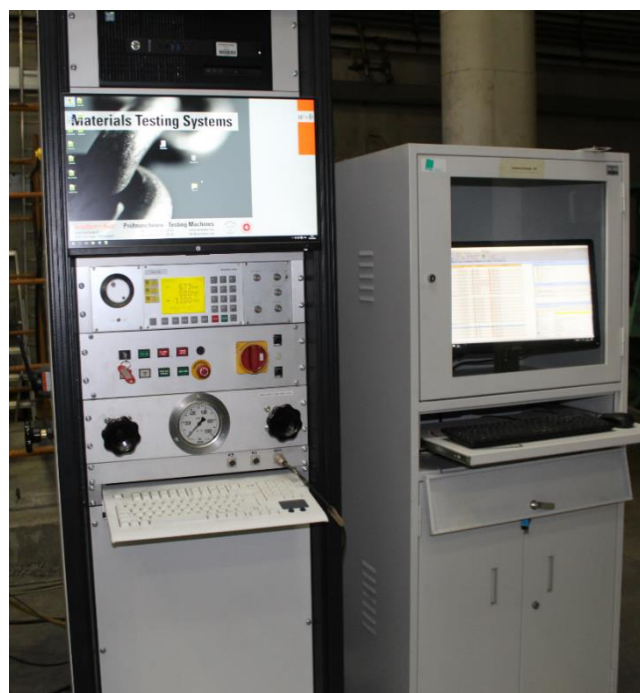
The servo hydraulic central unit W+B NSPA700/DIG2000 and the data acquisition system are presented in **Figure 4-5**.

Figure 4-5 – Servo control central unit and data acquisition system

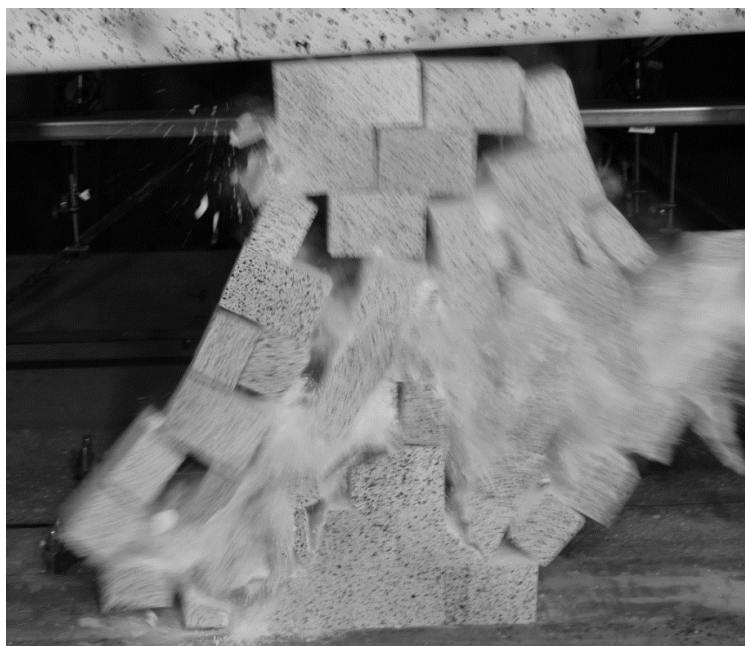
During stage *iii*, a slight decrease of the wall's stiffness was observed, which is typical on masonry due to the development of cracks in the material. These cracks are mostly thin and distributed in the specimen. A very brittle failure was observed in all specimens. The compressive strength for specimens S01.AT.LBC.01, S01.AT.LBC.02 and S01.AT.LBC.03 was 17.5 MPa, 13.5 MPa and 22.5 MPa, respectively. Specimen S01.AT.LBC.02, presented a low compressive strength due to an uneven load distribution in the specimen, caused by a relatively large shape imperfection, as observed in the DIC analysis (Figure 4-14a). The average compressive strength was 17.8 MPa (20.0 MPa if specimen S01.AT.LBC.02 is disregarded). The failure sequence is presented in Figure 4-15. **Figure 4-16** presents the picture taken by the DIC camera during the failure of specimen S01.HT.LBC.02.

Figure 4-16 – Test series S01.HT.LBC.02 – Specimen failure

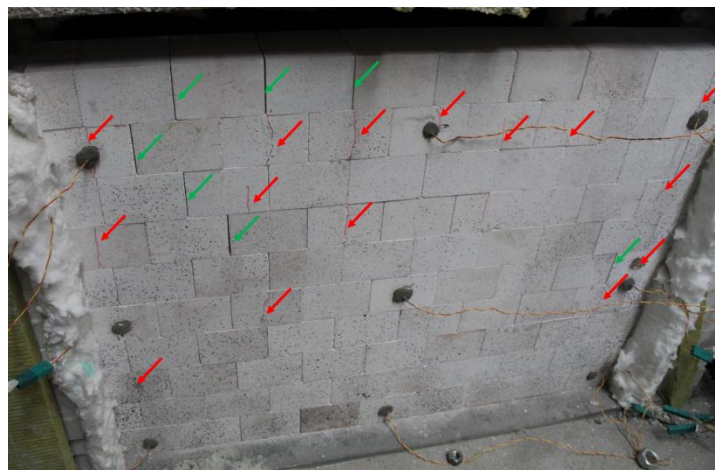
Despite the relatively low load level in the wall, again some cracks were observed between the load application beam and the wall’s top surface (similar to Figure 4-27). Figure 4-33 presents vertical cracks observed in the middle of the bricks (indicated by the red arrows), caused by an unevenness stress distribution, as discussed in test series S02.AT.CIC and S03.HT.LL8. Rigid body motions

Figure 4-33 – Test series S04.HT.RTE – Failures in the wall: Vertical cracks in bricks and joints openings (S04.HT.RTE.02)

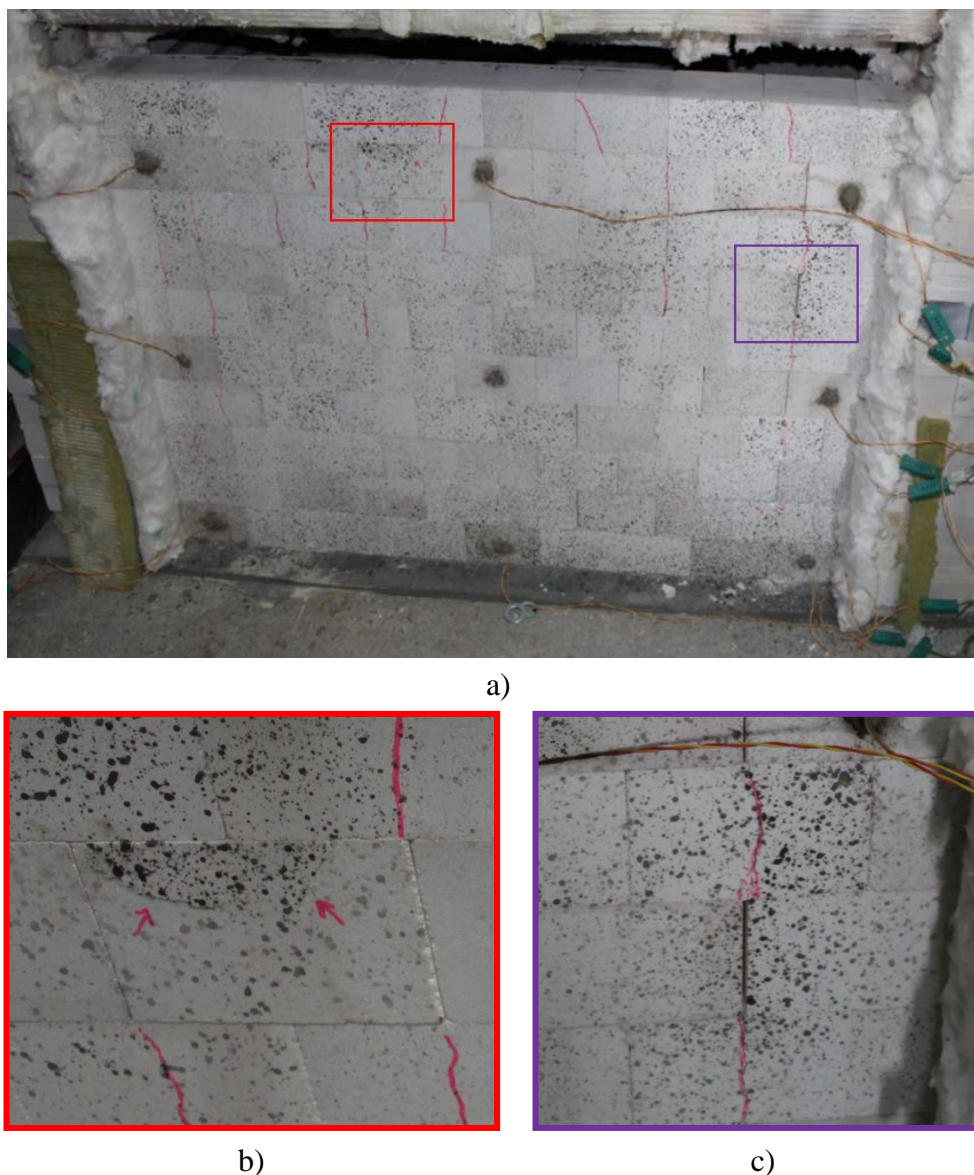
Figure 4-34 – Test series S04.HT.RTE – Overview of vertical cracks in specimen S04.HT.RTE.01; b) Brick crushing due to stress concentrations at the cross joints; c) Brick cracks and joint opening

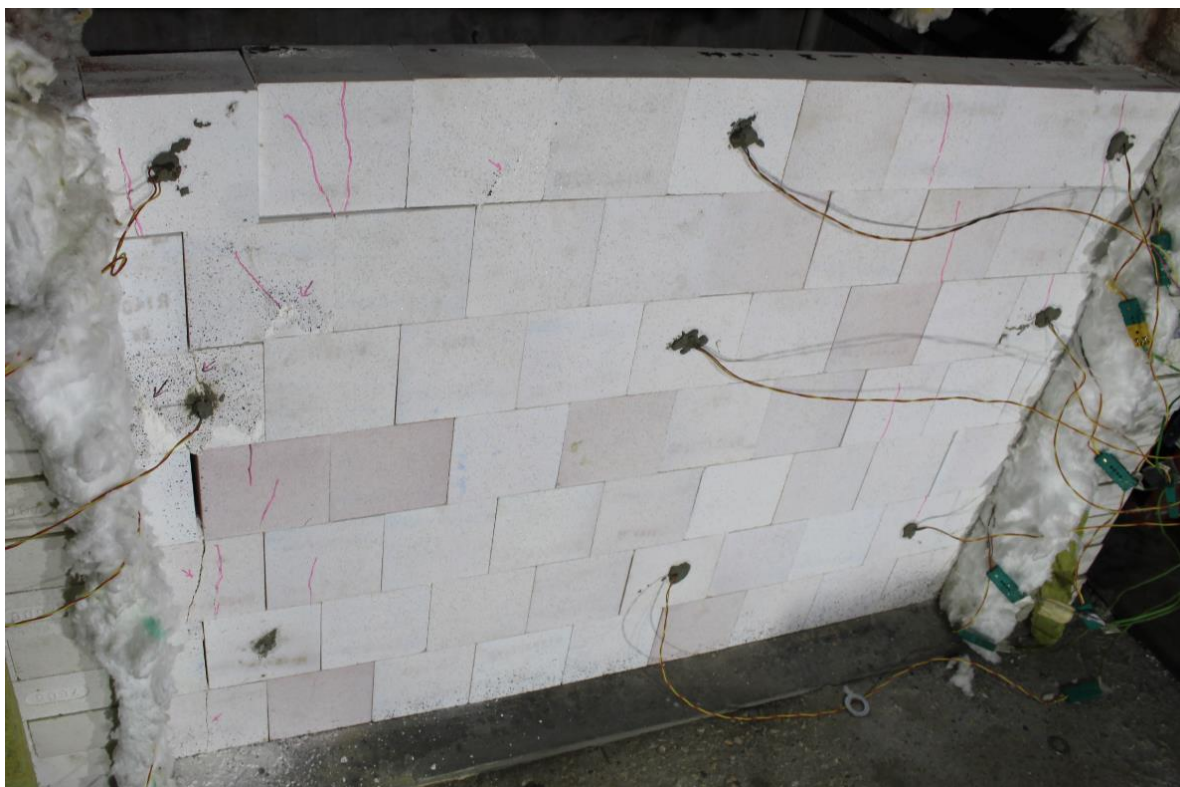
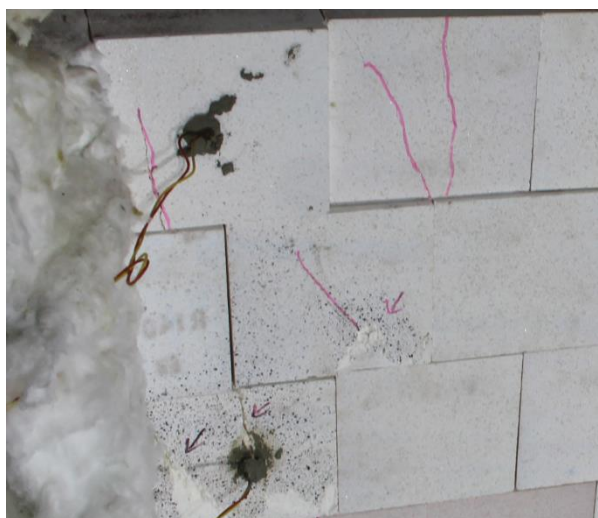
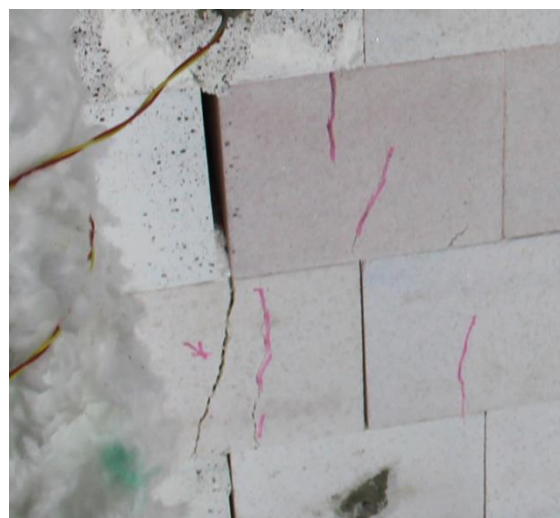
The test for specimen S05.HT.LL10.01 was finished after 360 minutes. At this moment, a positive displacement of 0.49 mm ($\varepsilon = 0.0005$) was registered. The failure of this specimen was not observed in the test. Nevertheless, some cracks and crushing were observed in the specimen, as shown in **Figure 4-39a**. The temperatures in specimen S05.HT.LL10.02 increased slightly faster in comparison with the other specimen due to the thermal insulation installed in front of the wall. As shown in **Figure 4-39a**, the strain rate of S05.HT.LL10.02 was higher as the thermal elongation is more significant.

Figure 4-39 – Test series S05.HT.LL10 – Vertical cracks in bricks and joint openings in specimen S05.HT.LL10.01: a) Crack's location; b) Details of the top left side; c) Details of the bottom left side

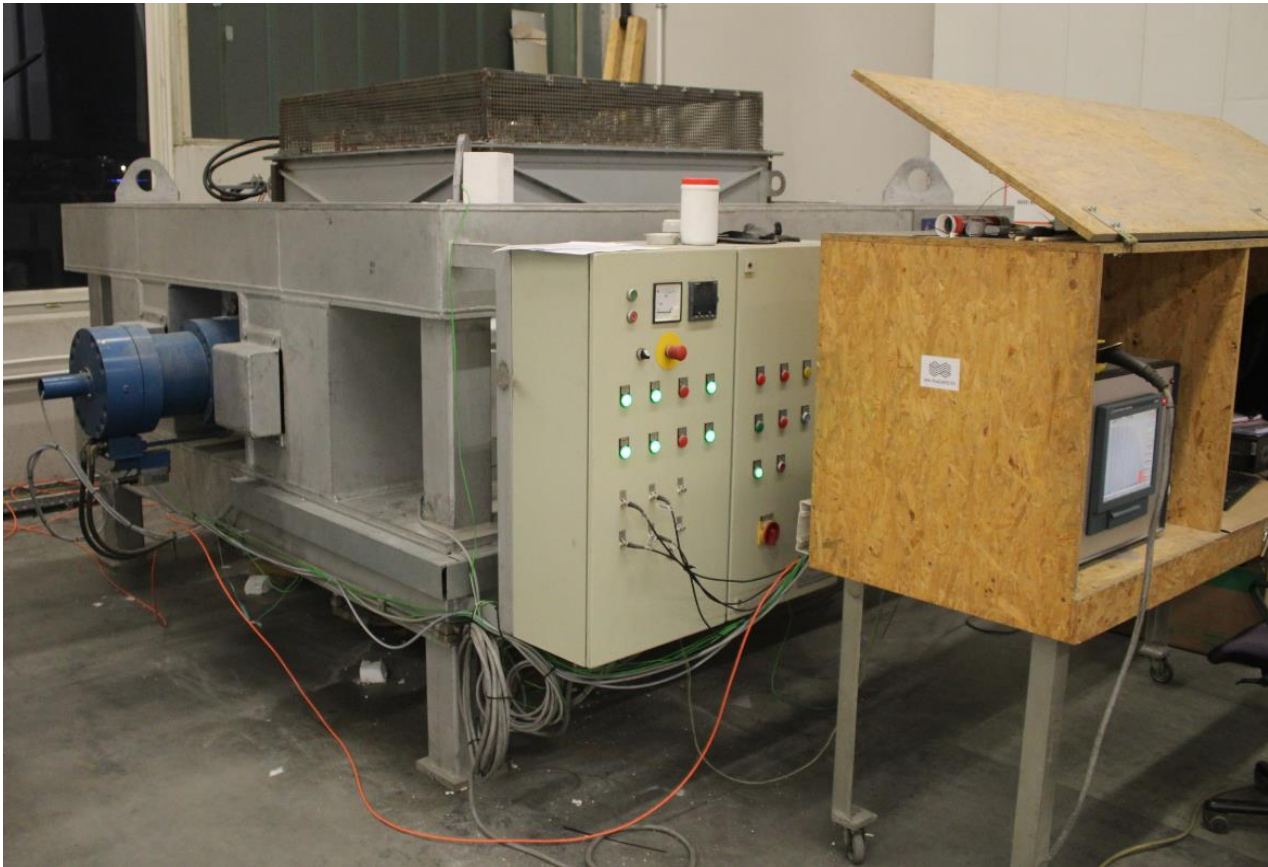
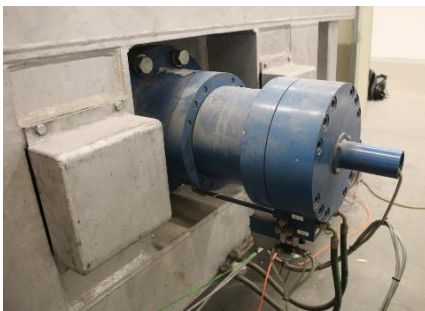
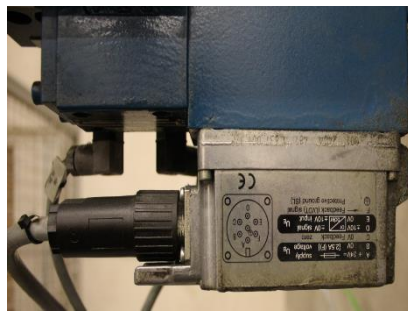
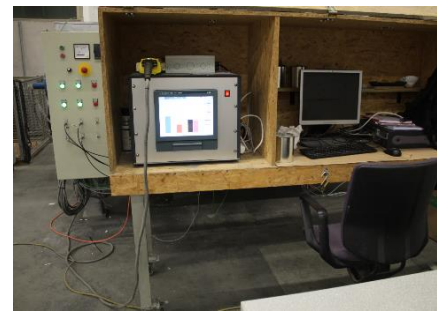
The test set-up consisted of a monolithic reaction frame in which the hydraulic jacks, LVDTs and heating system were connected. Two perpendicular hydraulic jacks with the capacity of 1000 kN were used, a Rexroth controller unit was used to control them. The applied forces were measured by two pressure gauges per cylinder. A 48-channel data acquisition system was used to record the data from the experiments. The biaxial press is shown in **Figure 5-2**.

Figure 5-2 – Test set-up: a) Isometric view; b) Hydraulic jacks; c) Pressure gauges; d) Data acquisition system

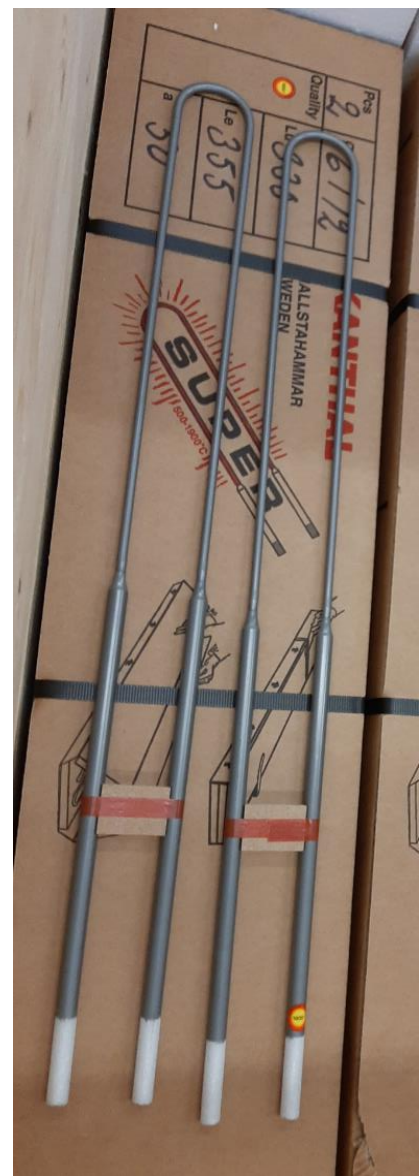
Figure 5-6 – Heating chamber: a) Overview; b) Bottom view; c) Heating elements details

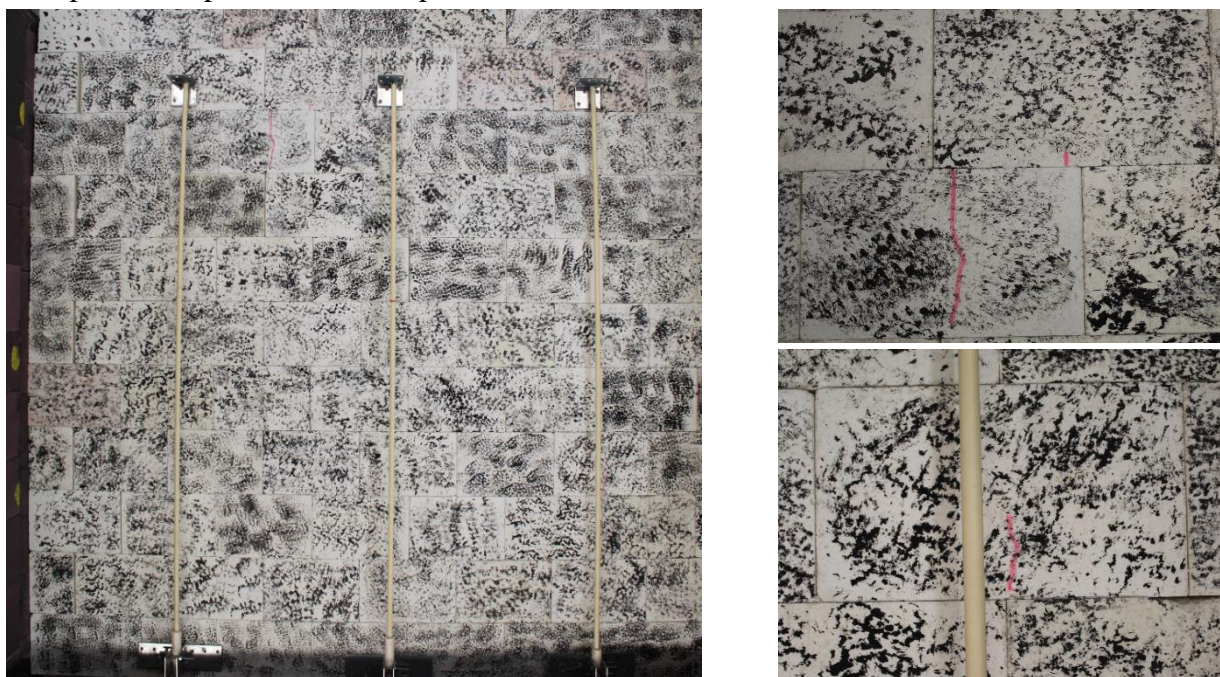
Figure 5-27 – Test series S06.AT.LBJ – Cracks observed in the specimen S06.AT.LBJ.01

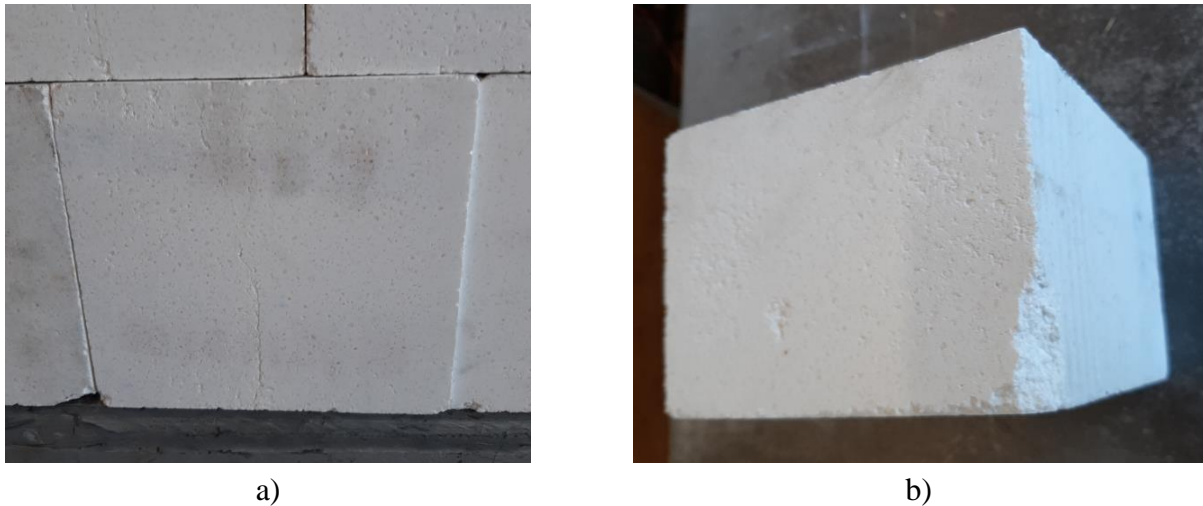
The cracks observed in the specimen was similar to the ones already discusses in the previous sections. **Figure 5-37** shows the cracks observed in the bed joints and the crushing in the edges of the bricks at the head joints.

Figure 5-37 – Test series S08.AT.LBI – Cracks observed in the specimen: a) Cracks at cross joints; b) Crushing at head joint

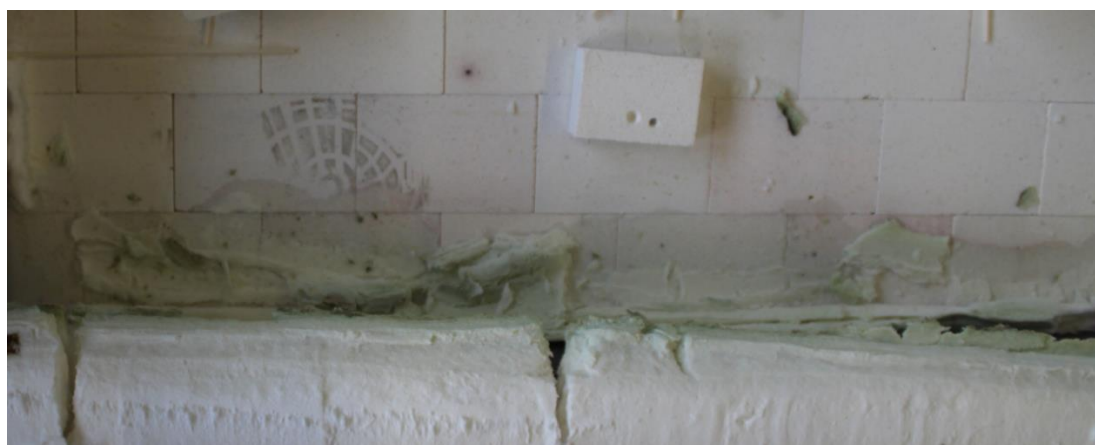
The rockwool used for insulation melt during the test. The molten material got in touch with the specimen, and it was possible to identify some corrosion caused by the reaction between the alumina spinel brick and the rockwool, as shown in **Figure 5-51**. Nevertheless, only surface damage was observed.

Figure 5-51 – Test series S09.HT.CBJ – Reaction between alumina-spinel bricks and rockwool insulation

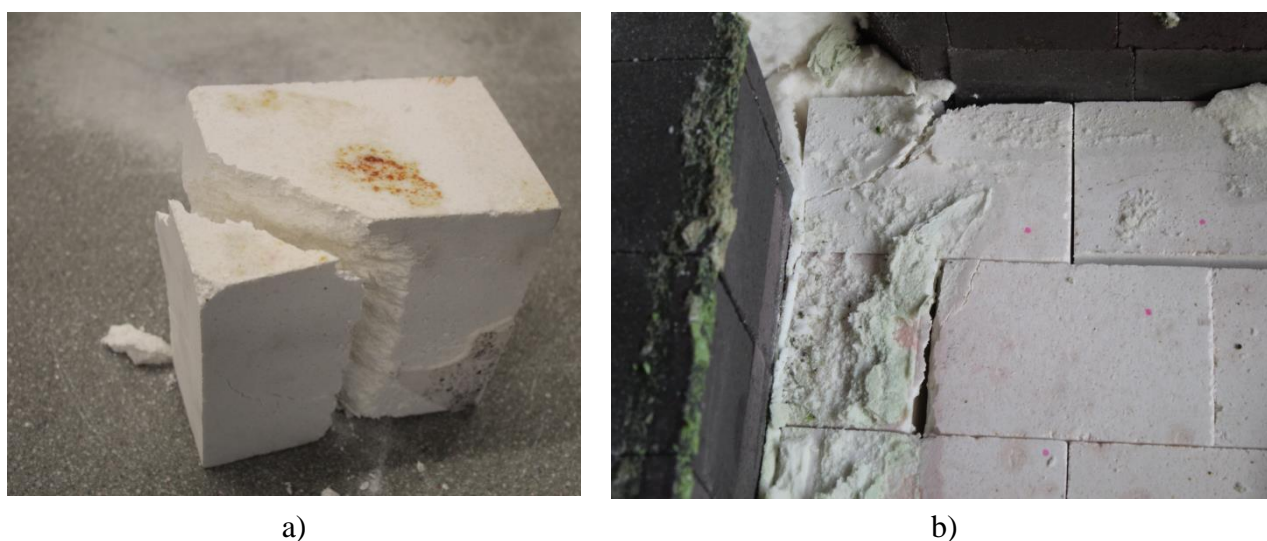
As noticed in test series S09.HT.CBJ, the shear failure observed in the brick situated in the edge of the wall also happened. The chamfers in the linings of the moveable plungers (**Figure 5-5d**) resulted from a non-homogeneous load distribution in this brick that led to shear failure associated to creep.

Figure 5-59 – Test series S09.HT.CBJ – Shear failure associated to creep at the brick adjacent to the plunger chamfers

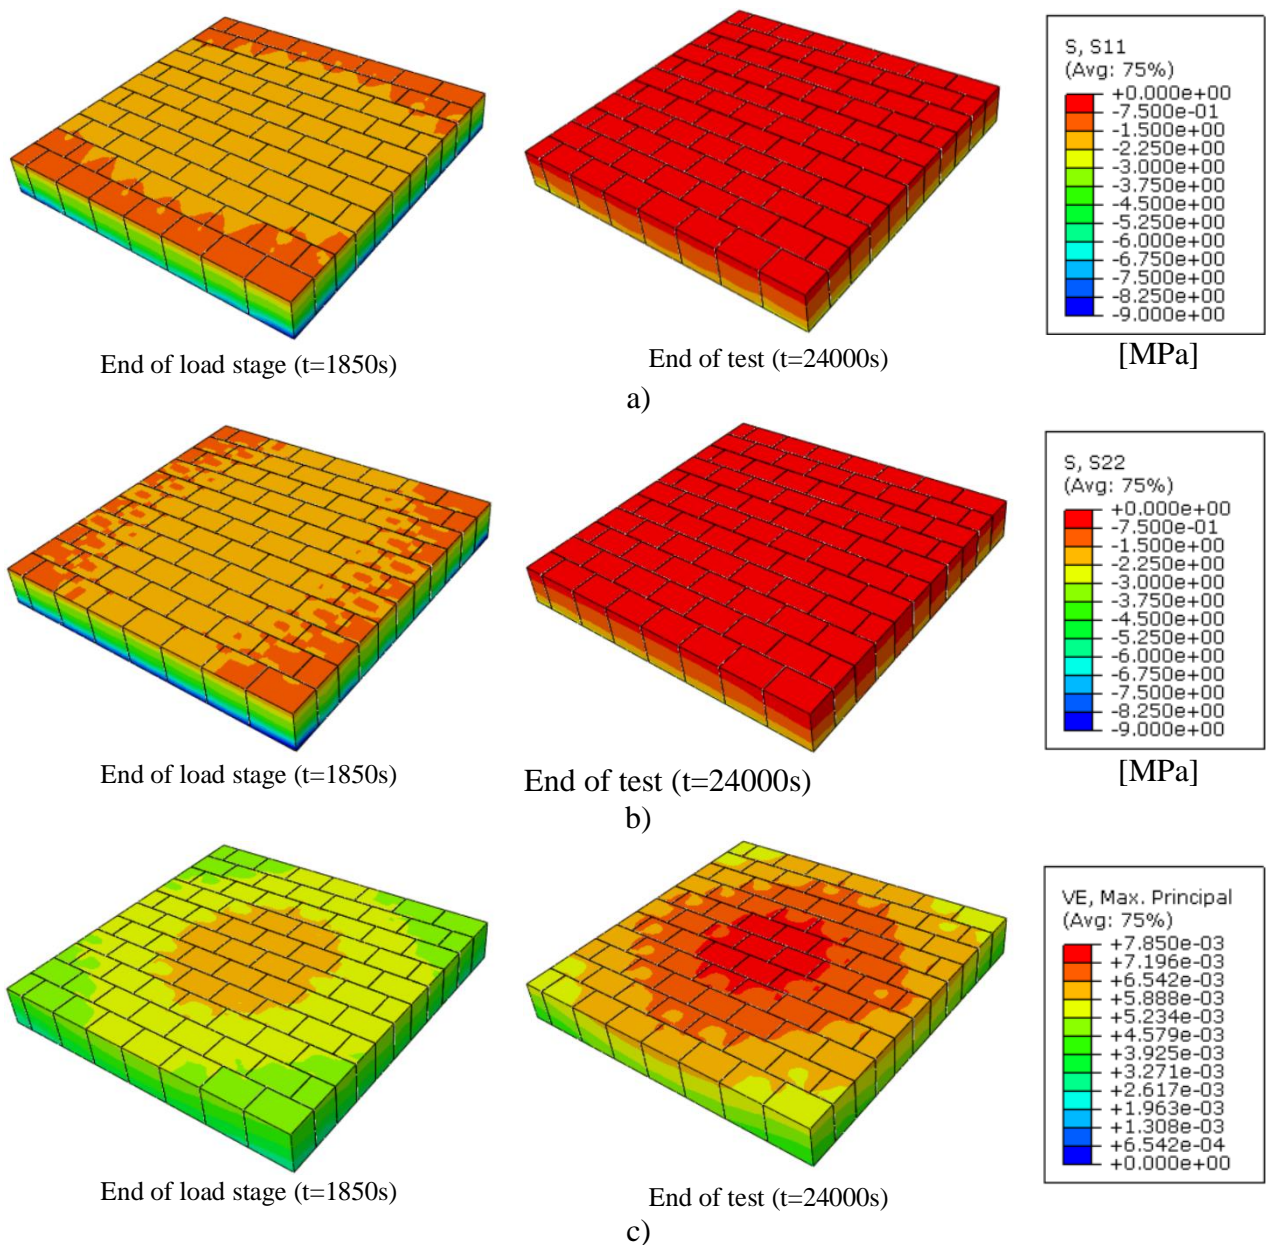
Figure 6-33 – Minimum principal strain –Test series S11.HT.RBI: a) Stresses direction X, b) Stresses direction Y; c) Viscoplastic strains
