Images in
Cardiovascular Disease

Aortic Root Honeycomb: A Rare Cardiac Surgery Complication

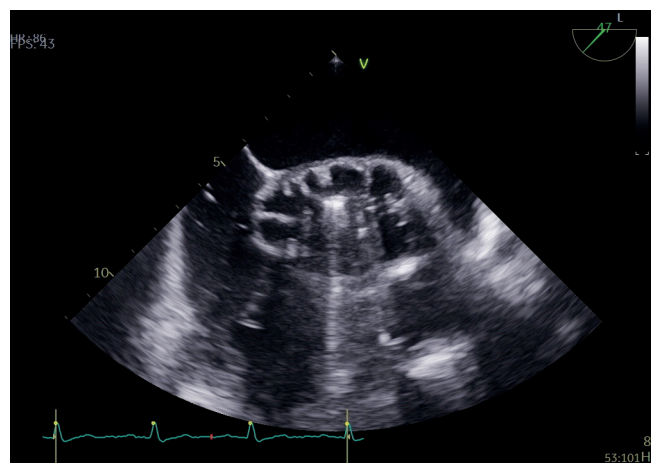
Figure 1. Transesophageal echocardiogram (short-axis view): hypoechoogenic image around the aortic prosthesis in the short-axis view, with a peculiar appearance of a honeycomb.

Two years after the surgery, a routine transthoracic echocardiogram revealed a perivalvular jet and left heart chamber enlargement. The patient was asymptomatic and the inflammatory parameters were normal. A transesophageal echocardiogram showed a hypoechoogenic image around the aortic prosthesis in the short-axis view between 9 am and 3 pm, with a peculiar appearance of a honeycomb, with flow inside and a severe eccentric jet of insufficiency originating from the saccular formation in the aortic-mitral fibrous curtain directed to the exit chamber of the left ventricle (**Figures 1** and **2**, **Movies 3-5**). Computerized tomography coronary angiogram revealed an extensive pseudoaneurysm of the aortic root with involvement of approximately 3-quarters of the prosthetic circumference, the main cavity was

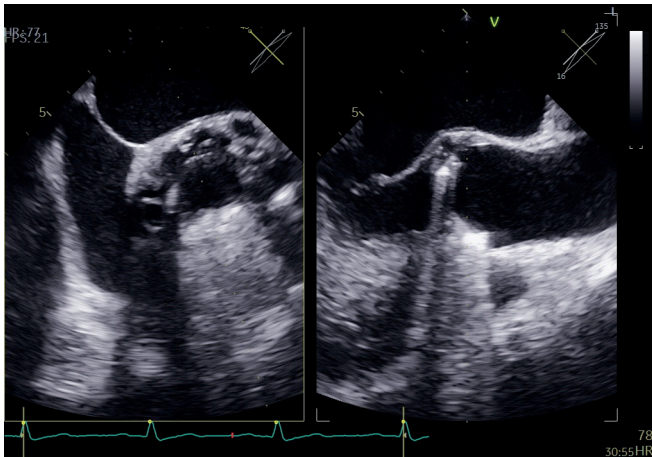
Figure 2. Transesophageal echocardiogram (left: short-axis view; right: long axis view): hypoechoic image around the aortic prosthesis.

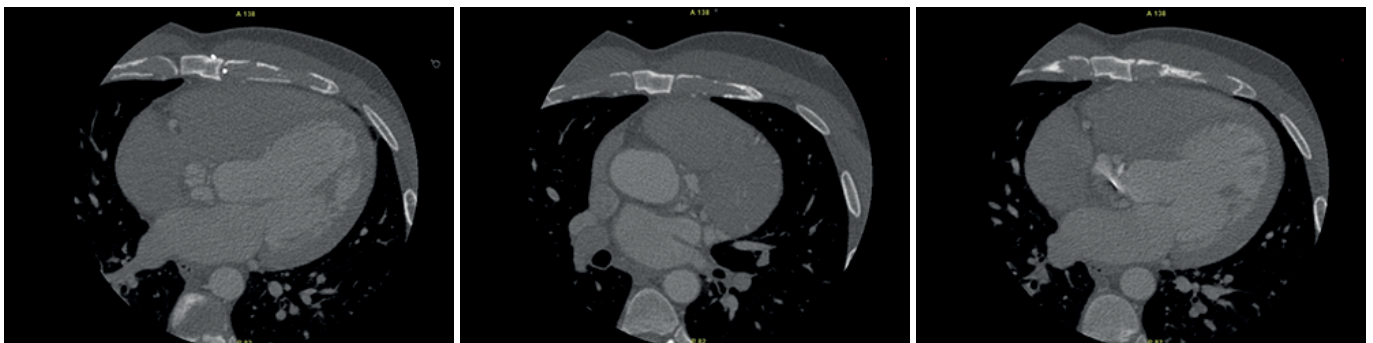
Figure 3. Computerized tomography coronary angiogram: extensive pseudoaneurysm of the aortic root.

located posteriorly with extension to the mitroaortic curtain (35 × 15 × 13 mm) and another cavity was located laterally-left and anteriorly (28 × 17 × 17 mm), conditioning prosthetic leaks (**Figures 3 and 4**), plus mild prosthetic oscillation (rocking) with good kinetics of the discs (**Movie 6**).

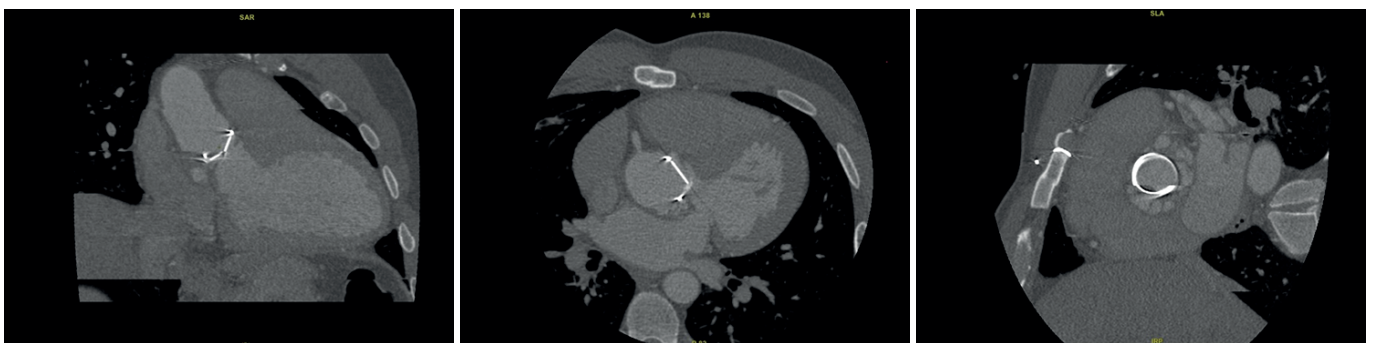
Figure 4. Computerized tomography coronary angiogram: extensive pseudoaneurysm of the aortic root.
