FCTUC FACULDADE DE CIÊNCIAS
E TECNOLOGIA
UNIVERSIDADE DE COIMBRA

Tribological Behaviour against Ti6Al4V of Ti- Based Coatings for WC-Co Cutting Tools

Submitted in Partial Fulfilment of the Requirements for the Degree of Master in
Materials Engineering

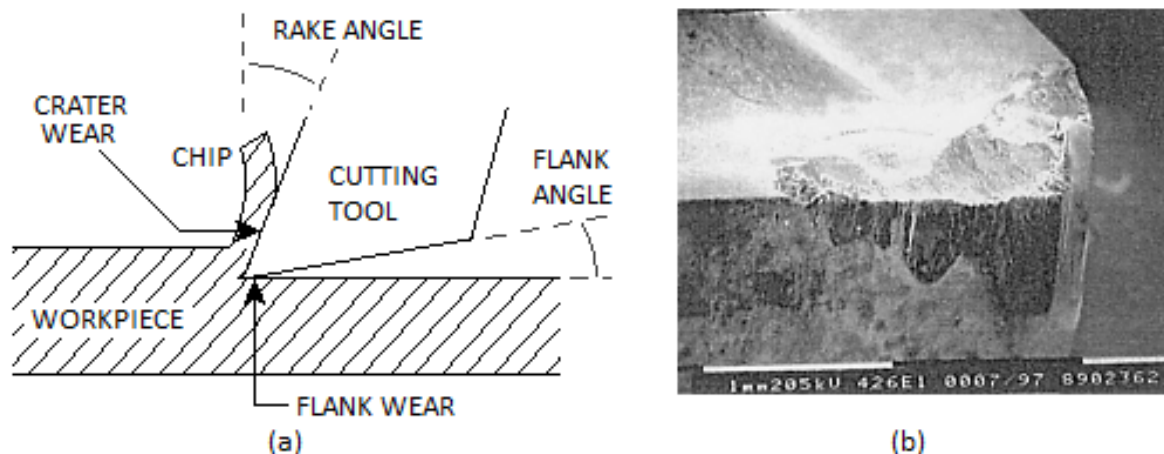
Figure 2.1. Cutting tool wear: (a) schematic location of flank and crater wear (b) SEM image of flank, rake and nose wear [5]

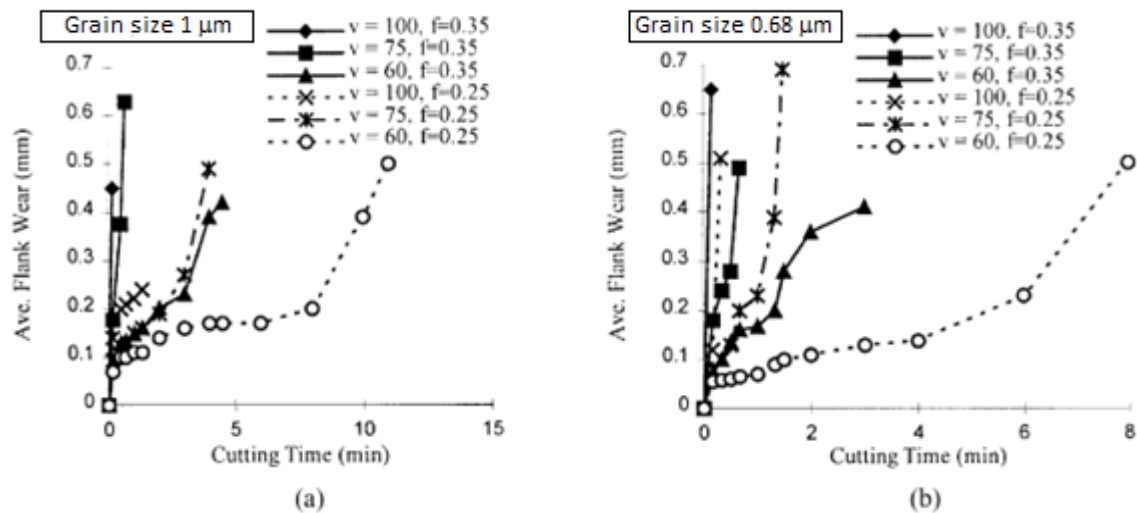
Figure 2.2. Flank wear of two WC-Co with different grain size (a) $1\ \mu\text{m}$ (b) $0.68\ \mu\text{m}$ (v = cutting speed, m/min; f = feed rate, mm/rev) [6]

Other findings mentioned that the significance of diffusion and attrition wear on tool flank and rake are different depending on the material of cutting tools. On uncoated cemented carbide and ceramic tools, diffusion wear dominates rake face while attrition creates more wear on the flank face. However, on straight-grade cemented carbide (WC + Co), flank wear also mainly due to diffusion instead of attrition [8]. Che-Haron [6] observed that besides the fact that flank wear increases with the cutting speed and feed rate, wear rate were also different depending on tool material. In Figure 2.2, tool materials are WC-Co with the same composition (94 wt.% WC with 6 wt.% Co binder) yet differ in grain size: $1 \mu\text{m}$ and $0.68 \mu\text{m}$, respectively.

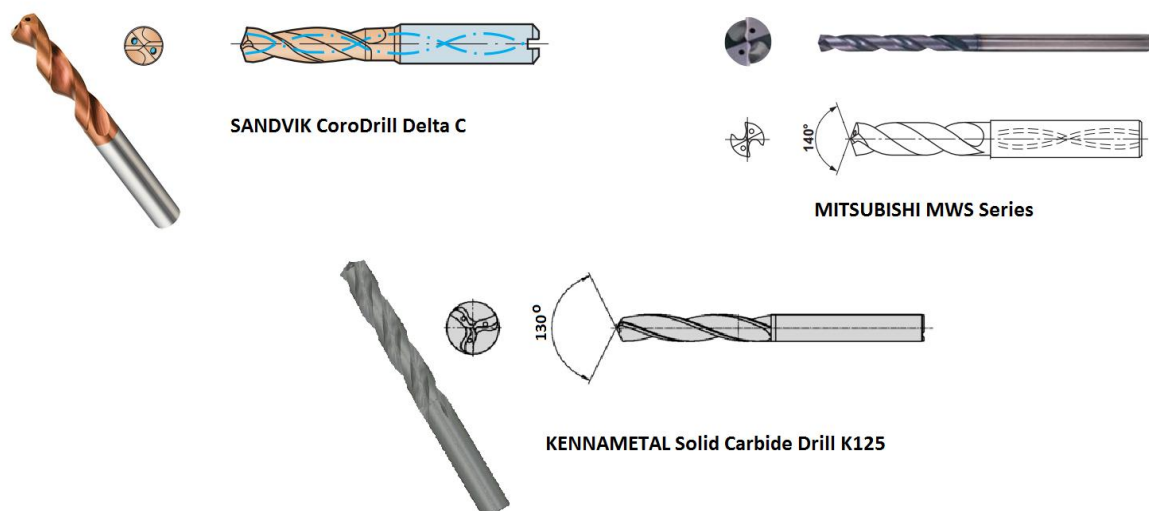
Figure 3.1. Examples of various types of drill geometry in the market

Different manufacturers in the market produce tools of different geometries, some of them are shown as examples in the Figure 3.1 and 3.2. The differences may appear in the angles (point angle, helix angle, etc), the number of flutes, cutting edges shape and dimensional measurements. However, the comparison of those tools available in the market to see the effect of geometry alone cannot be obtained only by testing each of those tools on workpiece because each one may have different material composition that becomes another variable determining the performance.

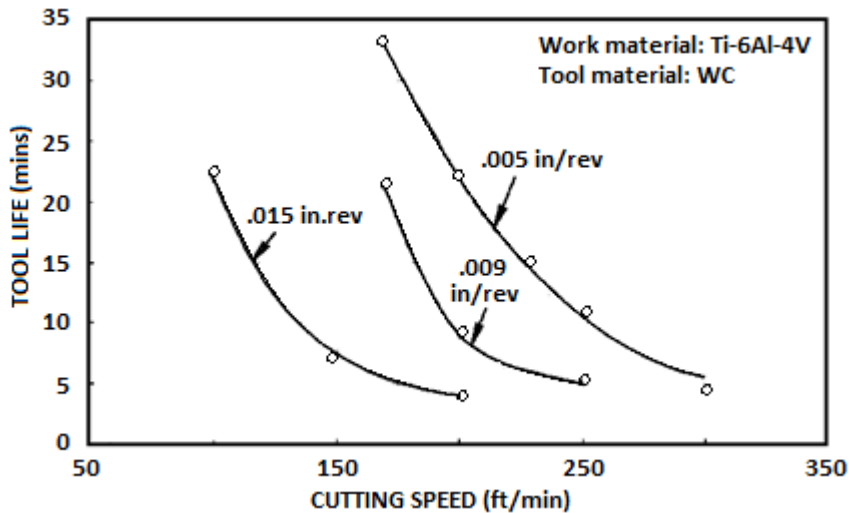
Figure 3.3. Effect of feed rate and cutting speed on tool life on Ti6Al4V turning [8]

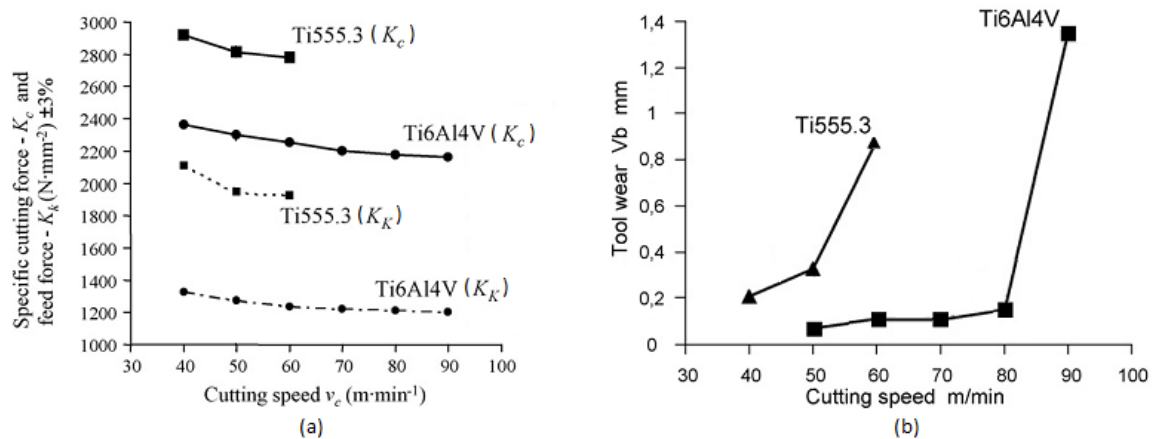
Figure 3.4. The relations of cutting speed on (a) cutting force and feed force; and on (b) tool wear [7]

When machining titanium alloys, cutting force is reduced at higher cutting speed. This is due to the softening of titanium at elevated temperature due to concentrated heating at cutting area [15]. On the other hand, high cutting speed accelerates cutting tool flank wear due to more intense contact with work material. As illustrated by the work of Arrazola *et al.* [7] in Figure 3.4, when machining two types of Titanium alloys (Ti.555.3 and Ti-6Al-4V), both cutting force and feed force tended to decrease with cutting speed, while the opposite trend occurred on flank wear.

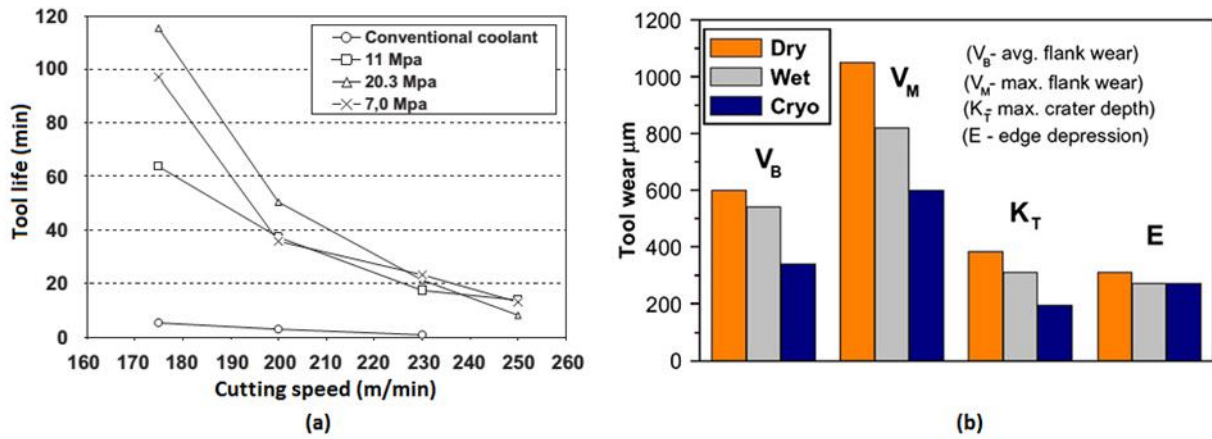
Figure 3.5. (a) Cutting tool life vs cutting speed at various coolant pressure [17]; (b) Wear on tool in different machining condition [19]

machining conditions on the cutting tool life is illustrated in Figure 3.5(b), where cryogenic machining demonstrates excellent performance [19].

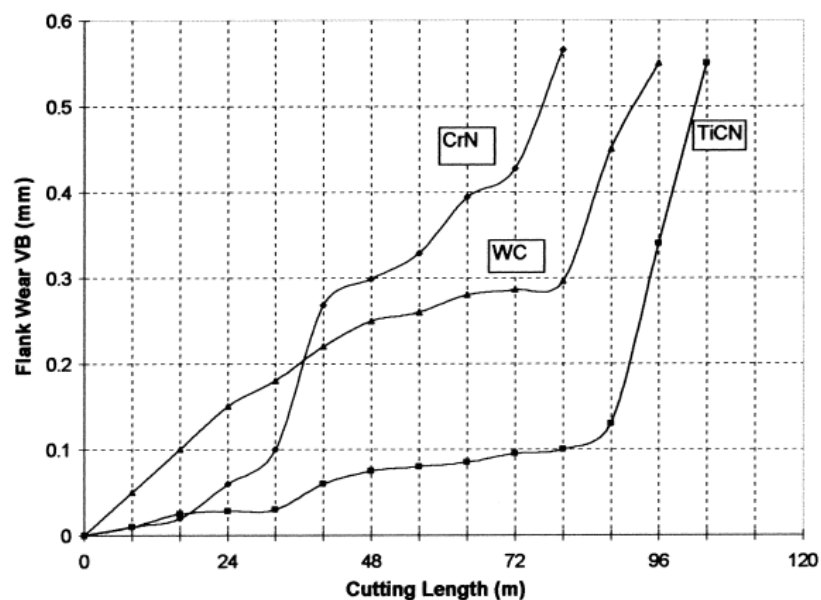
Figure 3.7. Flank wear in milling Ti-6Al-4V with CrN and TiCN coated HSS and uncoated WC-Co tool [20]

López de Lacalle *et al.* [20] deposited CrN and TiCN on HSS cutting tool and compared the performance with uncoated straight grade tungsten carbide in milling process at cutting speed of 51 m/min (HSS) and 100 m/min (WC). The result was found to be promising as TiCN coated tool went further length to reach the same flank wear as seen in Figure 3.7. Delay on the rapid wear of coated tool was related to the presence of TiCN layer, once it had been exhausted the tool made direct contact with titanium workpiece which boosted up the wear rate. Nevertheless, more in-depth and thorough understanding on the effect of coatings to tool performance is still needed before the coating strategy can be widely applied in industrial practice.

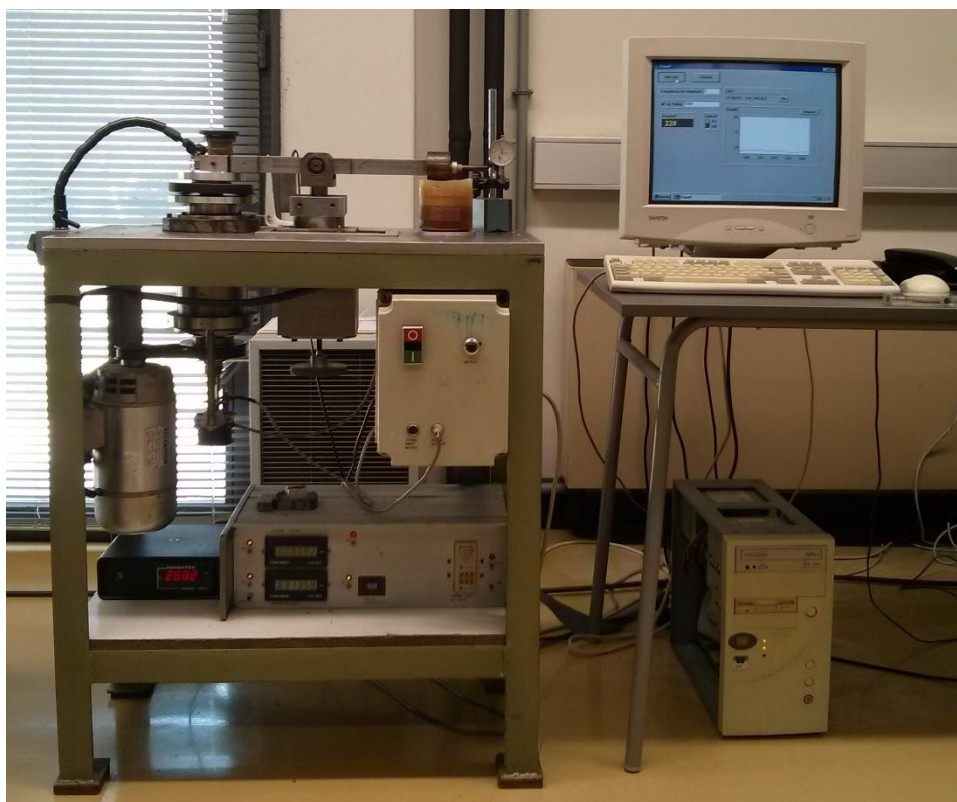
Figure 4.2. Ball on disk test apparatus at Instituto Pedro Nunes, as used in this work

Ball on disk apparatus used in this work (Figure 4.2) was a rotating disk with speed controller and a lever that pushed a load cell with the tangential force caused by friction of tribosystem. Signal from load cell was fed to computer at every corresponding rotation/cycle of the disk. As the reading from load cell represented friction force and the normal force was known (stacks of disks atop the lever), coefficient of friction at every cycle could be calculated. The number of cycle was set to achieve expected linear distance based on the linear speed and sliding track radius.

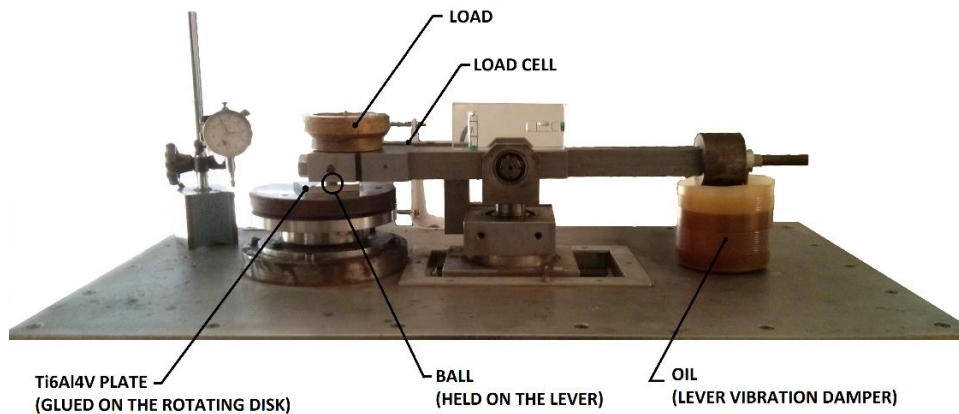
Figure 4.3. Ball on disk test apparatus setup for dry test

The differences in apparatus setup for dry test and lubricated test as seen in Figures 4.3 and 4.4, were only in the presence of liquid container and liquid diverter plate in lubricated test.

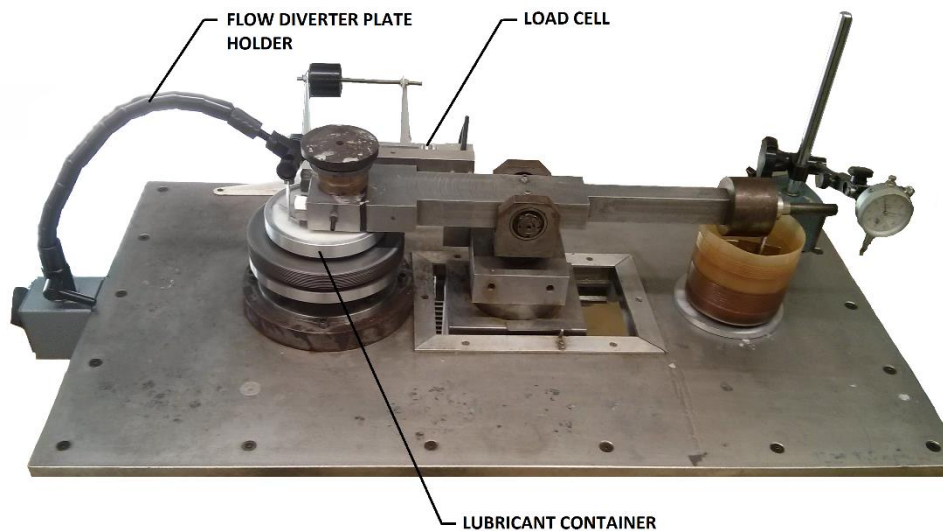
Figure 4.4. Ball on disk test apparatus setup for lubricated test

Lubricated ball on disk test was carried out with a container in which the Ti6Al4V plate was immersed in cutting fluid (Castrol Cooledge, 5%) up to slightly higher than its surface so the contact with the ball was lubricated. To prevent the liquid from being displaced centrifugally outwards that might leave the center area of container dry and/or spill the lubricant out of the container, a plate was placed near to the periphery of the container, acting as a diverter that redirect the lubricant inwards.

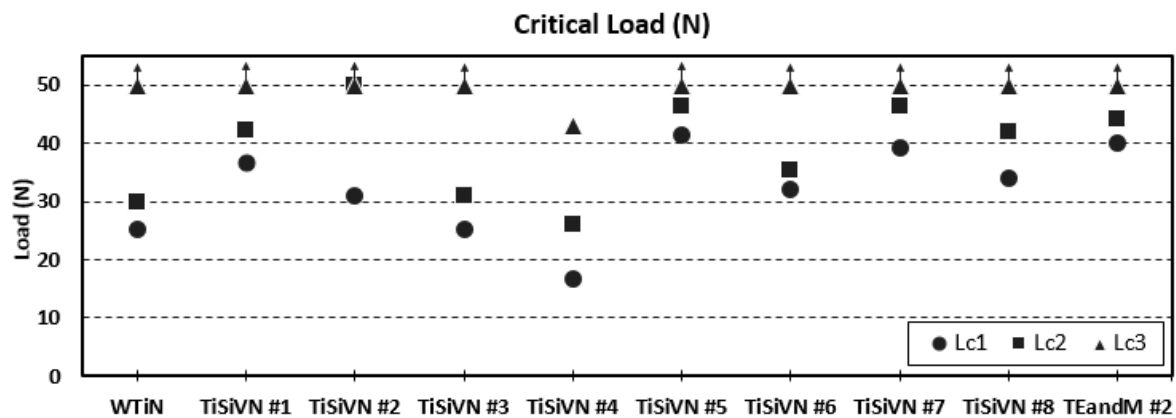
Figure 5.4. Critical load (10 – 50 N scratch test)

To compare the performance of coatings, L_{c2} is taken as reference because it is the point where continuous failure occurs, therefore it can be more confidently referred as the failure region. The very first failure that spotted, L_{c1} , may only be a small defect on sample that does not represent the true characteristic of sample. However, if the mark of failure is clear and convincing, L_{c1} can be important to see how the failure initiates and propagates until it forms a substantial failure. The L_{c3} cannot be the basis of comparison in this work because only one coating reached L_{c3} during the test.

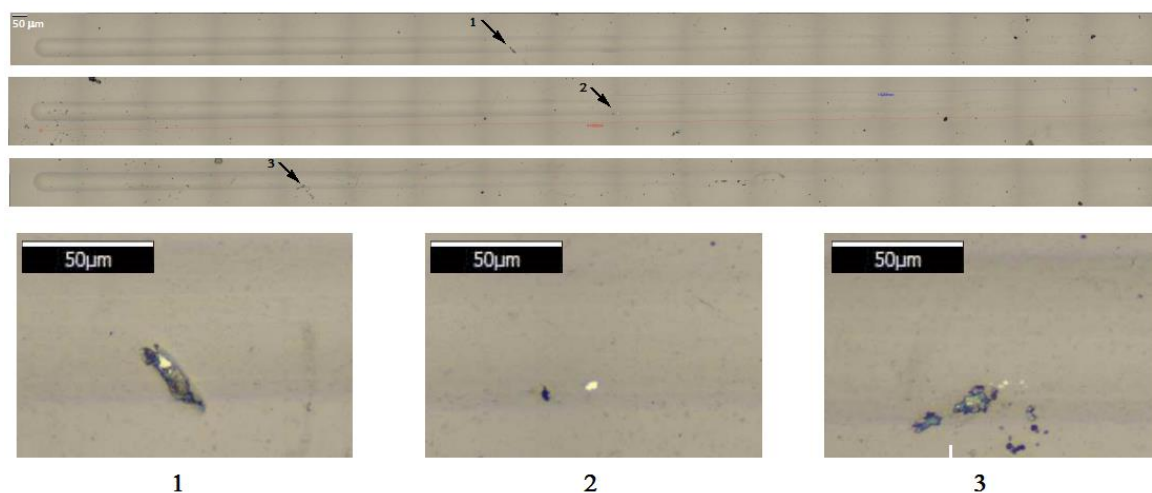
Figure 5.5. Scratches of TiSiVN #2: zoomed-in images of of each location of L_{c1} on 3 different scratches; there is no other failure afterwards

In TiSiVN #2, there was no continuous failure observed, therefore L_{c2} was not achieved within loading range (10 N – 50 N). In addition, the small areas of coating removal, which were then selected as L_{c1} , were found near to or at the spots of what looked like flaws on the surface of coating (Figure 5.5). Thus, these failures were probably related to local defect of the sample.

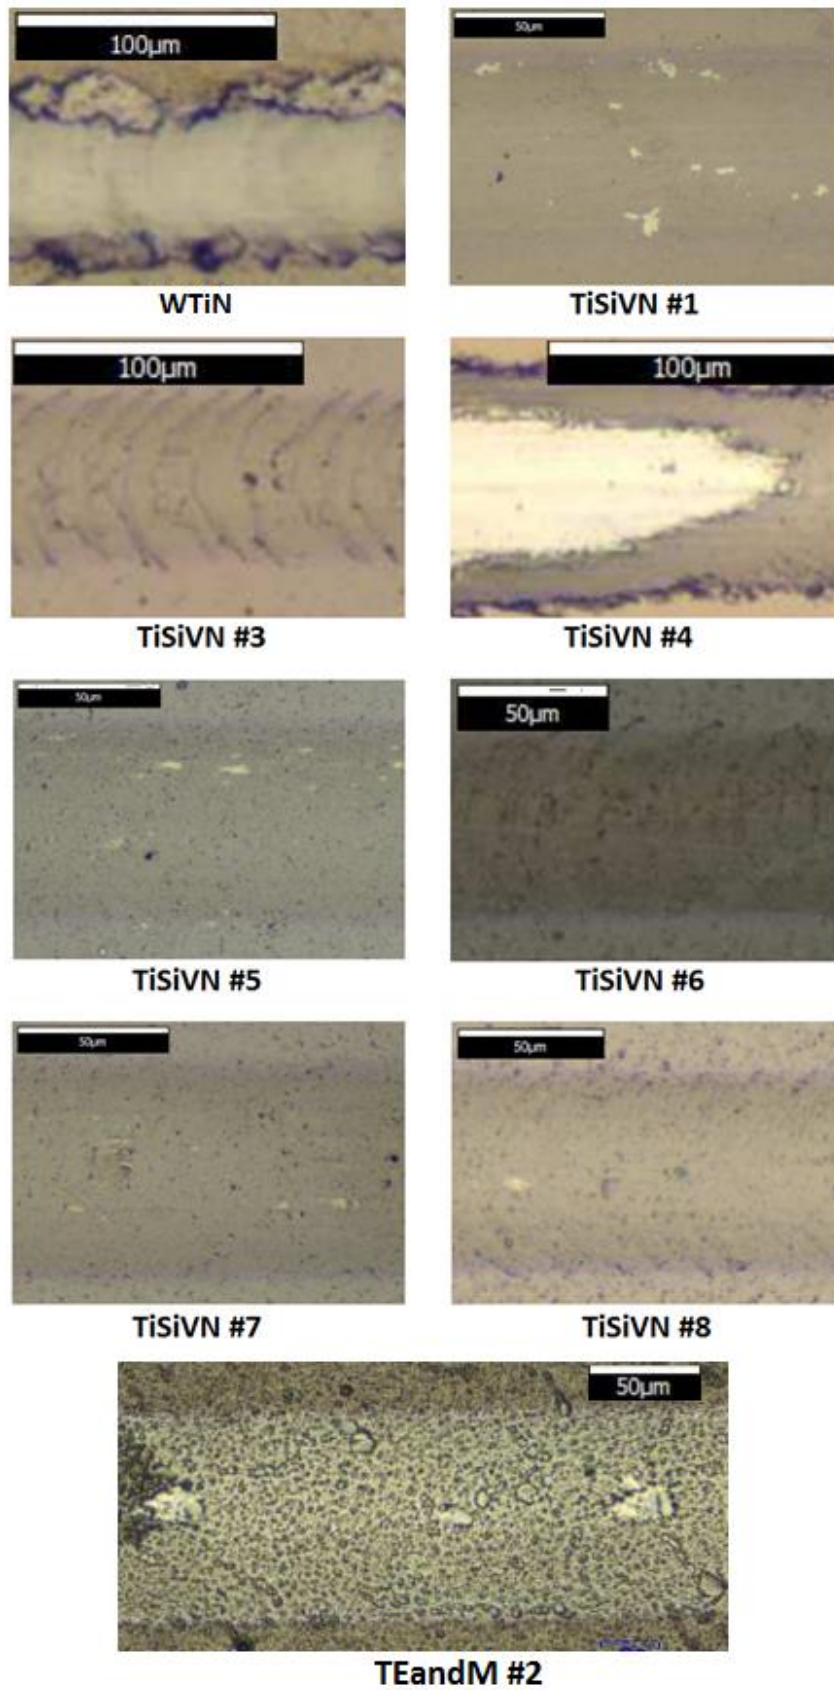
Figure 5.6. Failure modes on scratches of coatings (direction of indenter from right to left)

The failure mode occurred on WTiN coating as shown in Figure 5.6 is a compressive or wedging spallation failure, where the coating on brittle substrate (including WC-Co substrate as used in this test) detached in order to release compressive stress and minimize elastic energy stored in the coating ahead the indenter as it moves [29]. It indicates poor adhesion of coating to the substrate. This type of failure appears similar to recovery spalling which takes place behind the indenter and is caused by difference in modulus of substrate and coating. If the substrate has lower modulus than coating, during unloading they cannot relax at the same rate, leaving residual shear stress at the interface. Both wedging spallation and recovery spallation create cracks along the scratch track edges as visible in WTiN scratch, however the recovery spalling mode is not likely to be the case here because WTiN coating has lower modulus than WC-Co substrate.

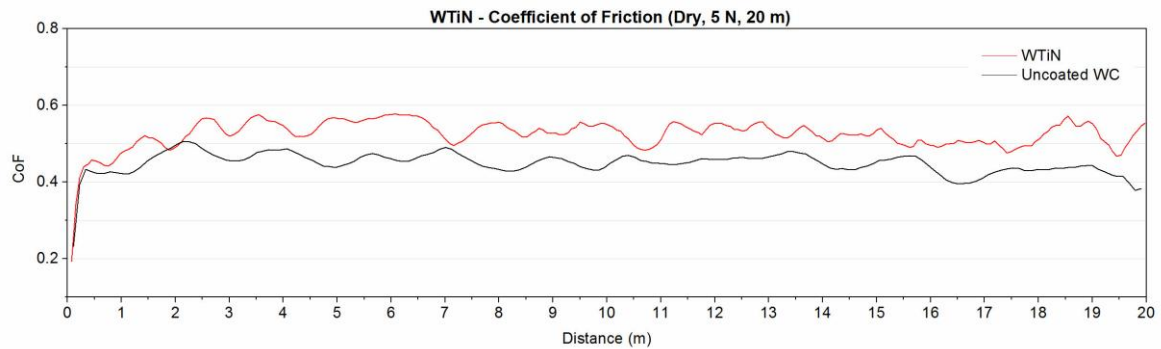
Figure 5.7. WTiN friction coefficient evolution on dry ball-on-disk test (5N load, 20 m linear distance)

Friction coefficient (CoF) of WC ball coated with WTiN against Ti6Al4V in dry condition was higher than that of uncoated WC ball, as shown in Figure 5.7. The value of CoF was considered steady after 10 m and the average for uncoated and WTiN coated balls were 0.44 and 0.52, respectively. Dry friction coefficient value of WTiN here is similar to that obtained by Silva *et al.* [28] on dry ball on disk test of WTiN against high strength low-alloy steel and cold rolled steel, which was between 0.45 to 0.6. Approximately the same value of friction coefficient of uncoated WC, 0.45, was reported by Yetim *et al.* [34] on dry sliding of WC pin against Ti6Al4V disk, confirming the result of this test. The figures showing only the early stage (first short distance) of CoF vs distance are available in Appendix C to enable a closer view of the running-in period.

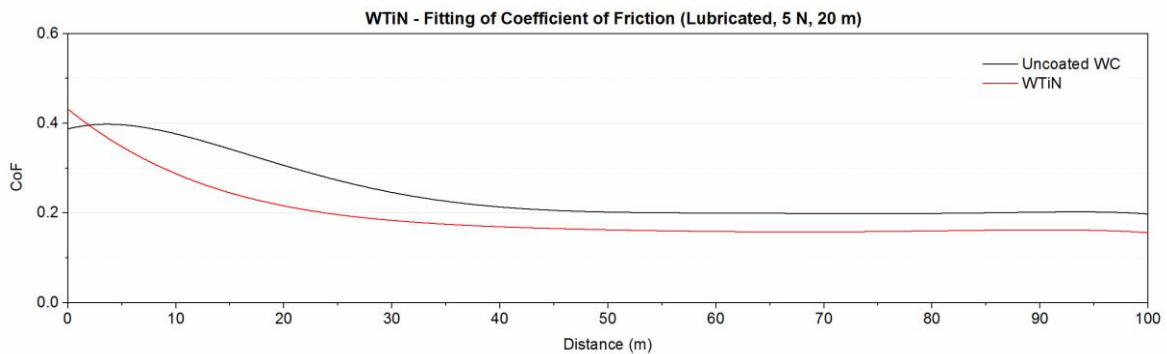
Figure 5.9. Polynomial fitting of WTiN friction coefficient evolution on lubricated ball-on-disk test (5N load, 100 m linear distance)

Polynomial fitting of CoF vs distance chart in Figure 5.8 is presented in Figure 5.9, where the difference in friction coefficient and its evolution over the distance can be more clearly identified.

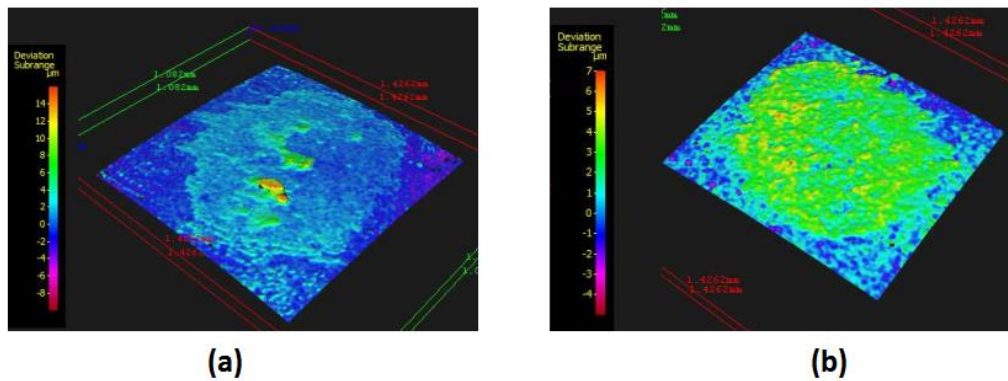
Figure 5.10. 3D profilometry of uncoated ball wear scar: (a) dry test; (b) lubricated test

Investigation on balls wear scar revealed that both uncoated and coated ball had some adhered materials on it. From 3D profile measurement on the scar area, taking the fresh (untested) ball surface as reference surface, the volume above the reference was more prominent than the volume below. The 3D profiles of balls wear scars are presented in Figure 5.10 and 5.11. They clearly show the evidence of adhesion.

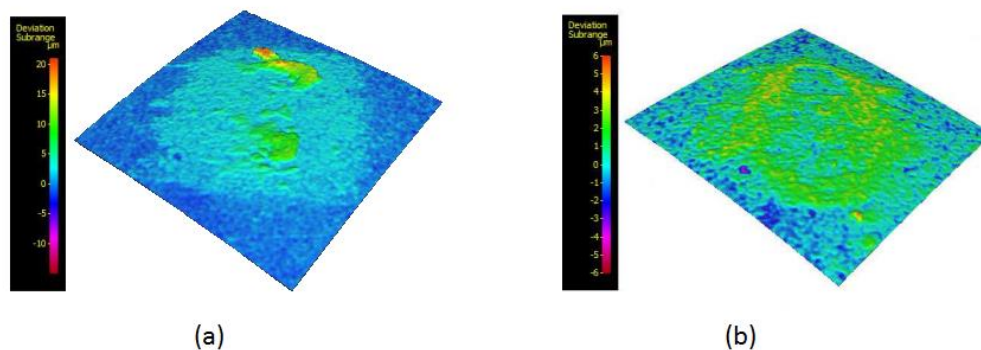
Figure 5.11. 3D profilometry of WTiN coated ball wear scar: (a) dry test; (b) lubricated test

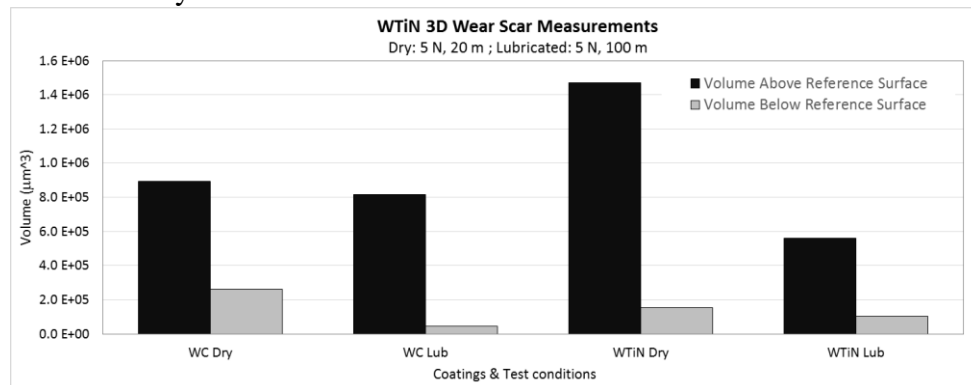
Figure 5.12. 3D profile volume calculation of balls wear scar

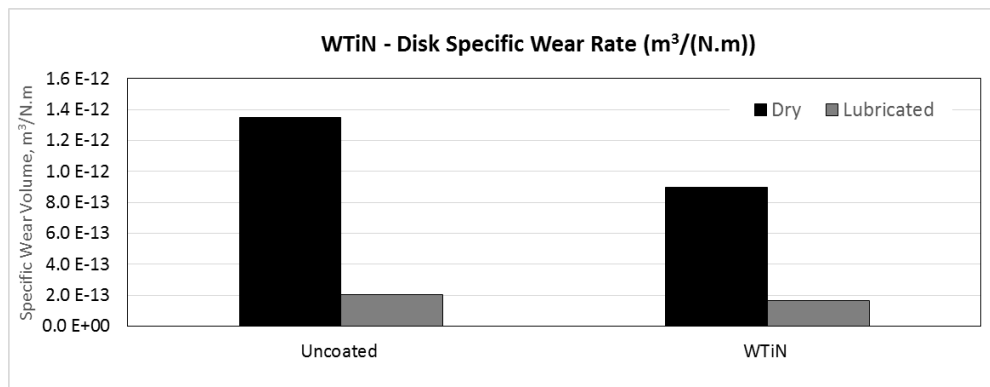
Figure 5.13. Wear track specific wear rate on Ti6Al4V disk, against WTiN coating

Wear track volume of the disk as presented in Figure 5.13 was calculated and expressed in specific wear rate (k). This term best serves as parameter that allow comparison between results of different load and/or distance as in these experiments where during dry test the linear distance was 20 m while it was 100 m during lubricated test. Despite having high adhesion on the ball, WTiN coating appeared to induce lower wear (material removal) on its Ti6Al4V counterface as compared to the uncoated one, which difference was more obvious in dry condition.

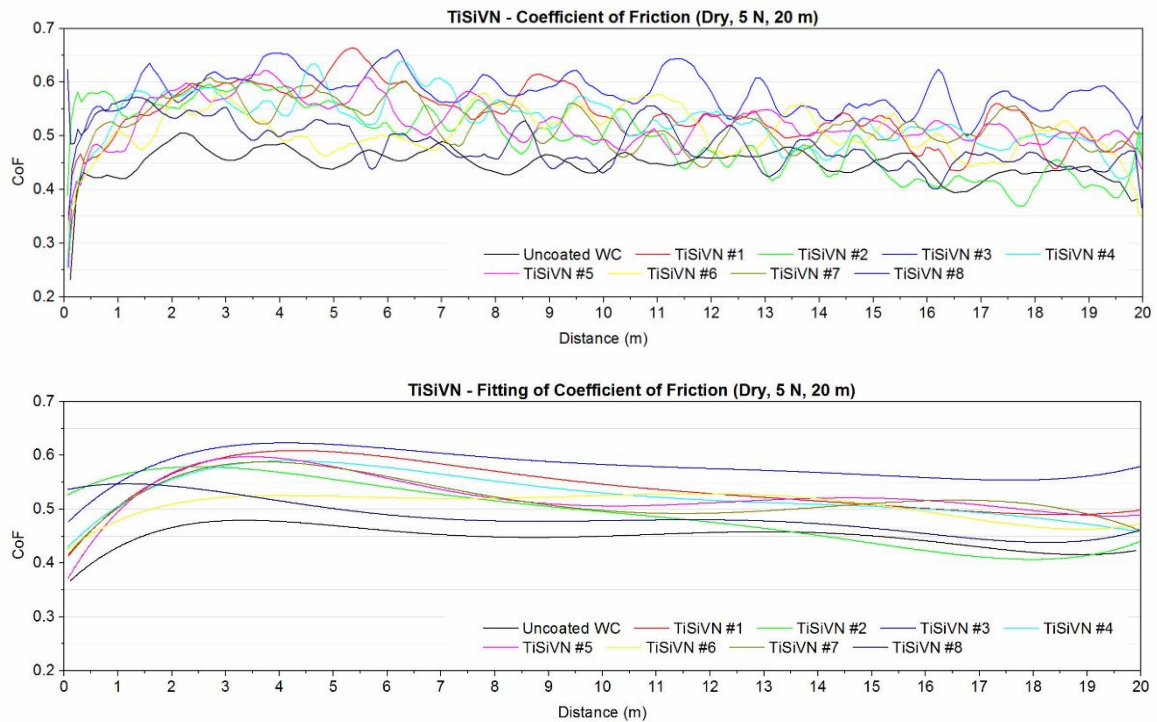
Figure 5.14. TiSiVN friction coefficient evolution on dry ball-on-disk test (5N load, 20 m linear distance)

The same manner of friction coefficient as happened in WTiN was also demonstrated by TiSiVN coatings, where at dry condition they performed poorly while once lubrication was introduced they were superior compared to the uncoated sample. The as-recorded chart of CoF vs distance and the polynomial fitting of it for dry and lubricated test are presented in Figure 5.14 and Figure 5.15, respectively. Polynomial fitting chart helps eliminating the waviness for easier analysis on the observation of mean and steady values while the as-recorded chart provides better resolution to see real features such as abrupt changes.

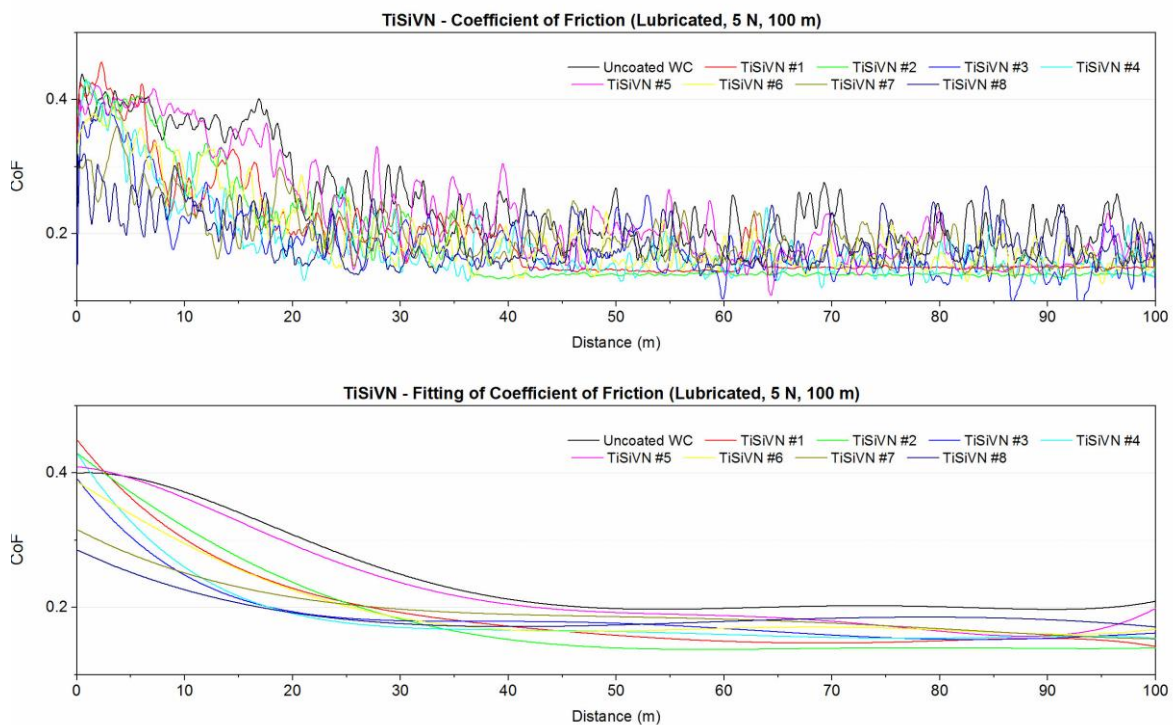
Figure 5.15. TiSiVN friction coefficient evolution on lubricated ball-on-disk test (5N load, 100 m linear distance)

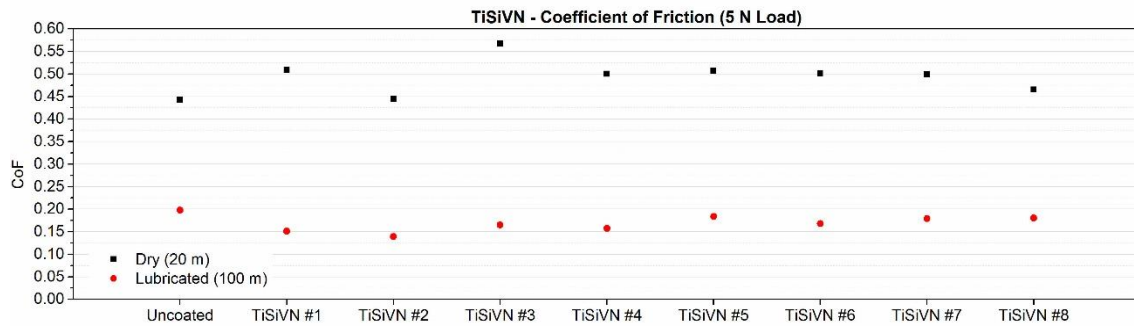
Figure 5.16 Steady state friction coefficient of TiSiVN samples on ball-on-disk test (5N load)

The comparison of steady state values of friction coefficient which can be seen in Figure 5.16 concludes that TiSiVN #2 is the best within this group. It has friction coefficient as low as uncoated ball in dry condition and much lower in lubricated. TiSiVN #1 is also good in lubricated condition, but it has high friction when dry.

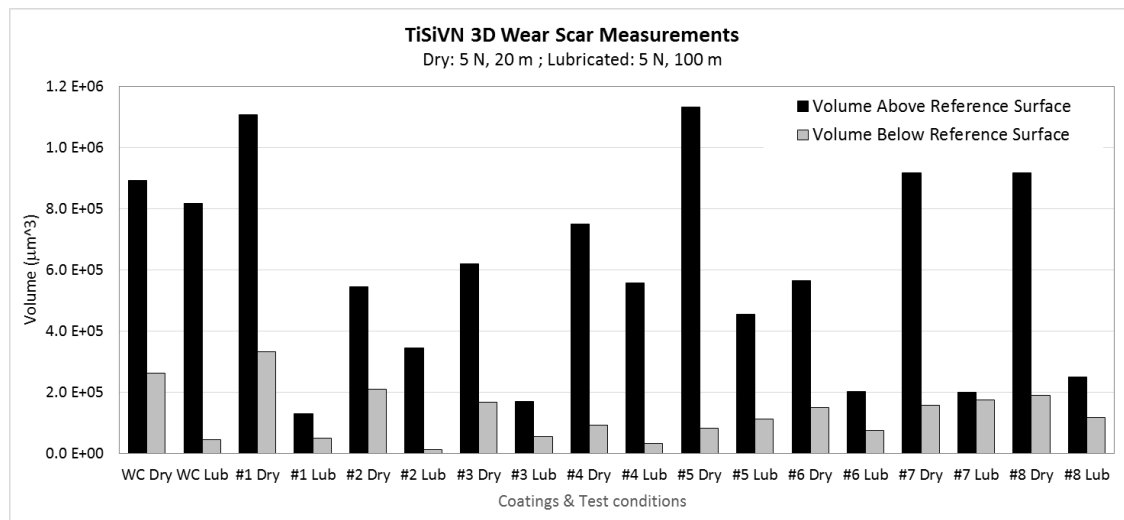
Figure 5.17. 3D profile volume calculation of TiSiVN coated balls wear scar

With the same measurement techniques as in WTiN, the same behaviour also appeared in TiSiVN coatings, where material transfer dominated the ball wear scar, as inferred from the graph in Figure 5.17. A recent work on titanium transfer in dry sliding contact [32] came into conclusion that more transfer of material tends to create higher friction. While it was true on some samples, the statement contradicted some results in this experiment where lower material transfer appeared in coating with higher friction such as in TiSiVN #3, #4 and #6. This was possibly because besides adhesive mechanism, friction depends also on surface topography which contributes to ploughing mechanism. The topography of built-up transferred material might be significantly different in such way that it created more friction on some samples since it induced more ploughing mechanism.

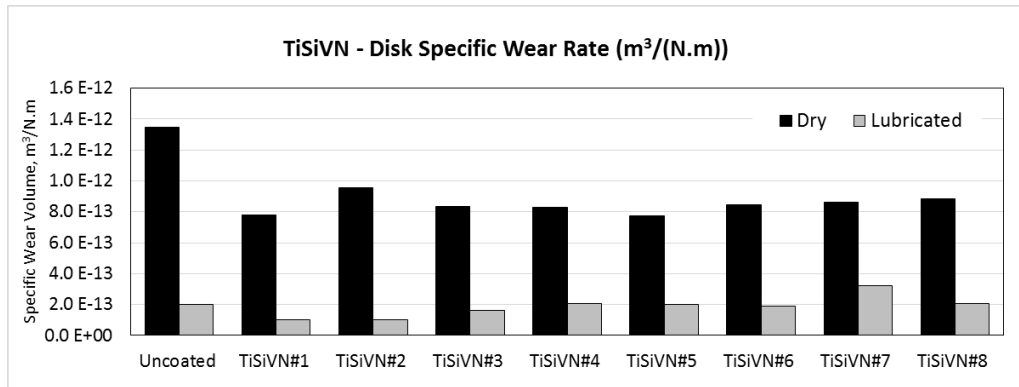
Figure 5.18. Wear track specific wear rate on Ti6Al4V disk, against TiSiVN coatings

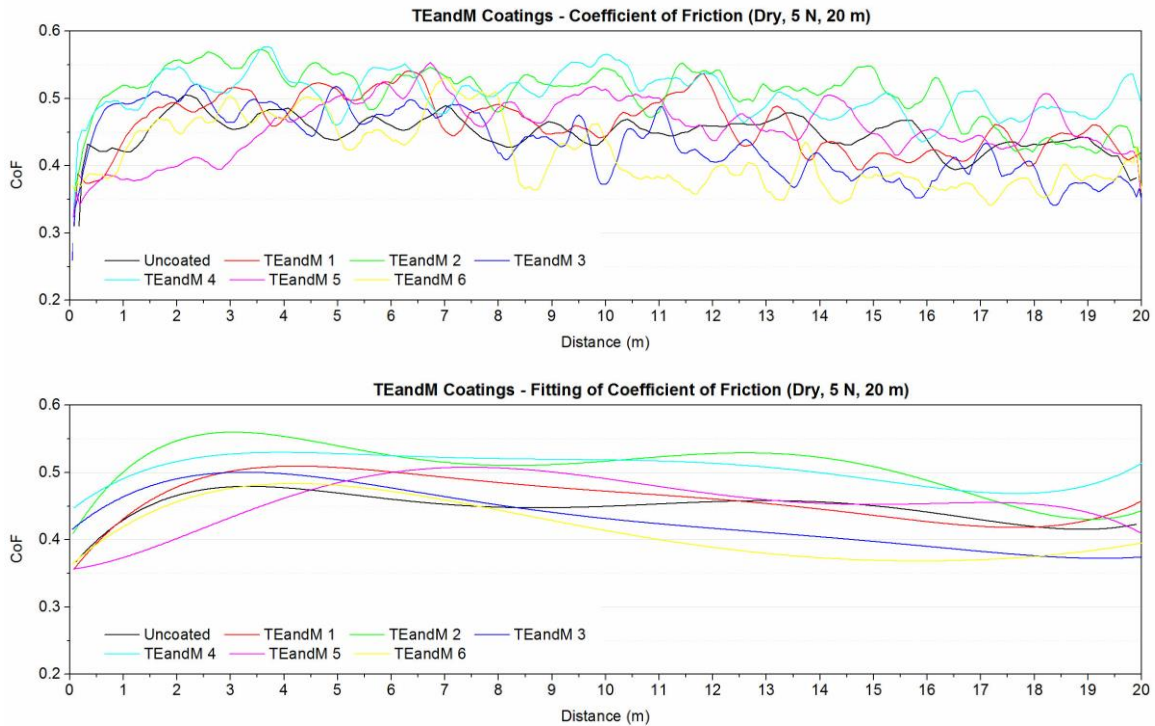
Figure 5.19. Friction coefficient evolution of TEandM produced coatings on dry ball-on-disk test (5N load, 20 m linear distance)

In terms of friction coefficient, several kinds of behaviours demonstrated by the coatings from TEandM (Figures 5.19, 5.20 and 5.21). Steady state friction coefficient of sample TEandM #1 and #5 were similar to uncoated sample, in dry and lubricated condition. Sample TEandM #3 and #6 maintained friction coefficient lower than uncoated one in either conditions. The other samples, TEandM #2 and #4, showed almost the same values of friction coefficient, which were high in dry condition yet low when lubricated, compared to the uncoated sample.

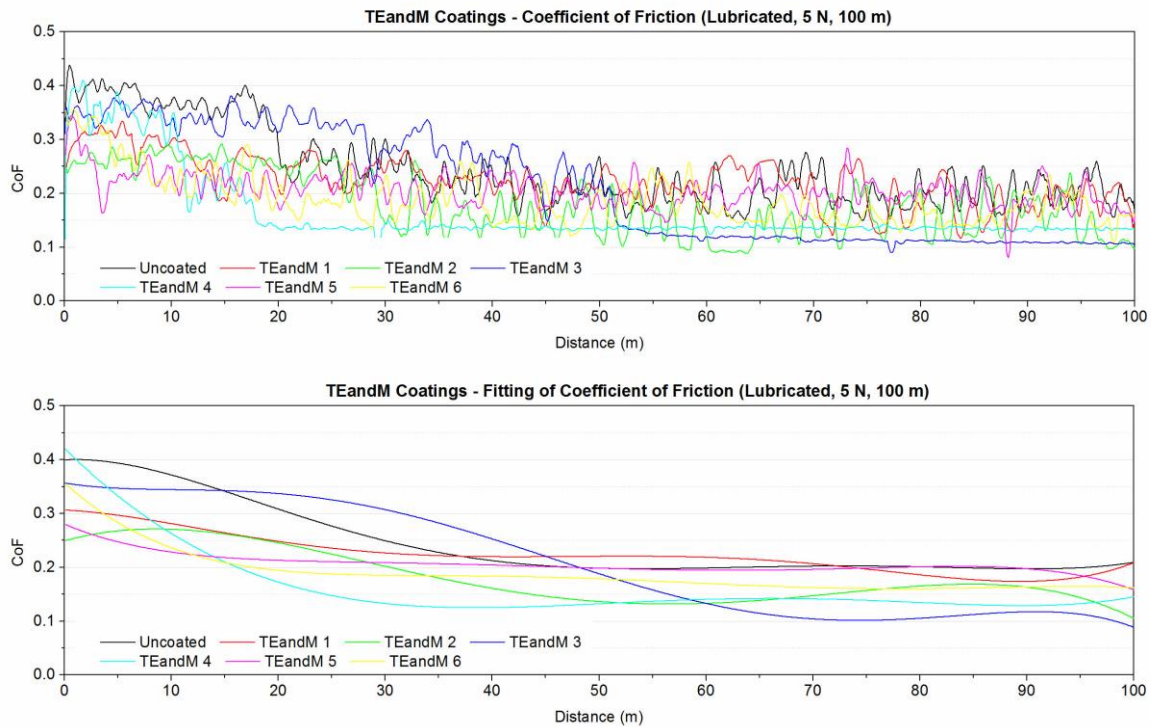
Figure 5.20. Friction coefficient evolution of TEandM produced coatings on lubricated ball-on-disk test (5N load, 20 m linear distance)

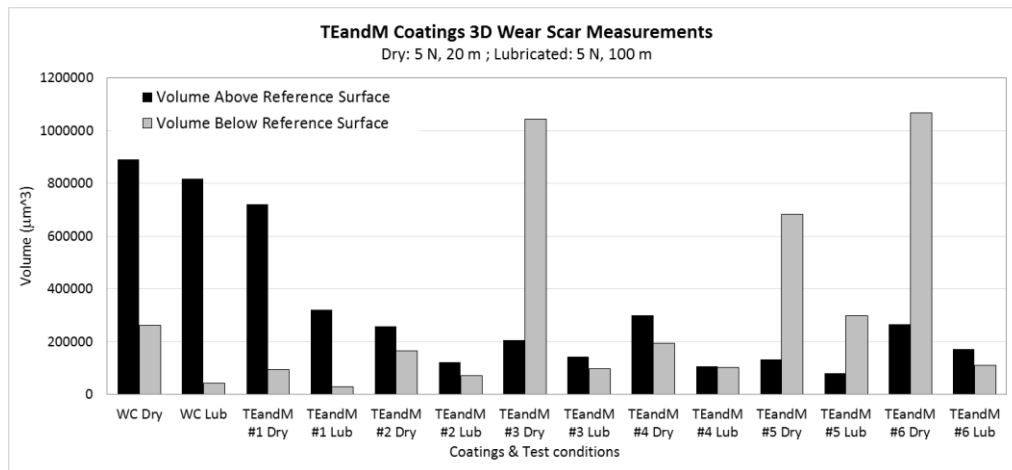
Figure 5.22. 3D profile volume calculation of TEandM coated balls' wear scar

this regard, coatings TEandM #2 and #4 provide good balance of material transfer and wear in both dry and lubricated conditions, compared to other coatings from TEandM.

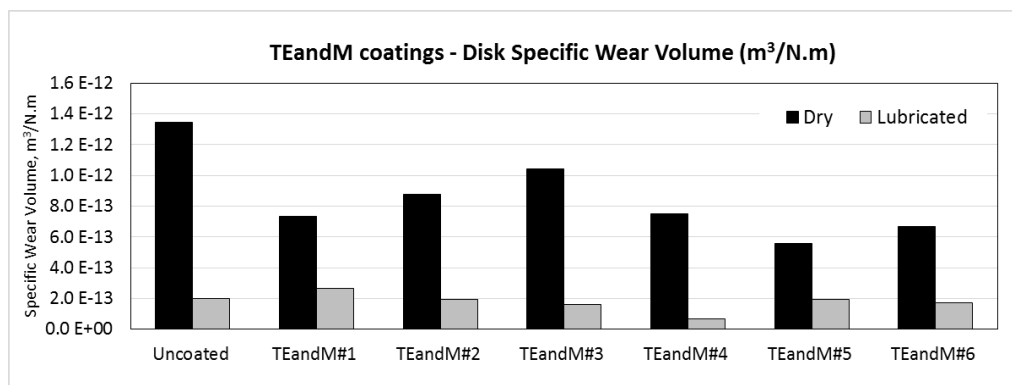
Figure 5.23. Wear track specific volume of Ti6Al4V disk, against TEandM coatings

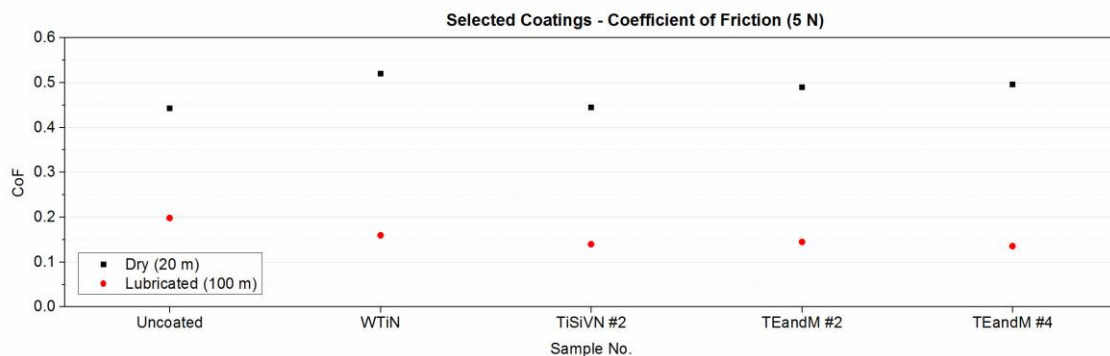
Figure 5.24. Friction coefficients of selected coatings

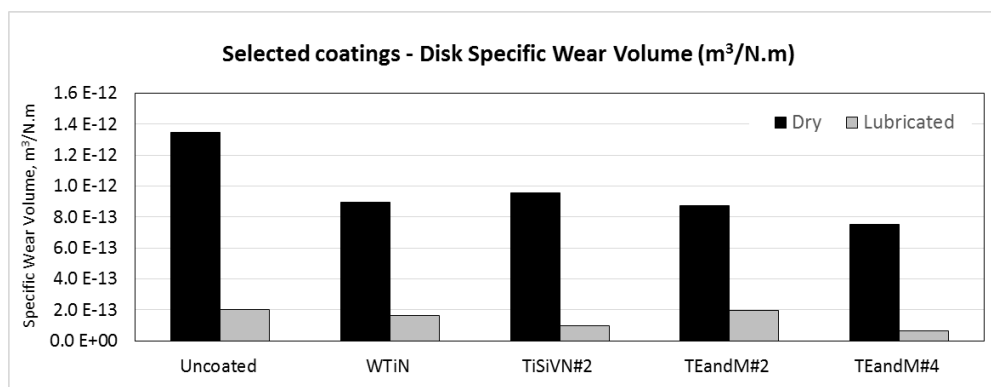
Figure 5.25. Specific wear rate of Ti6Al4V disks against selected coatings

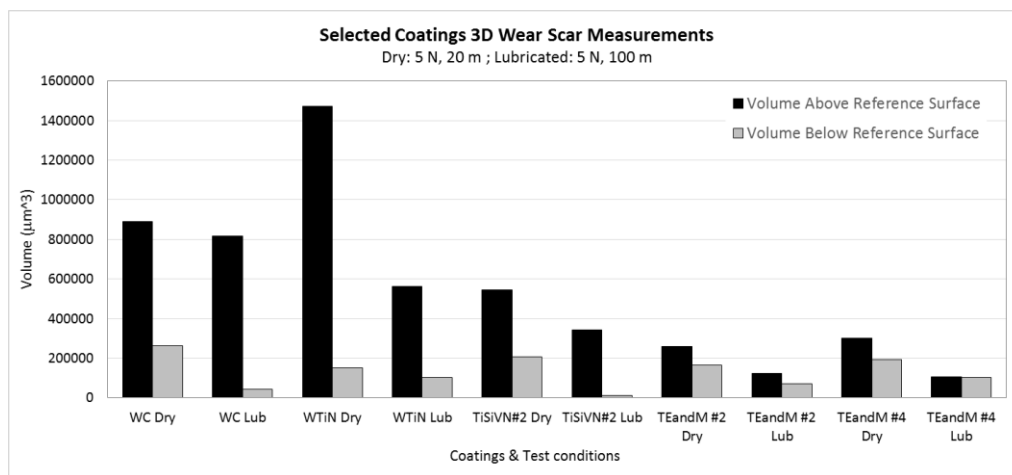
Figure 5.26. 3D measurements of ball wear scar of selected coatings

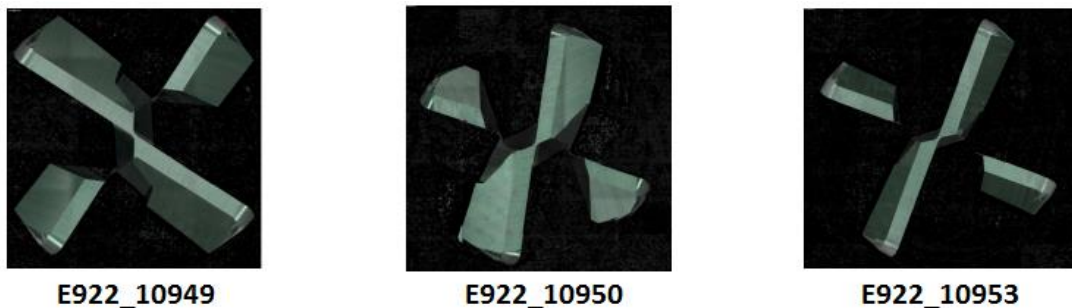
Figure 6.1. Prototypes of milling tools being tested

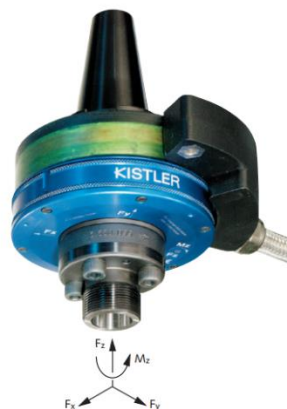
Figure 6.2. Kistler 9123C dynamometer

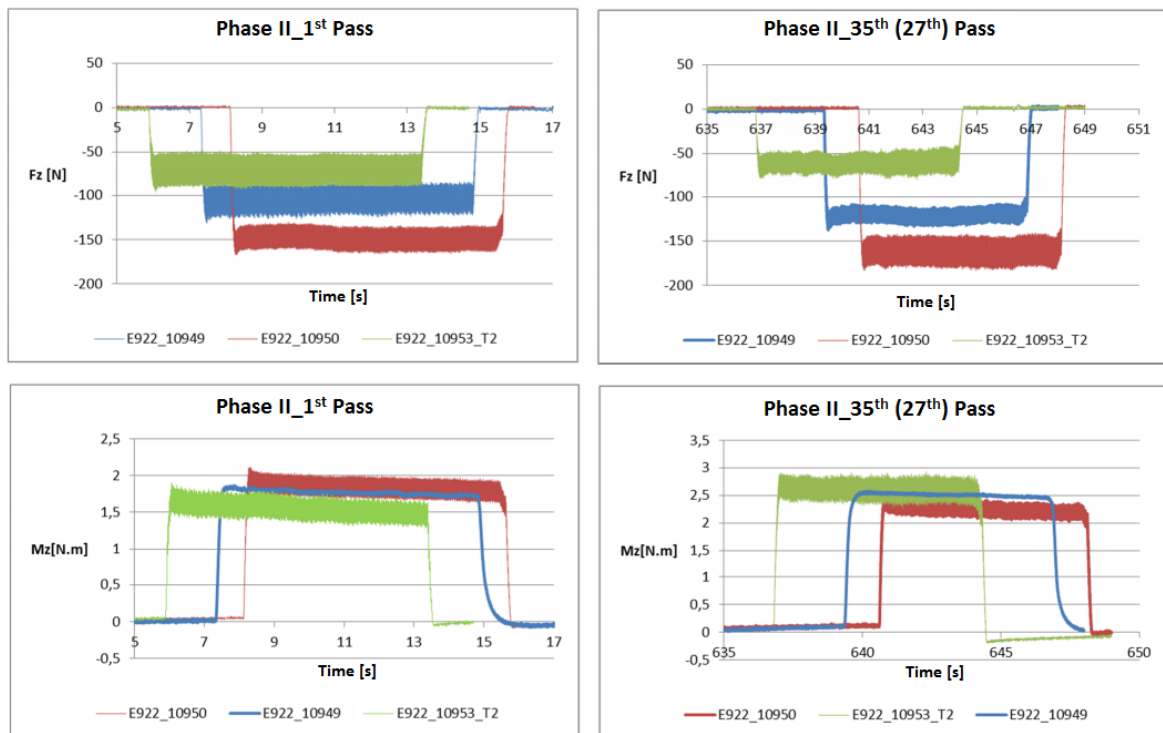
Figure 6.4. Force and moment during second phase of test

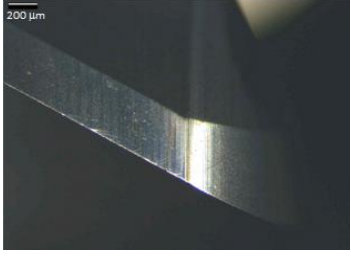
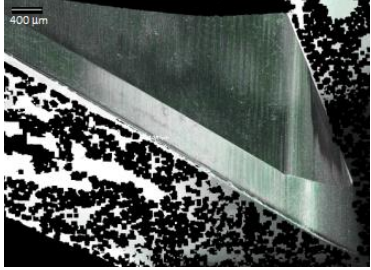
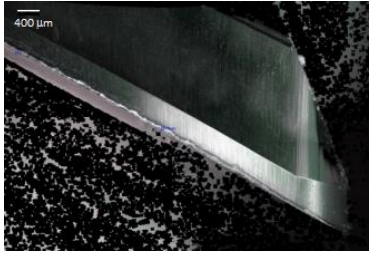
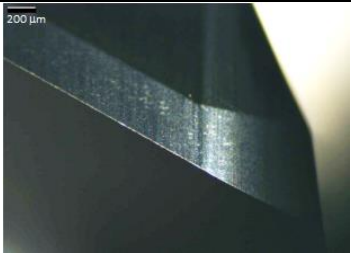
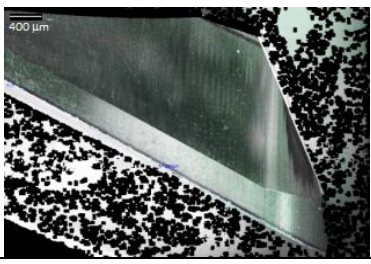
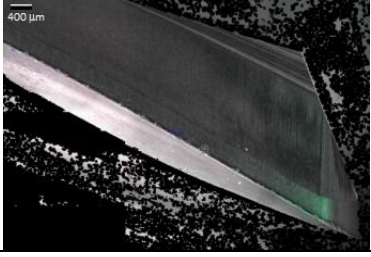
New	After Phase I	After Phase II
1

$V_b = 44.3 \mu\text{m}$	$V_b = 116 \mu\text{m}$
2

$V_b = 54.2 \mu\text{m}$	$V_b = 225.5 \mu\text{m}$
