FCTUC FACULDADE DE CIÊNCIAS
E TECNOLOGIA
UNIVERSIDADE DE COIMBRA

Tribological Behaviour against Ti6Al4V of Ti- Based Coatings for WC-Co Cutting Tools

Submitted in Partial Fulfilment of the Requirements for the Degree of Master in
Materials Engineering

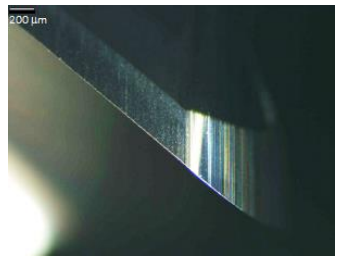
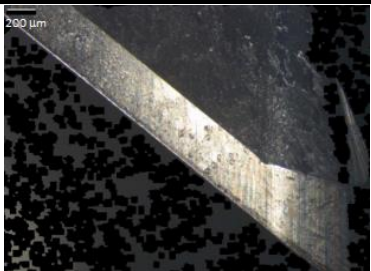
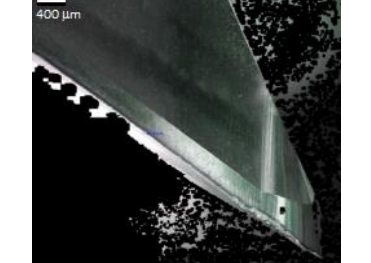
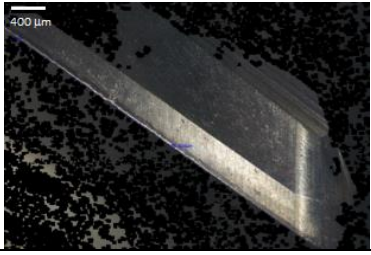
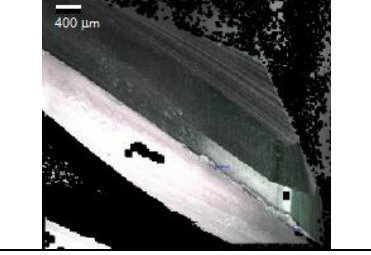
$V_b = 0 \mu\text{m}$	$V_b = 105 \mu\text{m}$
2

$V_b = 56 \mu\text{m}$	$V_b = 132 \mu\text{m}$

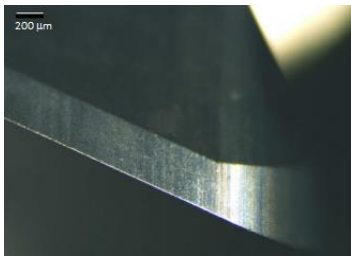
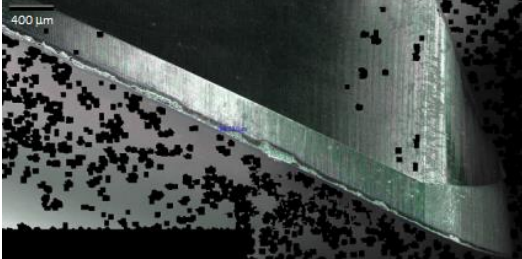
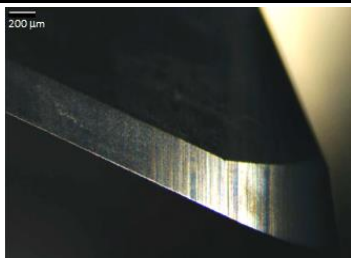
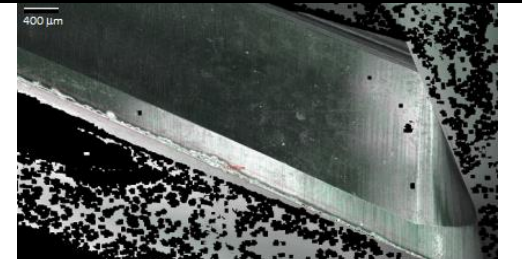
$V_b = 99.5 \mu\text{m}$	Tool broke
2

$V_b = 131 \mu\text{m}$	Tool broke

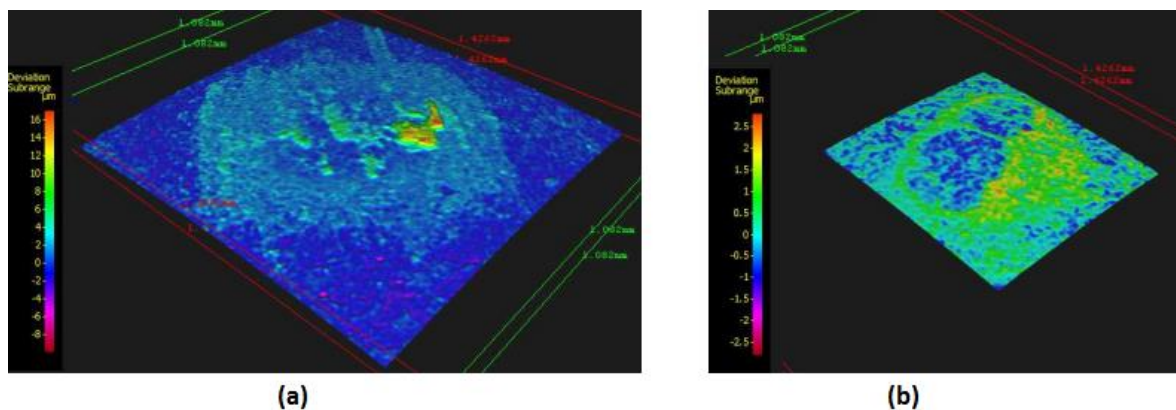
Figure B.3. Wear scar on TiSiVN #1 ball: (a) dry test; (b) lubricated test

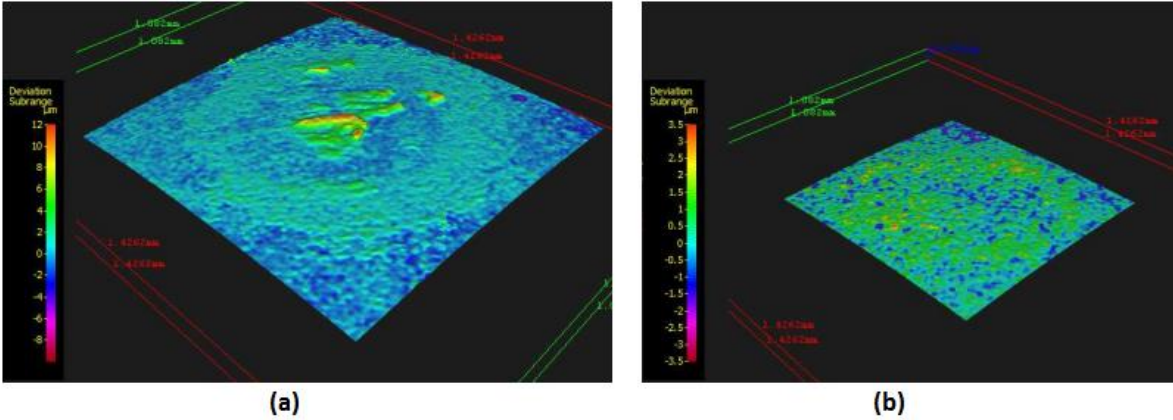
Figure B.5. Wear scar on TiSiVN #3 ball: (a) dry test; (b) lubricated test

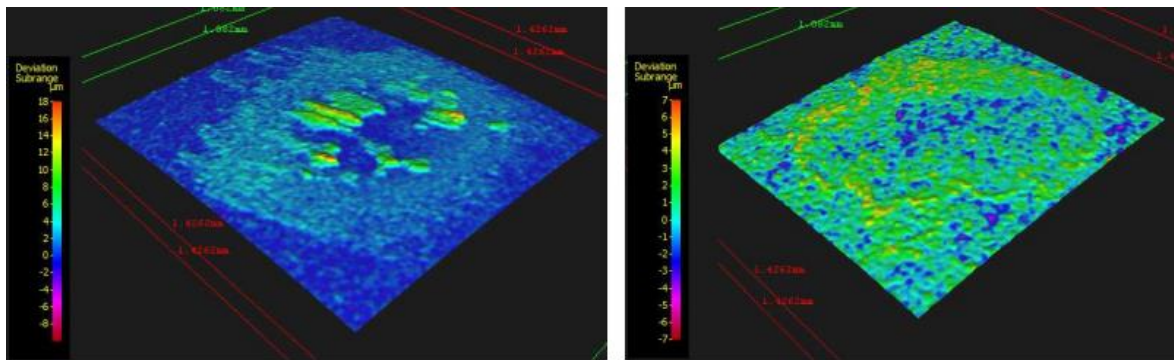
Figure B.7. Wear scar on TiSiVN #5 ball: (a) dry test; (b) lubricated test

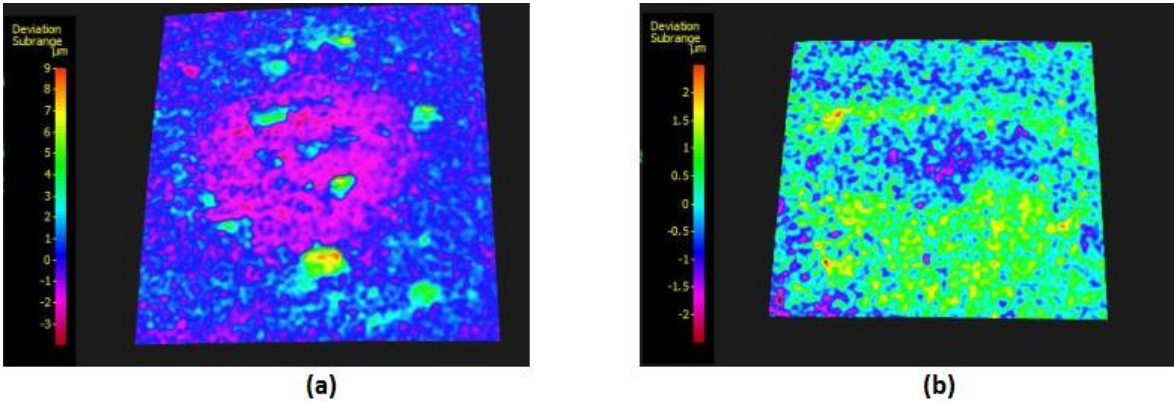
Figure B.11. Wear scar on TEandM #2 ball: (a) dry test; (b) lubricated test

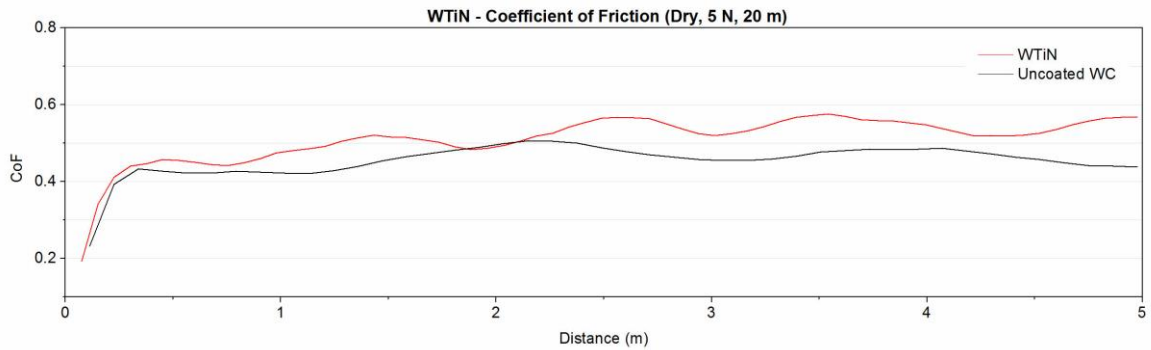
Figure C.1. Running in period of WTiN in dry condition

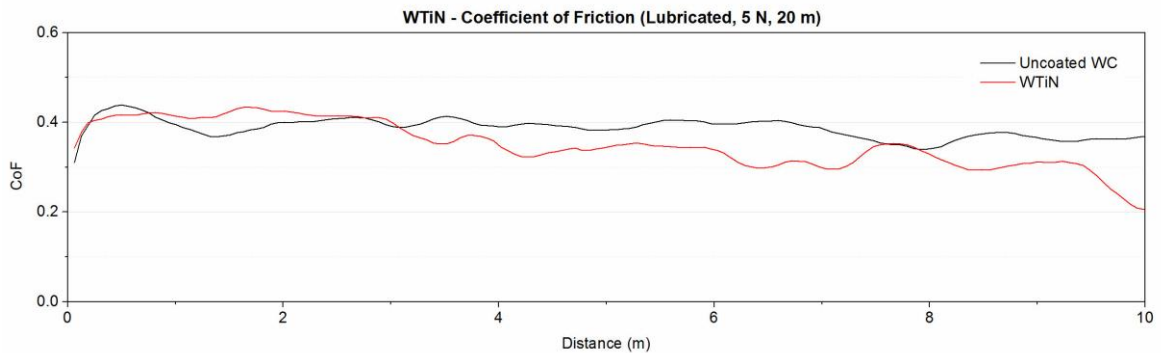
Figure C.2. Running in period of WTiN in lubricated condition

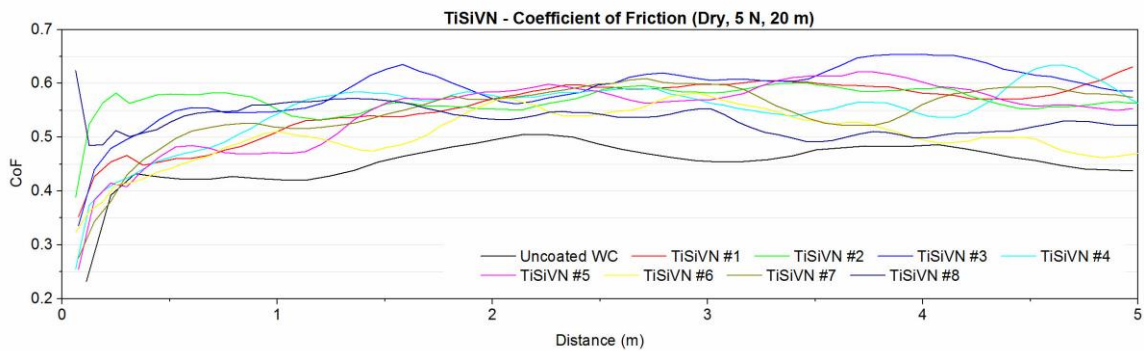
Figure C.3. Running in period of TiSiVN in dry condition

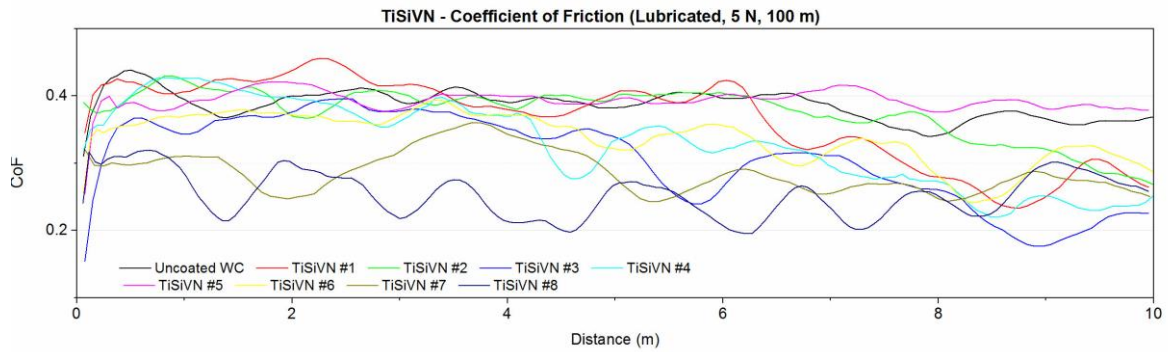
Figure C.4. Running in period of TiSiVN in lubricated condition

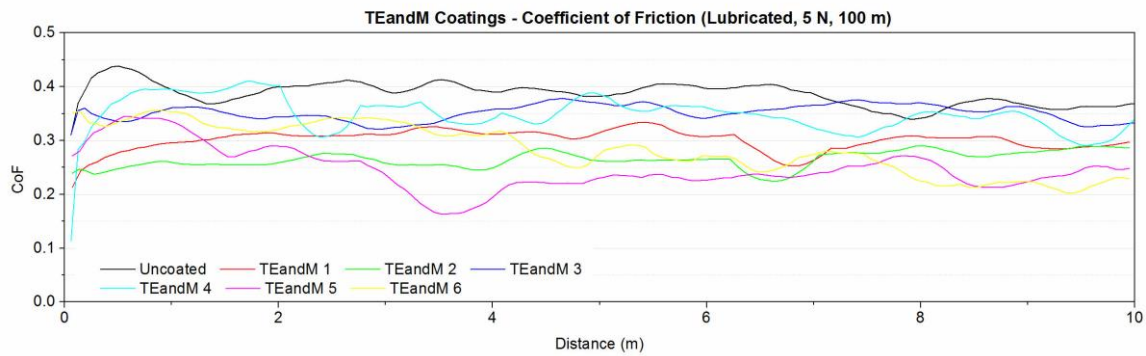
Figure C.6. Running in period of TEandM coatings in lubricated condition
