Tribological Behaviour of CoCrMo Alloys Influence of Strain Hardening

Dissertação no âmbito do
Mestrado Integrado em Engenharia Mecânica

Outubro de 2021

Análise da eficiência do endurecimento a frio no desgaste e propriedades mecânicas da liga Co₂₈Cr₆Mo

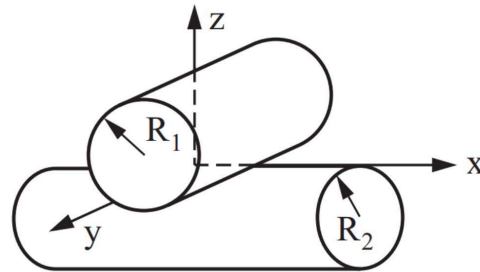
Figure 2.1. Contact between two crossed cylinders (Popov, 2010).

In the present research work, the contact geometry between the Co28Cr6Mo samples and a tungsten carbide cylinder in the mechanical tests (where cold-hardening was performed) was defined by crossed cylinders positioned at approximately 90° as shown in Figure 2.1, taken from Popov (2010). Furthermore, in the tribological tests, the Co28Cr6Mo samples were also crossed at 90° with the ring-shaped zirconia counter bodies. It is important to note that, in this case, the contact area isn't circular but elliptical. This happens because the samples and counter bodies have different radii.

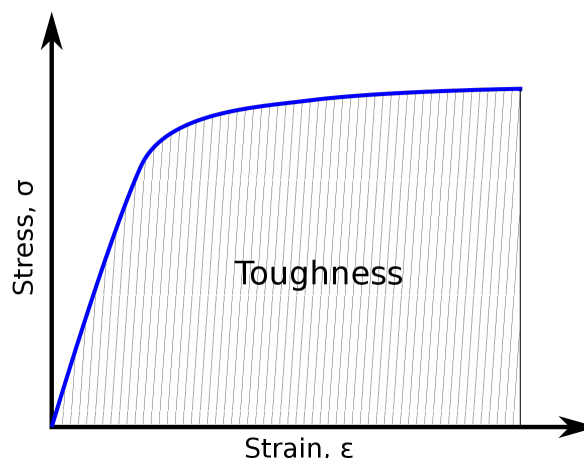
Figure 3.1. Toughness is the area under a stress-strain curve of a material.

To understand whether a material is prone to hardening and to quantify this proneness, it is necessary to consider the definition of toughness. Toughness is the ability of a material to absorb energy and deform plastically without fracturing. A material with a high toughness allows favourable conditions for its hardening, i.e. mechanical treatments. This capacity varies from material to material and can be graphically represented by the area under the stress-strain curve of the material in question, as seen in Figure 3.1.

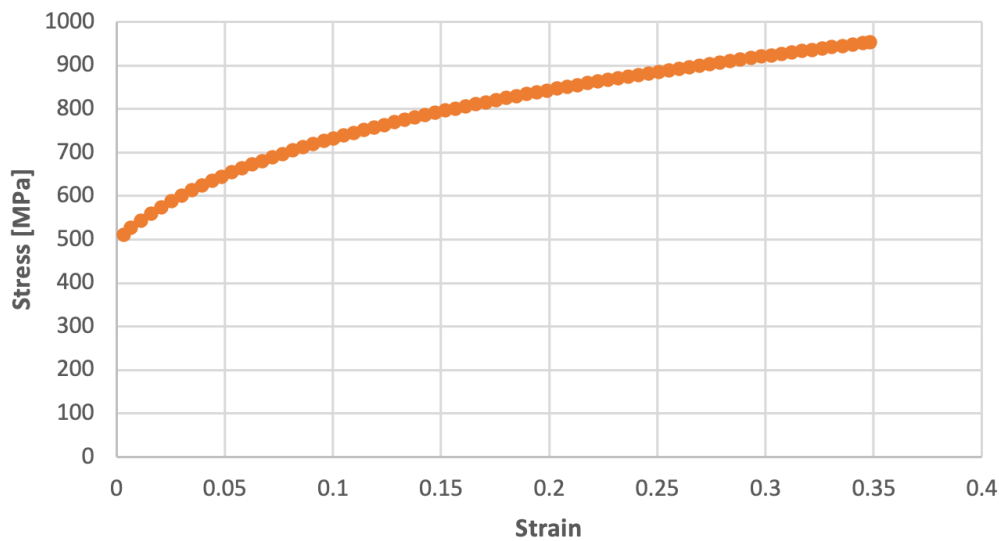
Figure 3.2. Plastic domain of the Co28Cr6Mo stress-strain curve.

Thus, it was necessary to analyse the stress-strain curve of the material of the present research work, Co28Cr6Mo, represented in Figure 3.2. This figure represents only the plastic domain of this material, since the area of the elastic zone is minimal, due to a very steep slope of the graph in this zone.

As can be seen, there is a large difference between the yield strength (503 MPa) and the ultimate tensile strength (952 MPa). The area of the graph between these two values represents the extent associated with the strain hardening (Figure 3.3). The greater this difference, the greater its ability to harden. Thus, this Co28Cr6Mo alloy proves to be favourable for mechanical treatment as it has a very high toughness.

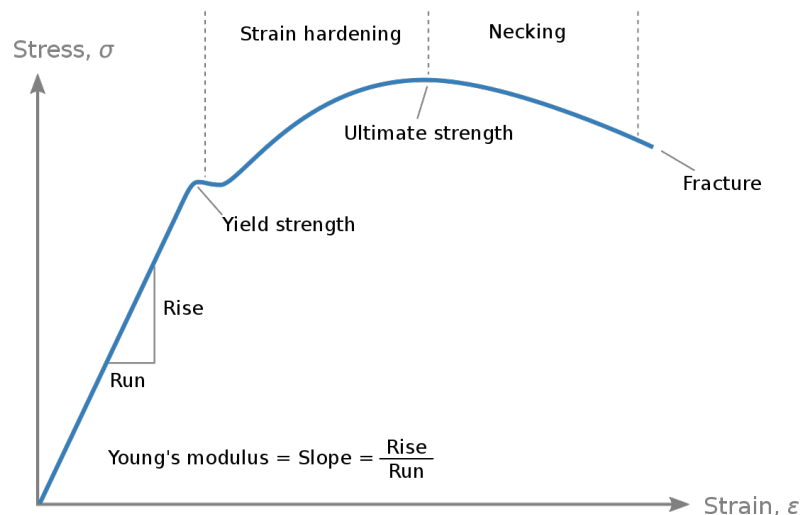
Figure 3.3. The extent between the yield strength and the ultimate tensile strength represents the strain hardening zone of the material.

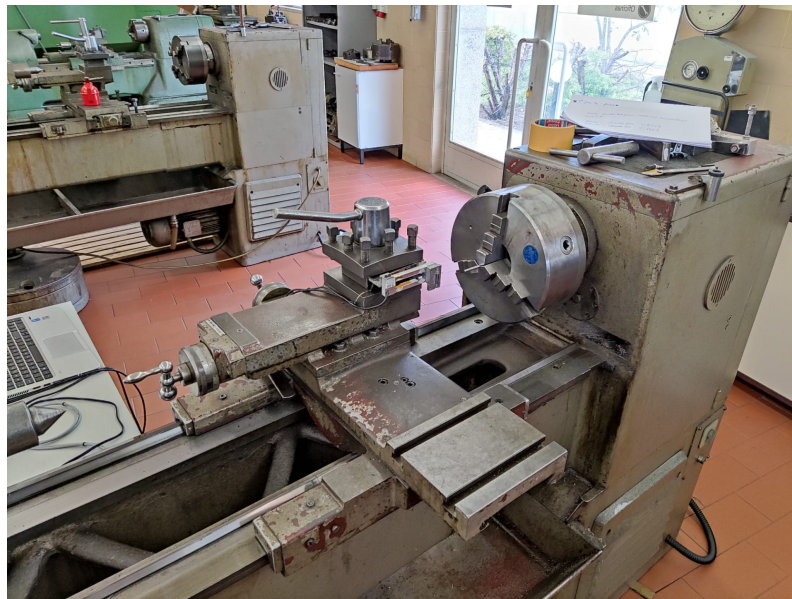
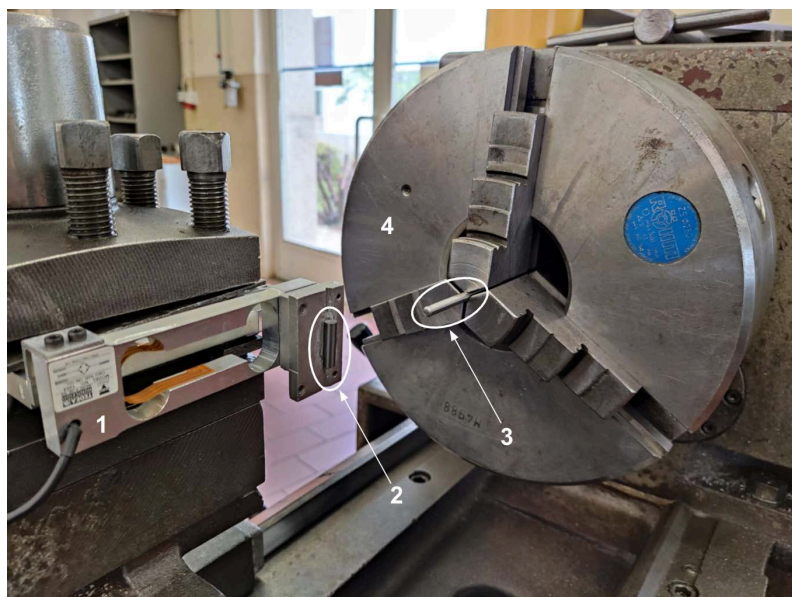
Figure 4.1. Equipment used during the mechanical tests.

In order to induce a superficial hardening of the Co28Cr6Mo specimens, a lathe was used to promote the rotation and the force between the crossed cylinders, as shown in Figure 4.1(a).

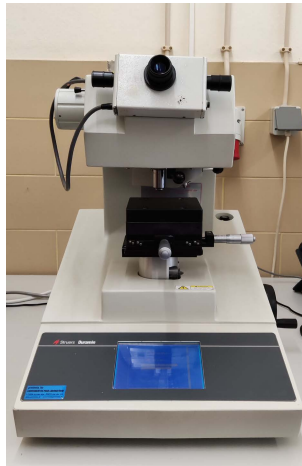
Figure 4.2. Struers Duramin durometer.

The hardness measurements were performed with a Struers Duramin durometer, shown in Figure 4.2. It has a maximum resolution of 0.01 μm and performs measurements on Vickers, Knoop, Brinell and Rockwell. In this case, these measurements were taken through Vickers micro hardness tests. This equipment is able to perform micro and macro-hardness measurements, with an applied load range of 10-2000 gf and automatic load system. The positioning of the samples is controlled by a micrometric measuring table with two degrees of freedom.

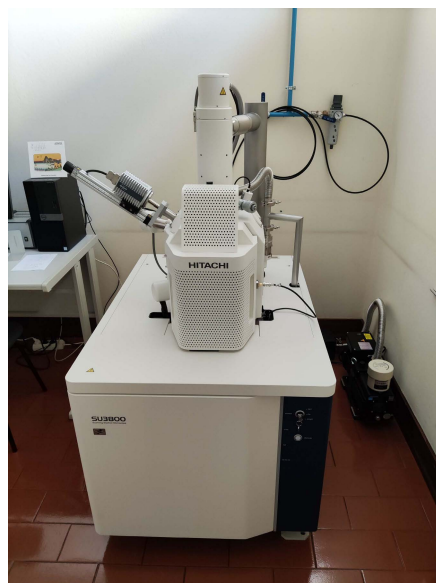
Figure 4.3. HITACHI SU3800 scanning electron microscope.

A scanning electron microscope (SEM) is a type of microscope that creates images of a determined specimen by scanning its surface with a focused beam of electrons that are generally produced in a tungsten filament. The electrons interact with atoms in the sample surface, producing various signals that contain information about the surface topography and composition of the sample. This equipment is also important to quantify in percentage the chemical composition of a certain pre-selected area of the material under analysis. The model used was a HITACHI SU3800 as shown in Figure 4.3.

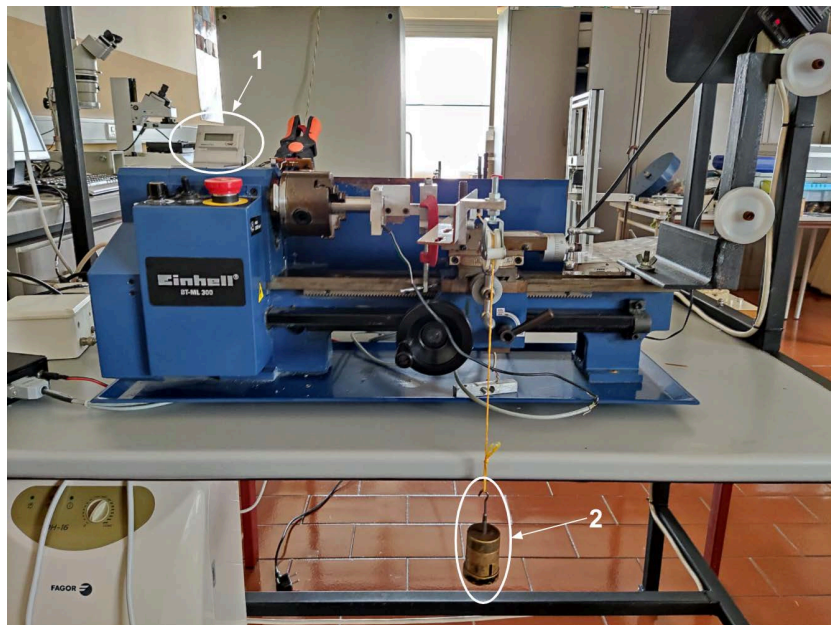
- 1- Total rotation counting system;
- 2- Set of weights;
- 3- Zirconia ring;
- 4- Co₂₈Cr₆Mo sample;
- 5- Load cell (connected through wire to the set of weights).

Figure 4.4. Tribological tests' equipment used.

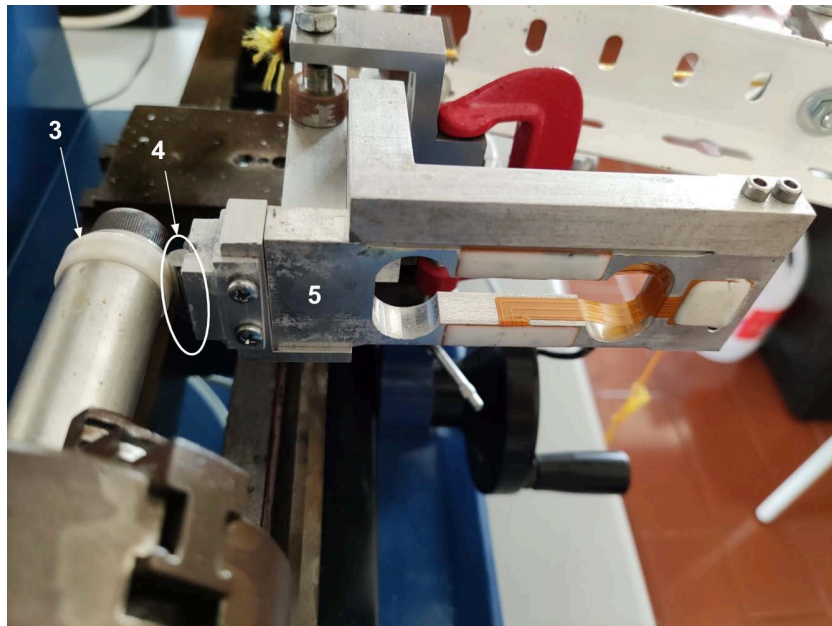
Figure 4.5. Tribological tests' equipment used: magnification of the contact area between the zirconia ring and the Co28Cr6Mo

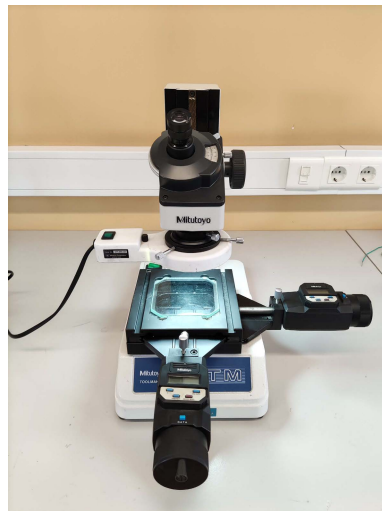
Figure 4.6. Mitutoyo Toolmaker's Microscope

Wear marks measurements were determined using a Mitutoyo Toolmaker's Microscope optical microscope (Figure 4.6), with 15x magnification and illumination with a circular lamp. It has a Microstage, a positioning system for the measuring plate, which holds two digital micrometers, one in each XY direction (two degrees of freedom), with an accuracy of 0.001 mm. Thus, using this equipment, it was possible to measure two diameters perpendicular to each other: the distances between the furthest ends and the closest ends, in the wear marks' ellipse. These measures allow the subsequent determination of the wear volume.

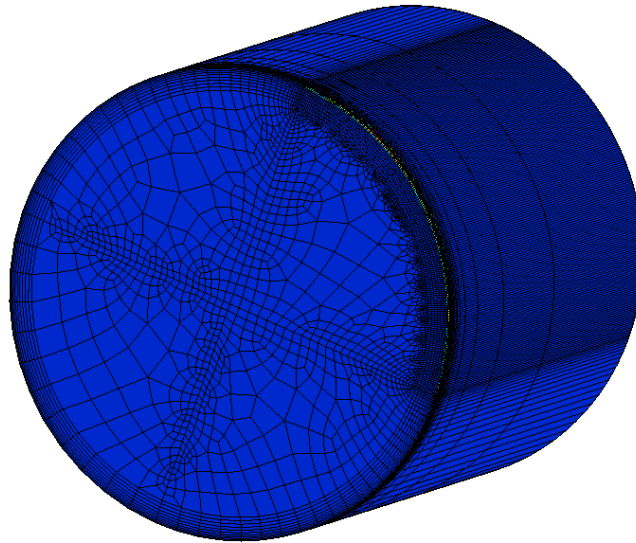
Figure 4.7. Generic aspect of the numerical model, with the most refined mesh in the analysed area.

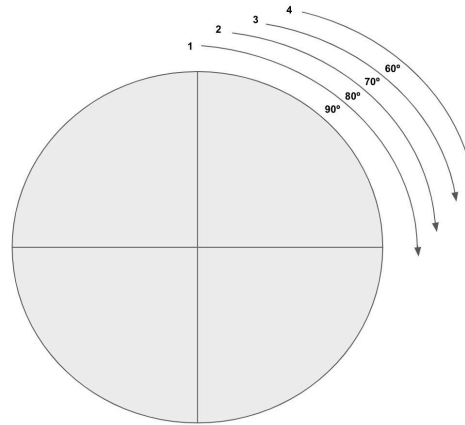
Figure 4.8. Simplified representation of the successive reduction in range of motion with the passage number.

fourth of 60° (reduction of 5° in each of the ends, totaling 10°). This reduction in scanning amplitude was taken into account to start the next passage in a stable area; that is, for the new passage to start in an area where the plastic deformation caused by the previous passage is uniform (at the beginning of each sweep there is a transition zone, not yet uniform). Thus, the scanning line is shortened as more passes are made (there is a gradual decrease in amplitudes, as seen in Figure 4.8).

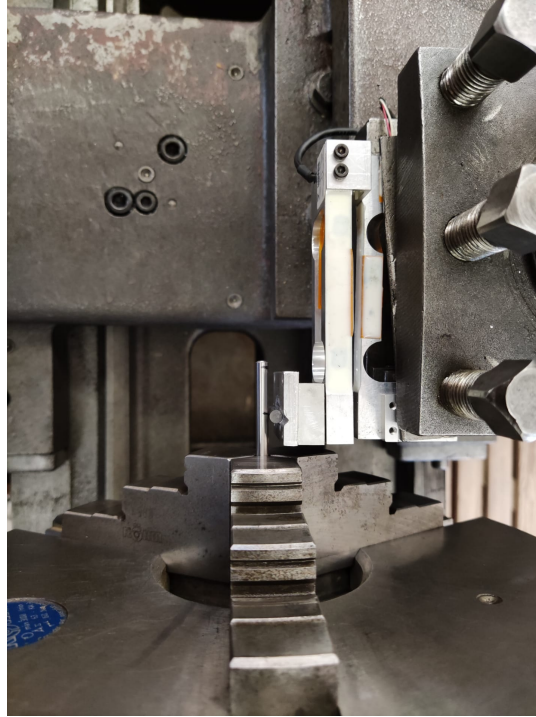
Figure 4.9. Top view of the contact between the Co28Cr6Mo and the WC cylinders. The Co28Cr6Mo cylinder is connected to the lathe, which gives it rotational and forward movement. Its sweeping area is delimited by the black marks.

there would be areas of the sample to be hardened that would not undergo this treatment. Hence, a reduced axial velocity was selected. Ten passages were taken into account in every test: each passage corresponds to the axial scan of a pre-defined distance (between two black lines previously drawn on the specimen, Figure 4.9).

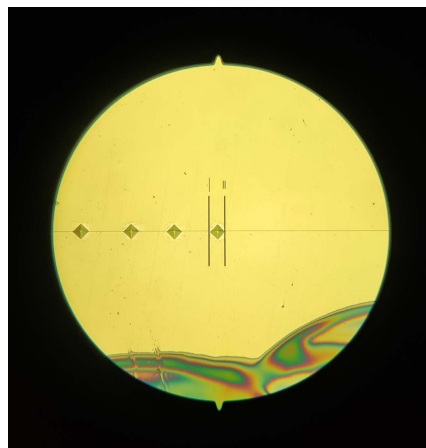
Figure 4.11. Vickers hardness measurements being performed on the Struers Duramin equipment.

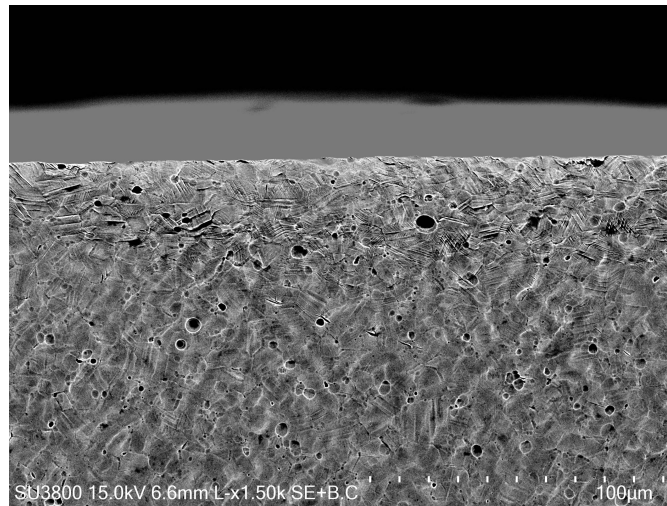
Figure 4.13. Example of a collected SEM picture of Co₂₈Cr₆Mo alloy after being subject to strain hardening with an applied normal force of 19.79N (Mechanical Test 2).

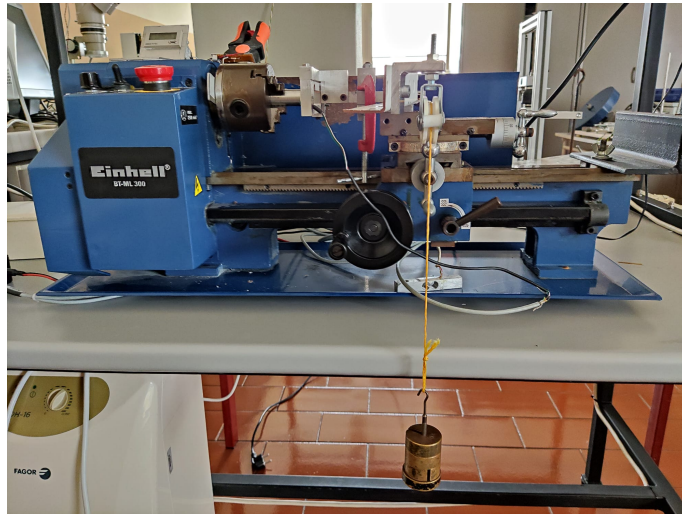
Figure 4.14. Tribometer used during wear tests: the set of weights applied, according to the desired normal force, is connected to the load cell by a wire, which in turn has the Co₂₈Cr₆Mo sample attached to it.

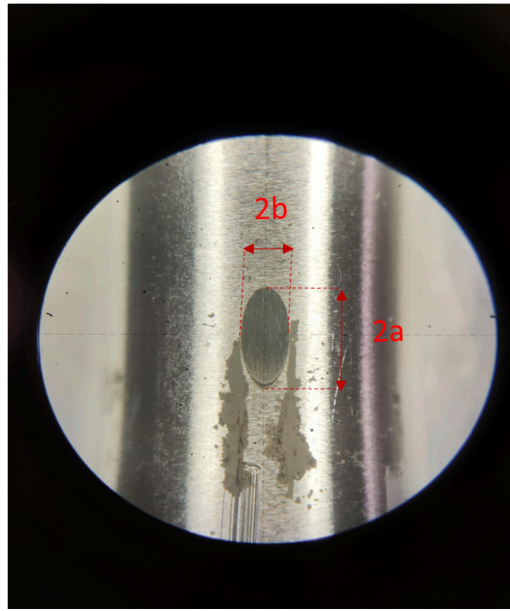
Figure 4.15. Contact zone observed through Mitutoyo toolmaker's microscope, after a tribological test.

After the tests on the tribometer, the Mitutoyo toolmaker's microscope was used to visualize the contact zone (Figure 4.15). As explained before, this contact zone was an ellipse and, with the help of two digital micrometre rules, the lengths of the respective major and minor axis were determined. These distances were needed to evaluate the volume of Co₂₈Cr₆Mo removed during each test.

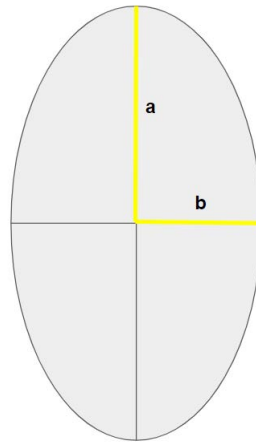
Figure 4.16. Schematic representation of distances a and b, on the elliptical contact zone.

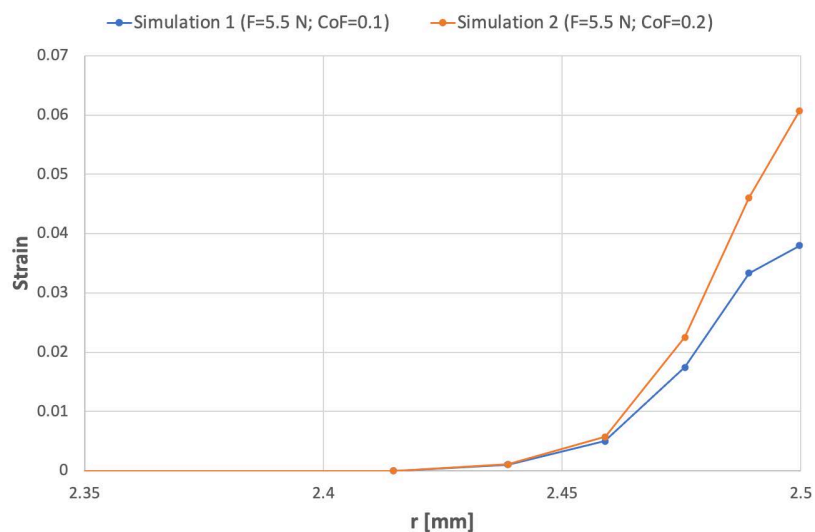
Figure 5.1. Influence of the coefficient of friction (CoF) on strain and on the depth of the deformed surface layer of a Co28Cr6Mo simulated cylinder.

Figure 5.1 represents the comparative graph between two simulations in which the same normal force was applied, differing only in the coefficient of friction. Through its analysis it is possible to verify that although Simulation 2 has higher strain values in a certain extension, a higher coefficient of friction does not lead to more extensive deformed zones; its variation does not cause any significant change in the depth of the deformed surface zone. Analogous conclusions can be drawn through a flow stress comparative graph, as can be seen in Figure 5.2.

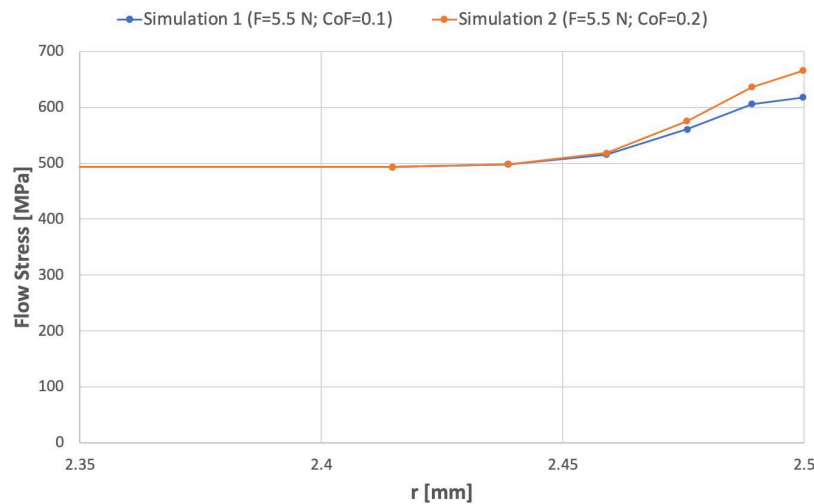
Figure 5.2. Influence of the coefficient of friction (CoF) on flow stress and on the depth of the deformed surface layer of a Co28Cr6Mo simulated cylinder.

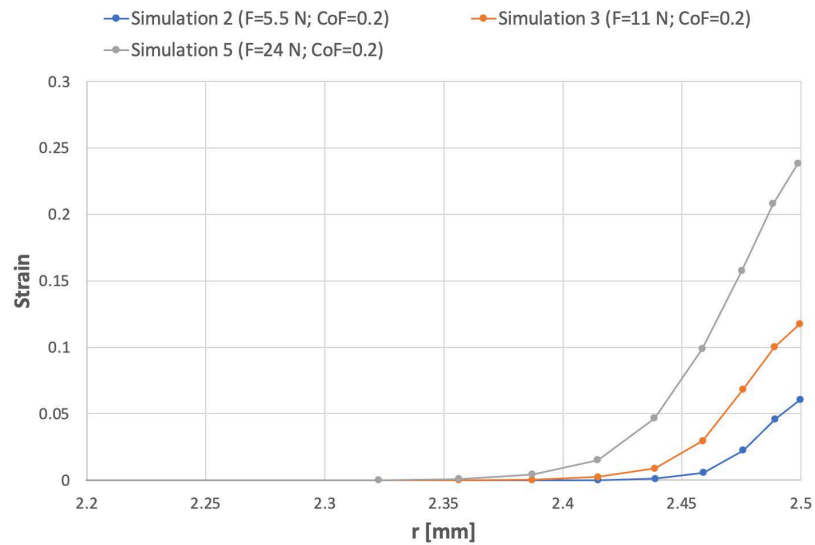
Figure 5.3. Influence of the normal load on strain and on the depth of the deformed surface layer of a Co28Cr6Mo simulated cylinder.

In addition to the previous analyses, the numerical model allowed to understand the influence of increasing the normal load from simulation to simulation on the depth of the plastically deformed Co28Cr6Mo cylinder surface layer. As can be verified in Figure 5.3, when maintaining the coefficient of friction constant, varying the normal load it is observed that, although the surface deformation reveals higher values for the higher values of force, the depth of the affected zone does not change. Thus, it was verified that the increase of the normal force, later on in the mechanical tests of strain hardening, would have no effect on the size of the plastically deformed layer. Analogous conclusions can be drawn through a flow stress comparative graph, as can be seen in Figure 5.4.

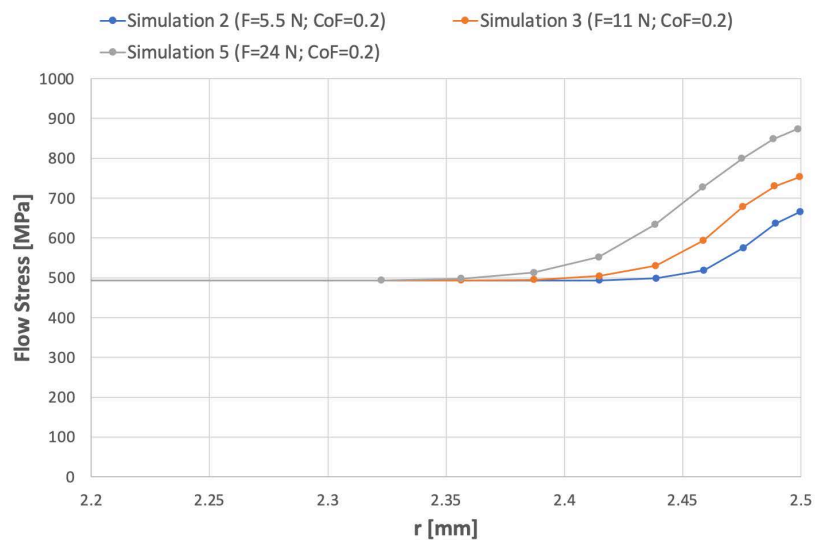
Figure 5.4. Influence of the normal load on flow stress and on the depth of the deformed surface layer of a Co28Cr6Mo simulated cylinder.

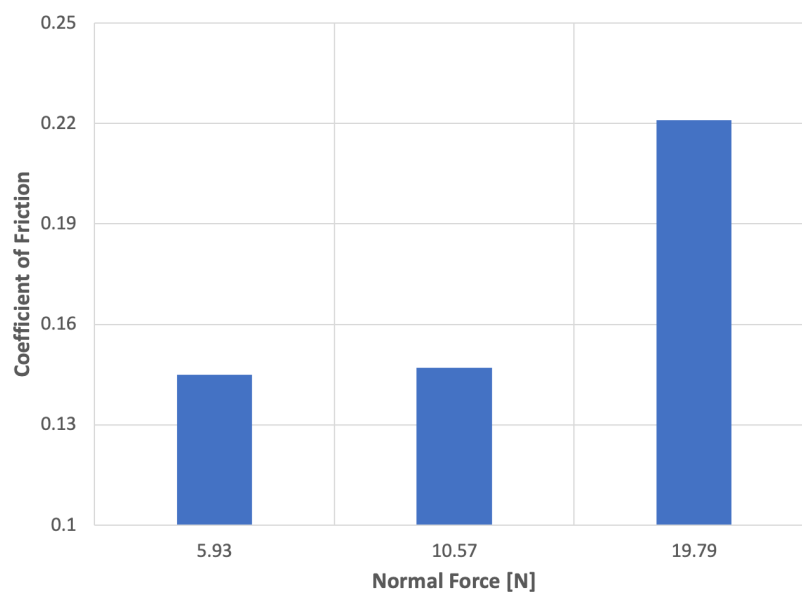
Figure 5.5. The increase of the normal force applied during the mechanical tests, between the tungsten carbide (WC) cylinder and the Co28Cr6Mo cylinder, lead to a visible increase of the coefficient of friction associated.

As mentioned previously in Section 4.3.2 (pg. 31), average normal force and coefficient of friction values were obtained for each of the three mechanical tests performed. It was found that, with the increase in the normal force applied, there was a consequent increase in the coefficient of friction (due to the greater tangential forces involved), as can be seen in Figure 5.5.

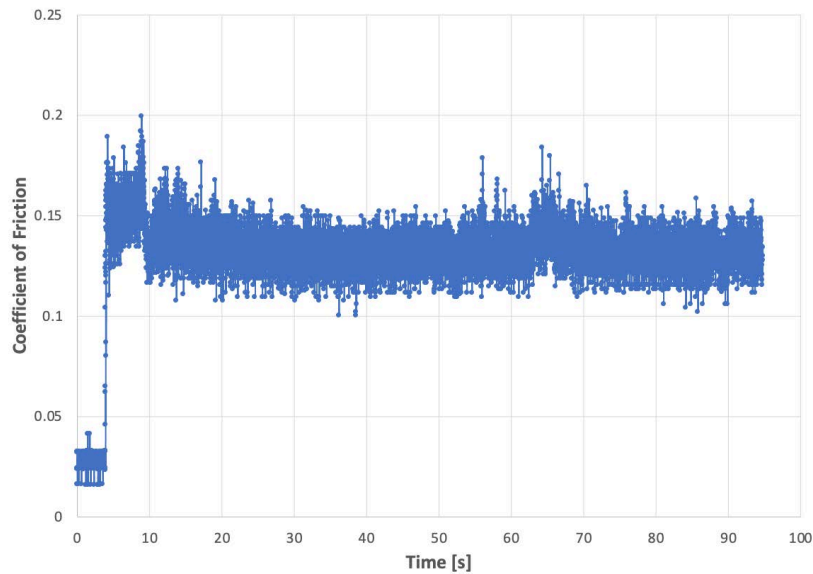
Figure 5.6. Instantaneous variation of the coefficient of friction, relative to the sixth passage of the mechanical hardening test in which 5.93N of normal force was applied.

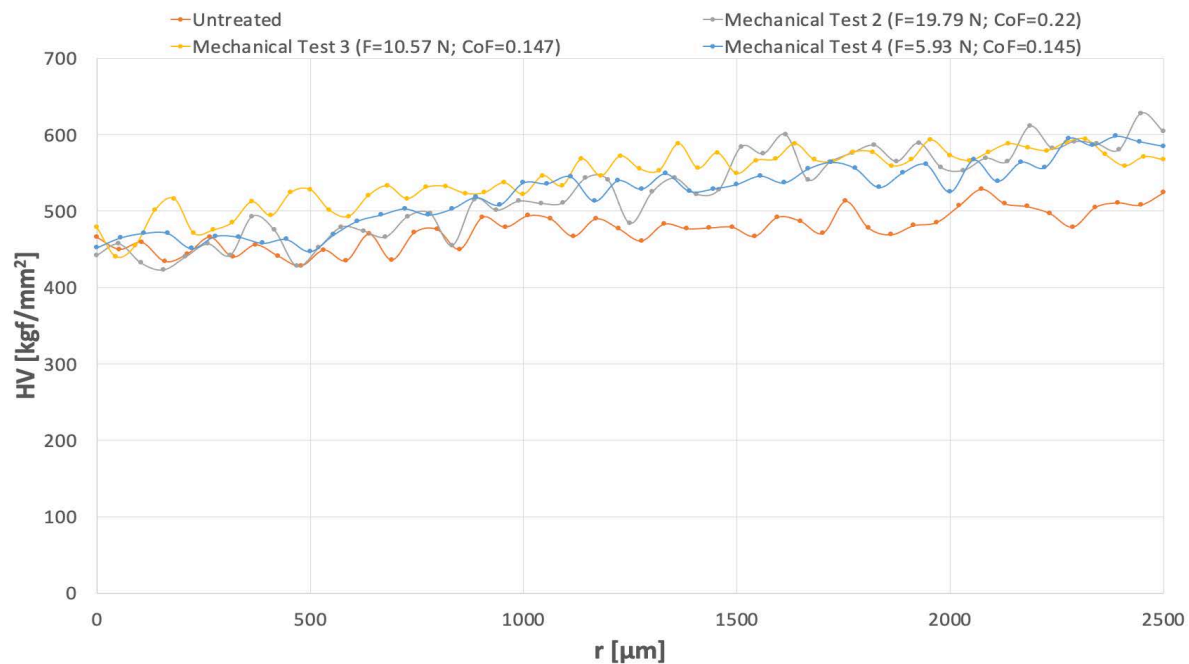
Figure 5.7. Evolution of microhardness with the radial distance for four different samples, three samples were subjected to different applied loads (5.93, 10.57 and 19.79N) and one remained as originally (untreated).

This graphical representation is depicted in Figure 5.7. Here, it is possible to see the different evolutions between the three mechanical tests under consideration and also in relation to the untreated sample. The origin of the horizontal axis corresponds to the centre of the cross section of the samples, and $r = 2500 \mu\text{m}$ corresponds to the total radius. The resolution of the hardness profile was approximately $50 \mu\text{m}$ between indentations.

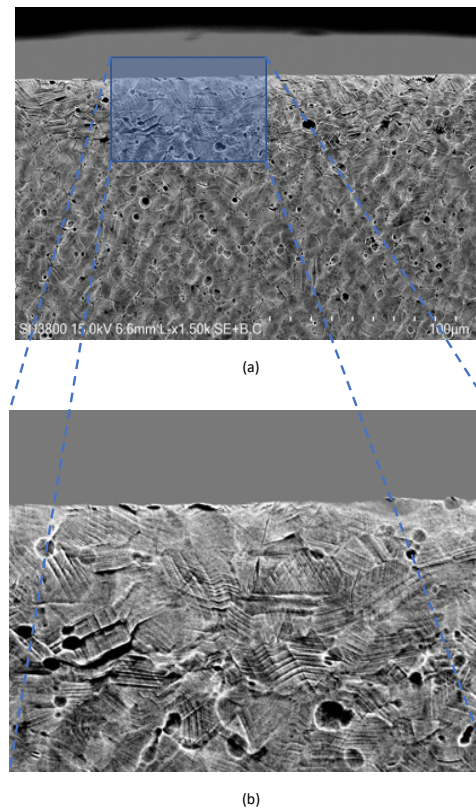
Figure 5.8. Visualisation through SEM of grain deformations, for the cross-section of the Mechanical Test 2 specimen, in this case: a) full micrograph and b) detail of deformed zone.

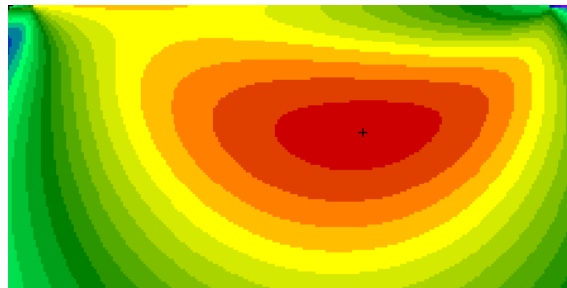
Figure 5.9. Location of maximum shear stress for Mechanical Test 2 (normal force of 19.79N and coefficient of friction 0.221), in dark red.

Figure 5.9, Figure 5.10 and Figure 5.11 represent, respectively, the locations of the maximum shear stresses for Mechanical Test 2 (normal force of 19.79 N and coefficient of friction 0.221), Mechanical Test 3 (normal force of 10.57 N and coefficient of friction 0.147) and Mechanical Test 4 (normal force of 5.93 N and coefficient of friction 0.145). Note that the surface of the samples is at the upper end of each image.

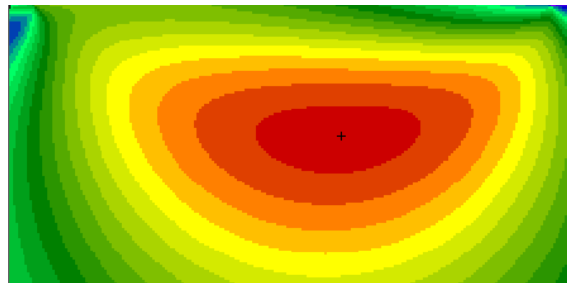
Figure 5.10. Location of maximum shear stress for Mechanical Test 3 (normal force of 10.57N and coefficient of friction 0.147), in dark red.

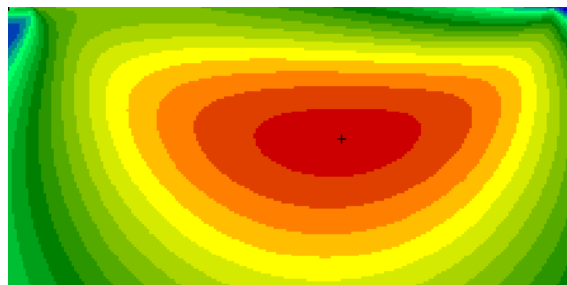
Figure 5.11. Location of maximum shear stress for Mechanical Test 4 (normal force of 5.93N and coefficient of friction 0.145), in dark red.

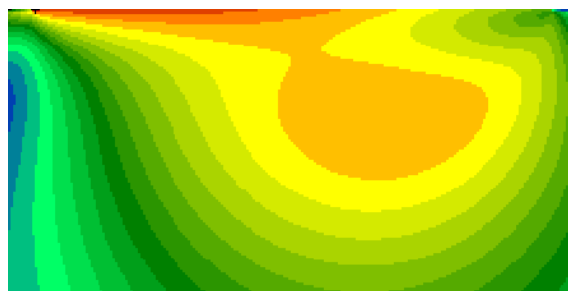
Figure 5.12. Location of maximum shear stress for a coefficient of friction of 0.4. Although this picture was taken for a normal force of 10N, loads of 5N or 20N produce a very similar image.

One of the preponderant factors that makes the zone of maximum shear stress to displace is the coefficient of friction. By analysing these images, it is possible to verify that the coefficient of friction values in question for the three mechanical tests were not high enough to cause considerable deformations on the surface of the Co28Cr6Mo specimens. Using again the HertzWin software, it was verified that a maximum of shear stress occurs in the most superficial zone for a minimum coefficient of friction value of 0.4, as shown in Figure 5.12. This representation is very similar for any value of normal force between 5 and 20 N, so that once again it shows the great influence of the coefficient of friction.

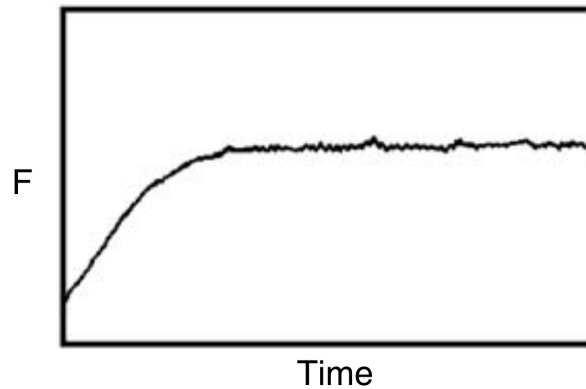
Figure 5.13. Typical abrasive situation friction-time curve (Blau,1996).

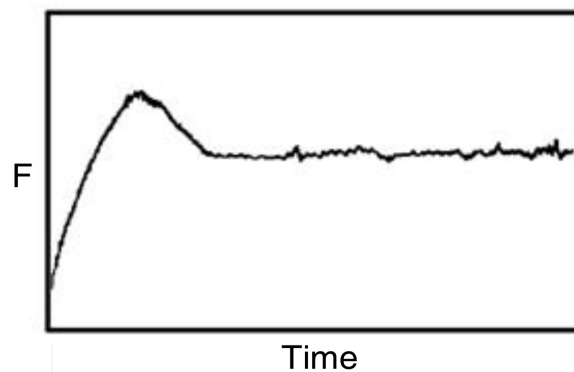
Figure 5.14. Typical friction-time curve from a situation with high formation and fixation of oxides in the wear surface (Blau,1996).

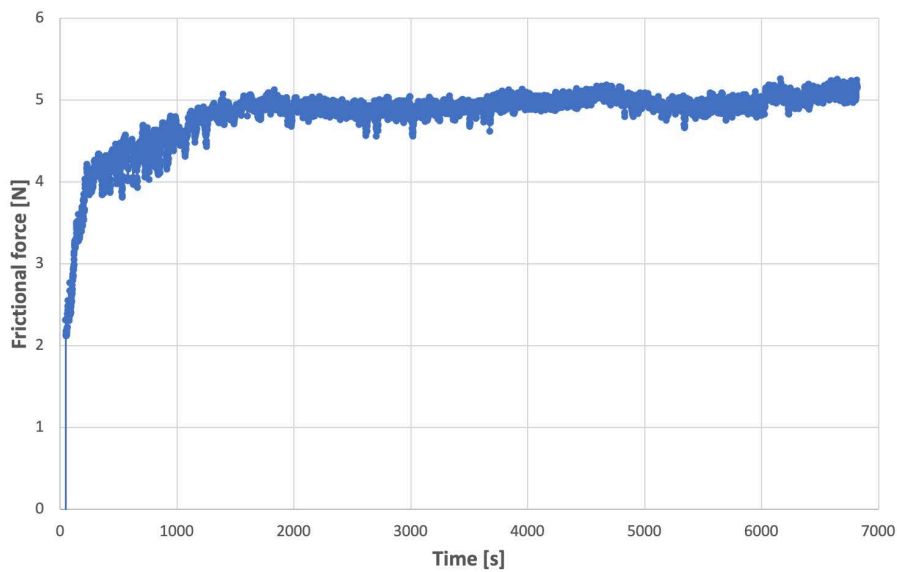
Figure 5.15. Friction-time curve for the 8N normal force tribological test with the untreated specimen.

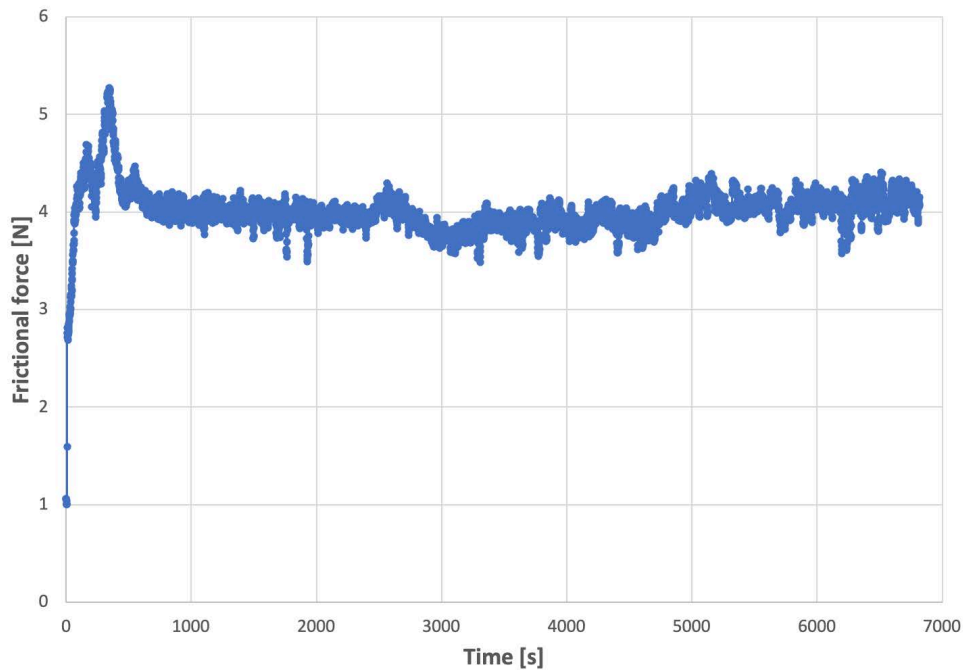
Figure 5.16. Friction-time curve for the 10N normal force tribological test with the Mechanical Test 3 (normal force of 10.57N and coefficient of friction 0.147) specimen.

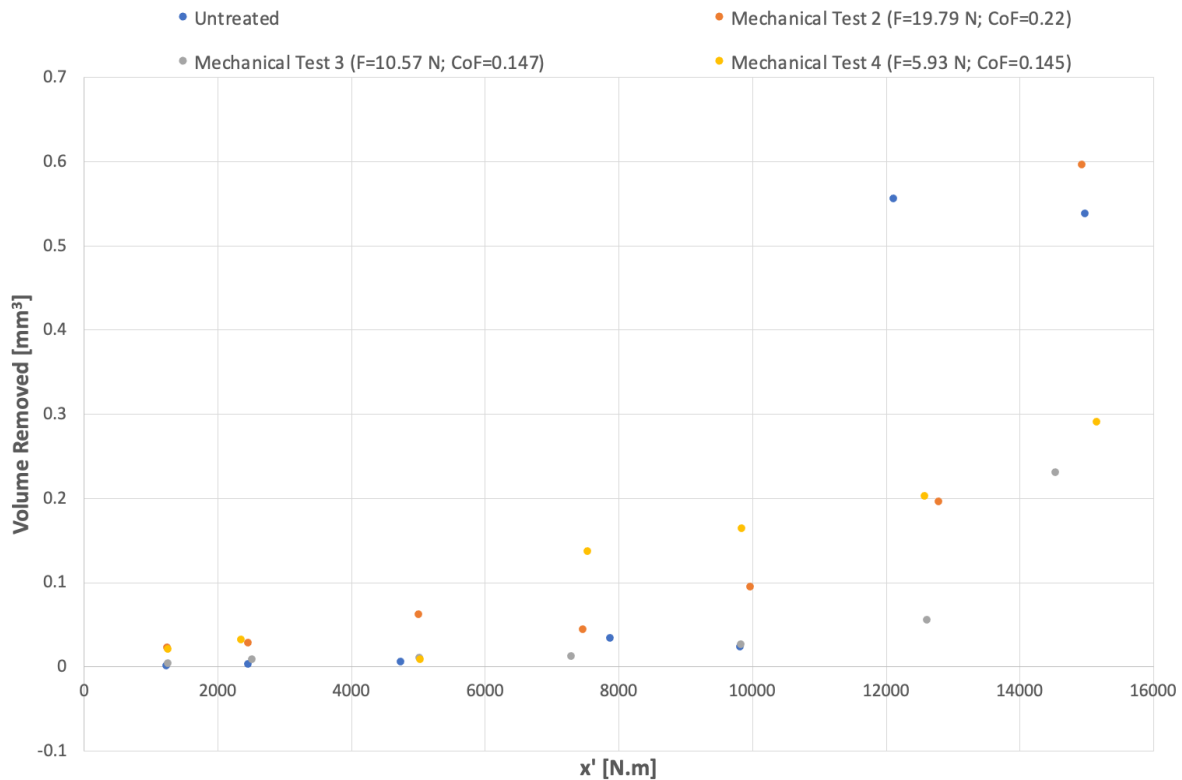
Figure 5.17. Evolution of the wear volume with the product between the applied load and sliding distance for Co28Cr6Mo samples (normal force applied: 1, 2, 4, 6, 8, 10 and 12 N).

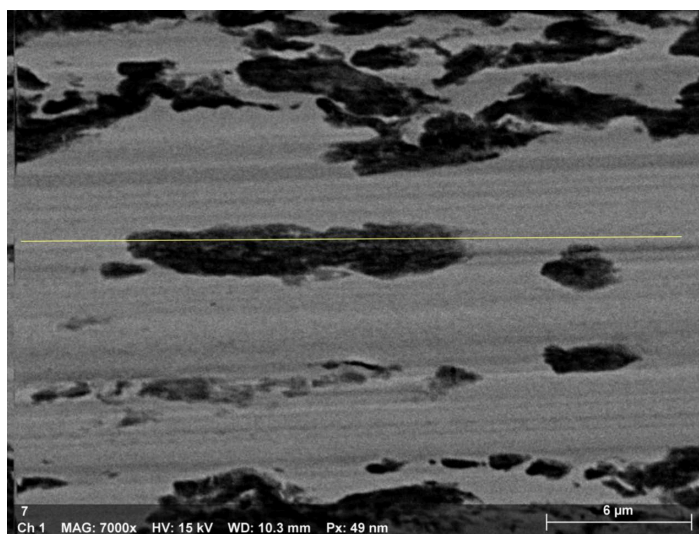
Figure 5.18. Line that will serve as a marker over the zone to be analysed in terms of chemical composition. This feature is one of the strengths of an analysis using a SEM.

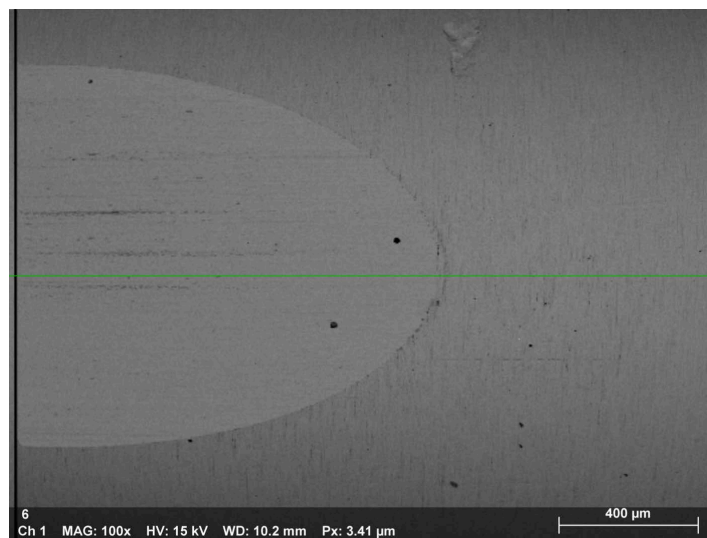
Figure 5.19. Line that will serve as a marker over the zone to be analysed in terms of chemical composition. This time it covers a relatively large area with a low percentage of black marks.

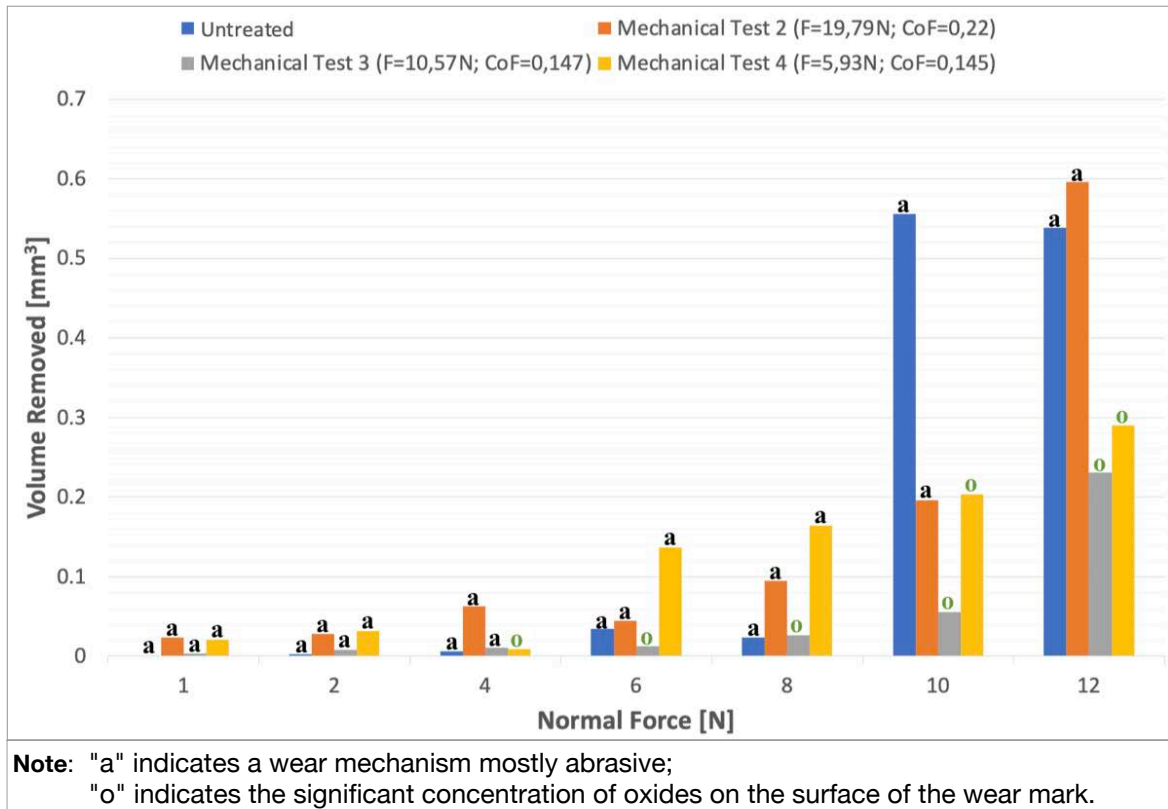
Figure 5.20. Evolution of the volume of Co28Cr6Mo removed during the tribological tests, for each normal force applied. Comparative analysis between the specimens previously hardened in different conditions and between these and the untreated specimen.

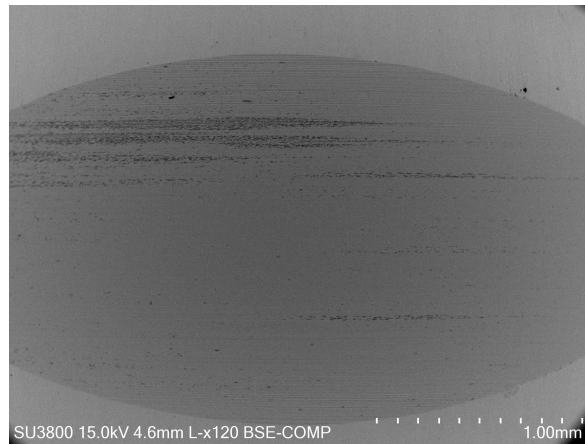
Figure 5.21. Visualisation in SEM of the wear mark from the test in which a load of 19.79N was applied (Mechanical Test 2) associated to a normal force of 12N in the tribological tests.

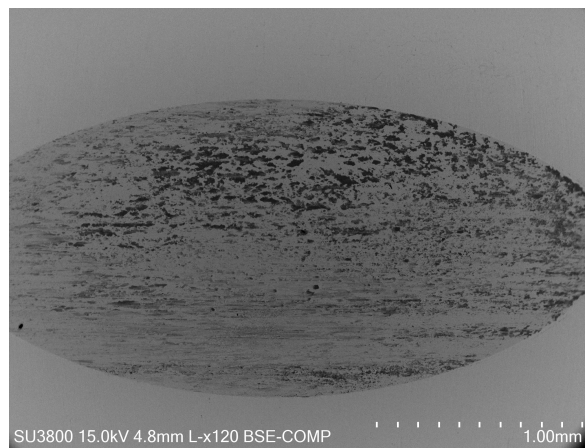
Figure 5.22. Visualisation in SEM of the wear mark from the test in which a load of 10.57N was applied (Mechanical Test 3) associated to a normal force of 12N in the tribological tests.

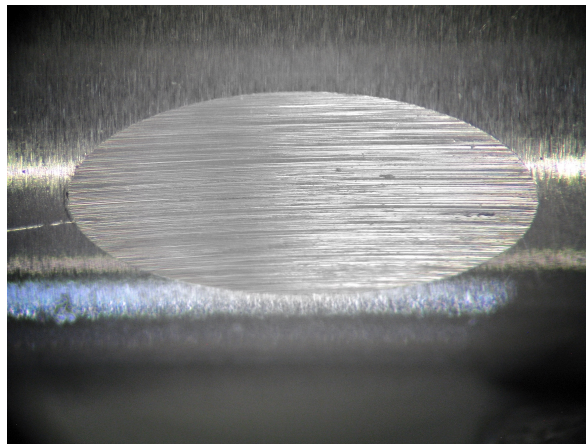
Figure 5.23. Visualisation in the optical microscope of the wear mark from the untreated sample associated to a normal force of 10N in the tribological tests.

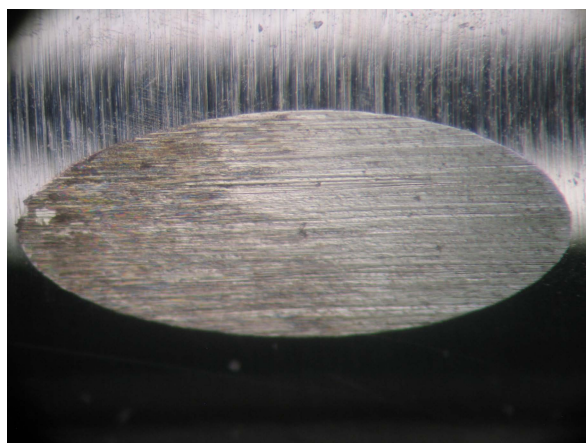
Figure 5.24. Visualisation in the optical microscope of the wear mark from the test in which a load of 10.57N was applied (Mechanical Test 3) associated to a normal force of 10N in the tribological tests.

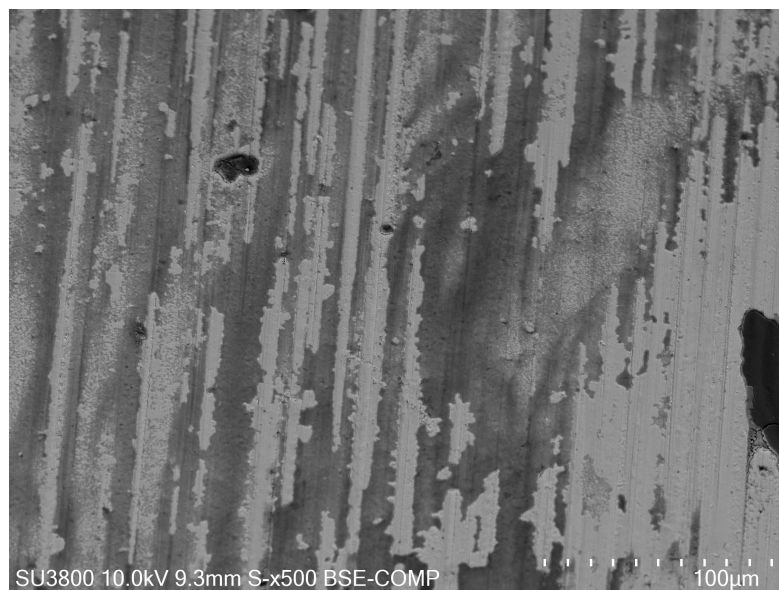
Figure 5.25. Black marks on the zirconia ring associated to the 10N normal force tribological test for the specimen hardened in Mechanical Test 3 (normal force of 10.57N and coefficient of friction 0.147).

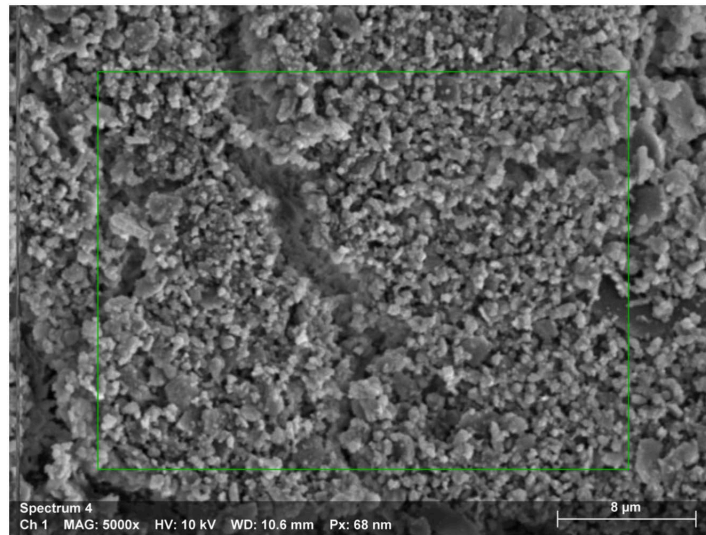
Figure 5.26. Magnification of one of the black spots from the zirconia ring associated to a 10N normal force tribological test on the Mechanical Test 3 sample, ready to be chemically analysed.

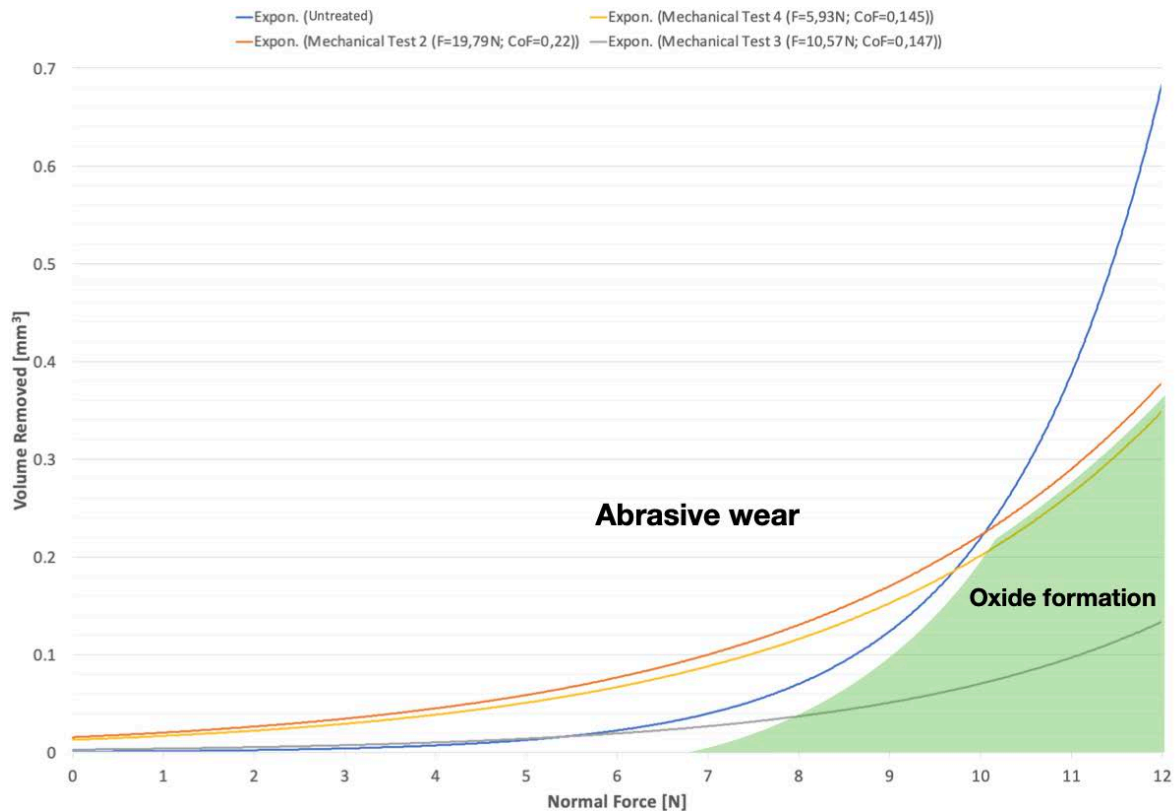
Figure 6.1. Domain of the optimal conditions for the formation and fixation of oxides in the wear marks and consequent improvement of the mechanical properties of the alloy Co₂₈Cr₆Mo in green, namely the significant reduction of the volume removed by wear.
