SUSTAINABLE MANAGEMENT OF
CONTAMINATED LAND - EXAMPLES OF
PORTUGAL AND AUSTRALIA

Dissertação de Mestrado Integrado em Engenharia do Ambiente, na área de Especialização em Território e Gestão do ambiente, orientada pela Professora Doutora Maria Isabel Moita Pinto e pelo Professor Doutor António Alberto Santos Correia e apresentada ao Departamento de Engenharia Civil da Faculdade de Ciências e Tecnologia da Universidade de Coimbra.

Faculdade de Ciências e Tecnologia da Universidade de Coimbra
Departamento de Engenharia Civil

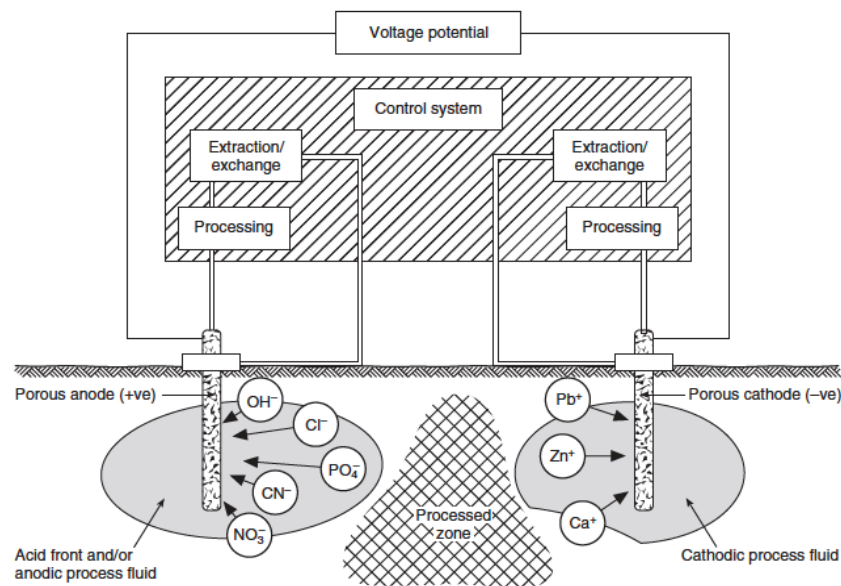
Figure 2.10 Electroremediation process. (Sarsby, 2013)

Electroremediation is the application of direct currents across electrodes implanted *ex-situ* in the soil to produce an electrical field for the mobilisation and extraction of pollutants (Figure 2.10). Transport under electrical fields, in combination with electrolysis and other processes, are the driving mechanisms. Furthermore, the electrical field will promote soil-water flow via the electroosmosis process. As a result, *electroremediation* is a technique for moving contaminants across treatment zones in soils where low hydraulic conductivity makes difficult the use of wells and pumps to circulate water in the soil (Tack & Bardos, 2020).

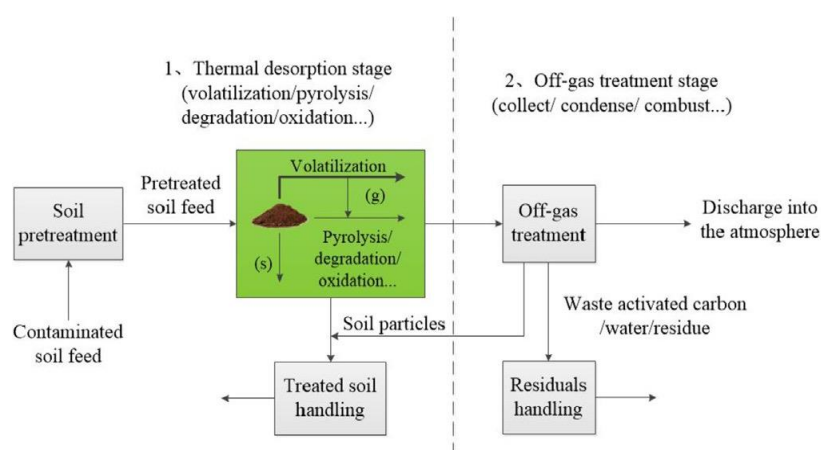
Figure 2.13 Basic process of Thermal Desorption system. (Zhao et al., 2019)

As shown in Figure 2.13 there are two stages for the *TD* system: the stage of thermal desorption and the stage of off-gas treatment. The *TD* phase involves the volatilization of pollutants in prepared soil by heating and other processes, such pyrolysis, degradation and oxidation. The gas created in the *TD* phase is released into the second stage and the waste solids are treated.

The off-gas treatment processes the gaseous pollutants produced in the TD phase, which are treated by different processes such as adsorption, condensation or incineration. To a safely discharge from the off-gas treatment stage, existent contaminated soil particles return to the previous stage in order to prevent/minimise secondary contamination. Wastewater and carbon activated waste must be carefully handled (Zhao et al., 2019).

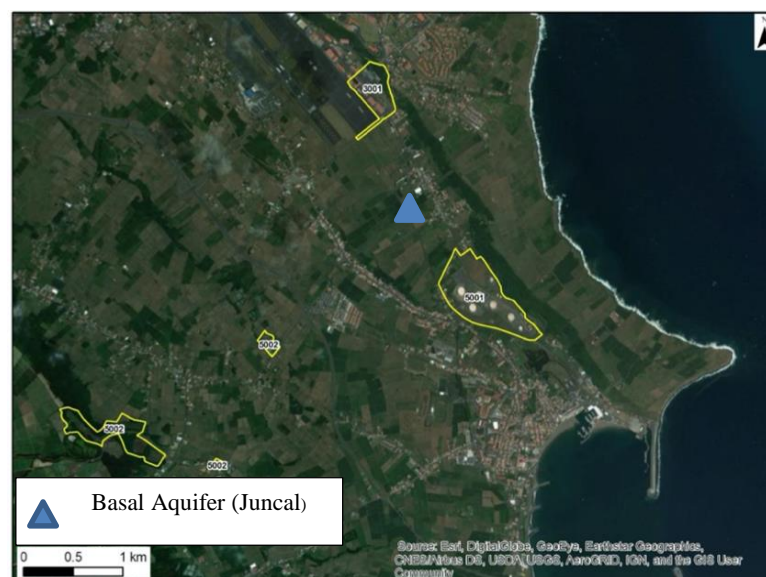
Figure 3.1 Localization of the 3 sites and the basal aquifer of Juncal. (Adapted from Ferraz Pinheiro, 2018)

The region under study is in Terceira Island on east side (Figure 3.1). Base das Lajes is in the northeast band exhibiting an area of about 8.5 to 10 km in length and between 3.5 and 4 km wide from Cabo da Praia to Vila Nova located in the north. In the south, it extends from Praia da Vitória to Cabo da Praia. In Figure 3.1 there are identified three sites associated with the higher environmental risk: Main Gate Area (3001), South Tank Farm (5001) and Cinder Pit Farm (5002) (Paulo et al., 2012).

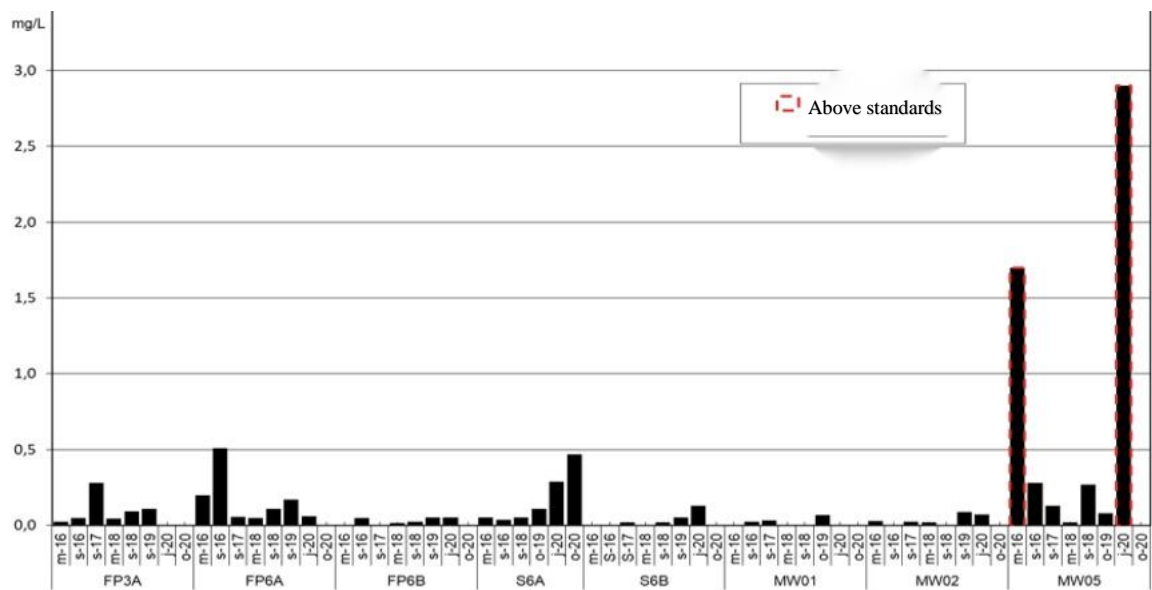
Figure 3.6 Concentration of TPH in piezometers located inside and outside of the Site 3001 between 2016 and 2020. (Adapted from Leitão and Henriques, 2020)

Concentrations over the quantification limit in relation to TPH were observed at different locations in 2020, such as in previous campaigns (Figure 3.6). The piezometer MW05 is the only one in which concentrations over the standard are present. Since 2019, the development of TPH in the S6A piezometer appears to show an increase. The oscillations between camps are due to the leaching of soil pollutants to deeper layers, during rainfall periods (Leitão & Henriques, 2020).

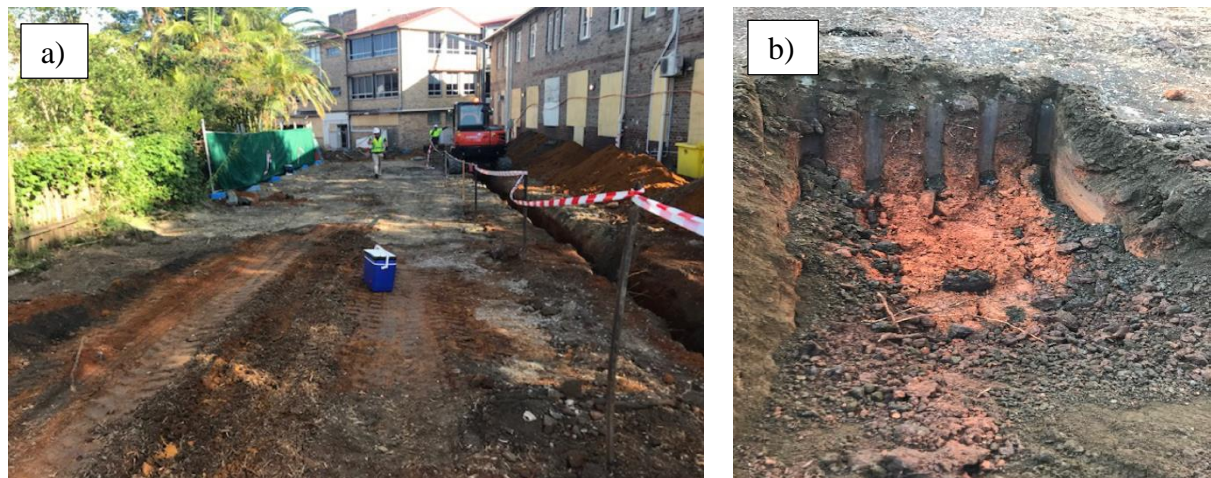
Figure 3.8 North Sydney Council (a) View of site conditions. (b) View of sub-surface conditions. (EI Australia, 2020)

The collection of soil samples and their processing was performed by a suitably qualified, trained and experienced environmental engineer. To collect the soil samples, the site was split in one rectangle and the sampling points were divided equally. Manual grab samples were collected from six test pits (all the reports from the six test pits are available for consultation in the Attachment A) managed by an excavator supplied by the client and by a trained and qualified staff member (Figure 3.8). The six samples were distributed evenly across the south-western portion of the site (Figure 3.9) (EI Australia, 2020).

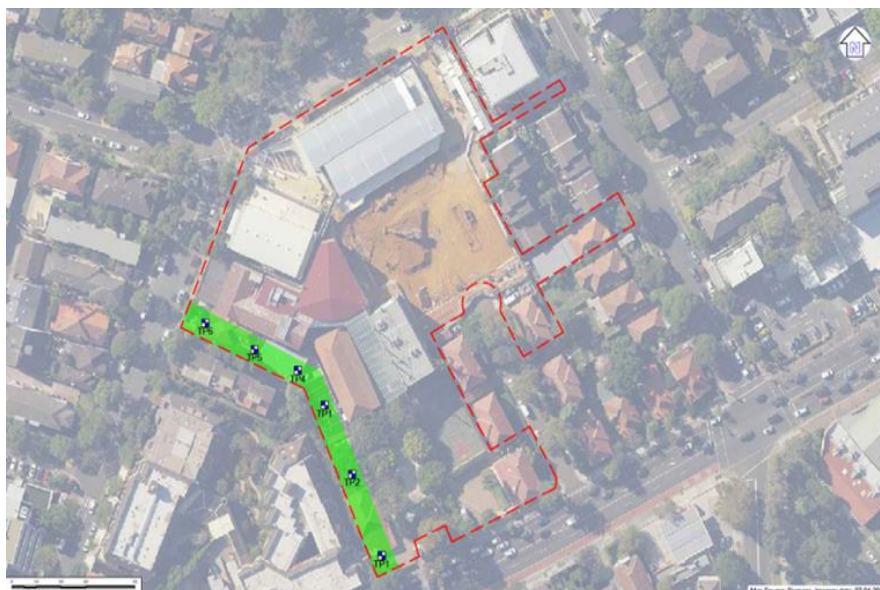
Figure 3.9 Sampling points of the site. (EI Australia, 2020)

Soil samples were collected using sterile, single-use/dedicated nitrile gloves and placed into 250g laboratory-prepared glass jars, which were capped using Teflon-sealed, screw caps and immediately refrigerated prior to being delivered to the laboratory (Authority, 2014). The collected material is mostly composed by gravelly sand (medium to coarse grained, dark brown, no odour) and by silty sand (fine to medium grained, orange with trace gravels, no odour). This is only applicable to *in-situ* fill soil material located within the south-western portion of the site (EI Australia, 2020).
