LAYERS OF RUIN AND REHABILITATION:
THE CASES OF CHIMBEL AND GRAÇA
(GOA, INDIA)

Thesis in the Master's degree in the rehabilitation of edifices, in the area of Non-Structural Rehabilitation of Edifices, supervised by Professors Marcela Maciel Santana and Walter Rossa and presented to the Department of Civil Engineering of the Faculty of Science and Technology of the University of Coimbra

Layers of ruin and rehabilitation: the cases of Chimbél and Graça (Goa, India)

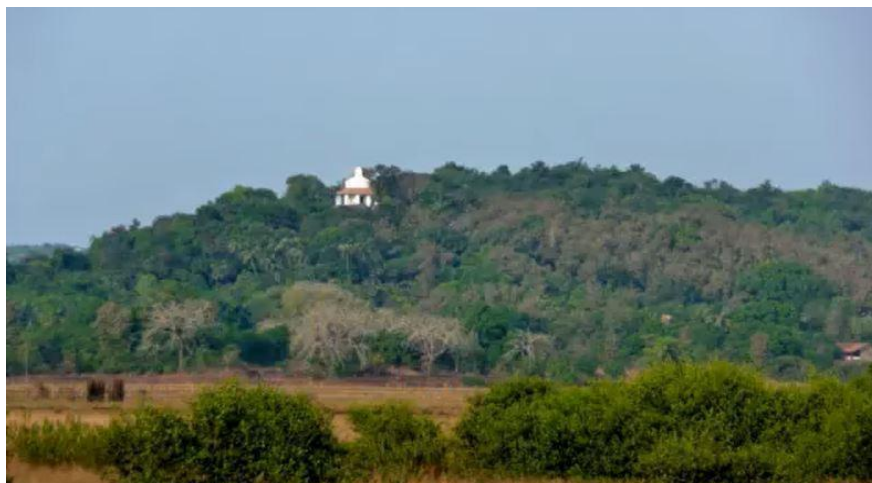
Figure 4: Seminary of *Chorão*, 2022

Today, all that remains of this once magnificent monument is an unassuming and insignificant foundation obscured by overgrown vegetation as seen in Fig. 4. The Chapel

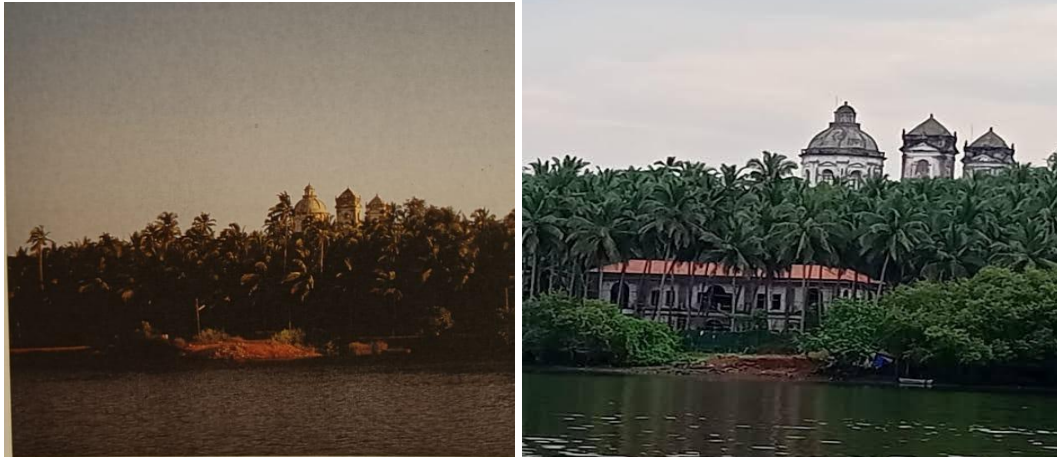
Figure 7: Images from the river Mandovi, to the left by Rossa (1997) and to the right showing the illegal construction by TOI (2021)

However, in recent times, illegal permanent constructions have emerged within the red zones. These plots were acquired and developed, and managed to obtain construction permission documents. One particular structure can be noticed in Fig. 7: Images from the river Mandovi, to the left by Rossa (1997) and to the right showing the illegal construction by TOI (2021), is a ground-plus-one villa with a tiled roof, stands between the Mandovi River and St. Cajetan Church, near the Viceroy's Arch in Old Goa's heritage precinct.

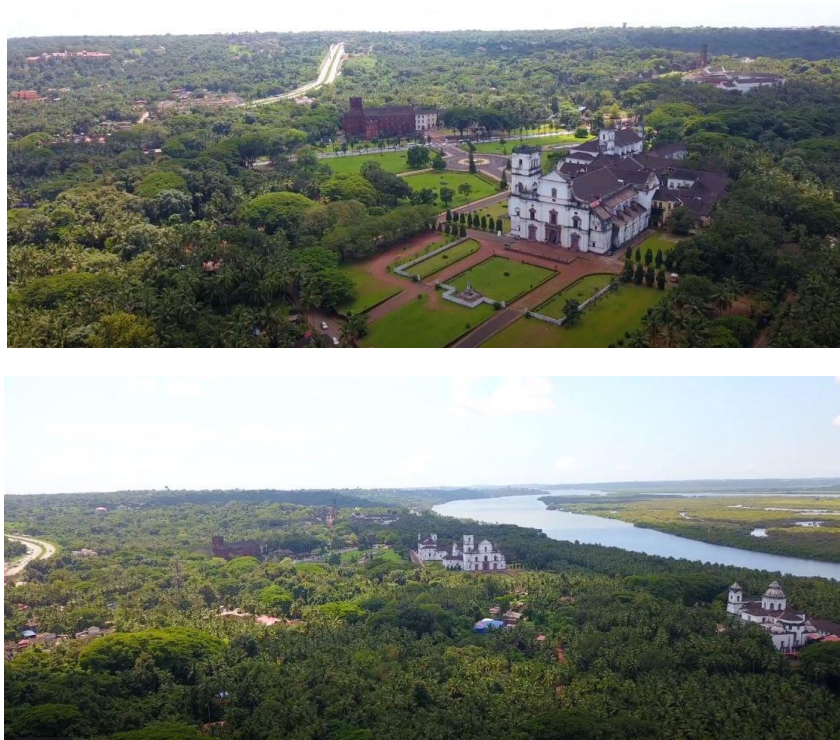
Figure 20: Drone images showing the newly constructed highway (far left) within the buffer zone of the UNESCO protected Heritage sites. (India : 123RF, 2021)

structures directly affects their integrity. Moreover, the absence of a buffer zone for vehicular movement allows vehicles to park adjacent to these monuments, exacerbating the risks.

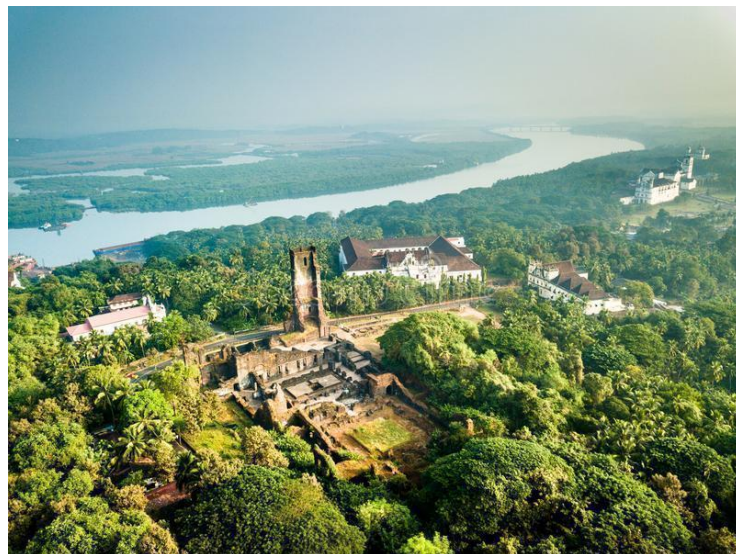
Figure 21: Old Goa drone image showing the ruins of the Church and Convent of St Augustine with other Voluminous structures that still exist in Old Goa. (India : 123RF, 2021)

In Fig. 21 we observe the remaining structures that still dominate the skyline of old Goa. However, as previously noted, numerous monuments were dismantled during the capital's relocation to Panjim. Over time, many of these monuments were eroded by monsoons and concealed by overgrown vegetation. These excavated sites have been largely forgotten. One could easily pass by what is now a 'Lost Monument' without ever suspecting that a grand, imposing structure once stood there.

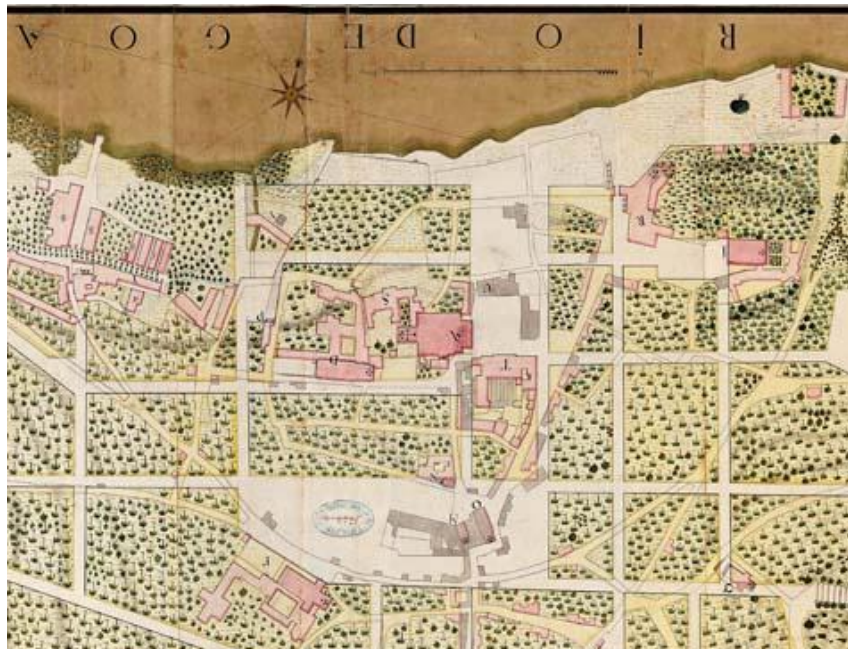
Figure 22 : Detail of "Project for the new City of Goa by José de Morais Antas Machado, Chief Infantry Sergeant, serving as an engineer, last quarter of 18th century". (Lisbon : GEAEM, 1775)

This 1775 map, seen in Fig. 22, reveals the layout of Rua Direita, which began in the north with the expansive Old Viceroy's Palace [R]. To the east, the road passed by the Church of Our Lady of Divine Providence and the St. Cajetan Convent [I]. Further south, smaller structures lined both sides of the street. Moving to the west, it opened up to the courtyard of the Sé Cathedral of Goa [A], with [T] denoting 'casas que foram da Inquisição' or houses formerly belonging to the Inquisition. The Inquisition's palace

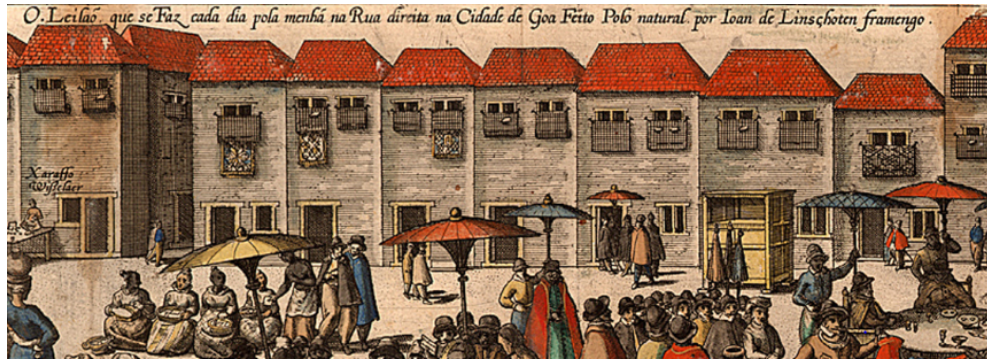
In Fig. 25 flat fronted mostly two to three storied masonry houses are seen with steep tiled roofs with overhanging eaves. The windows and doors have prominent but plain framing in flat lintels and door and window posts the same conventional and familiar cantoneira elements to be found in Portuguese buildings almost everywhere. On the upper floors, the windows have balconies or more likely screens, some of them with carpets hanging below. These would have afforded privacy to those in the upper stories.

Figure 25 : Detail of two storied houses that lined the eastern side of *Rua Direita*. (also seen marked in the Map) *Rua Direita na Cidade de Goa. Século XVI, Descrição da viagem do navegante Jan Huygen van Linschoten às Índias Orientais Portuguesas, 1579 - 1592. (Amsterdam, 1596)*

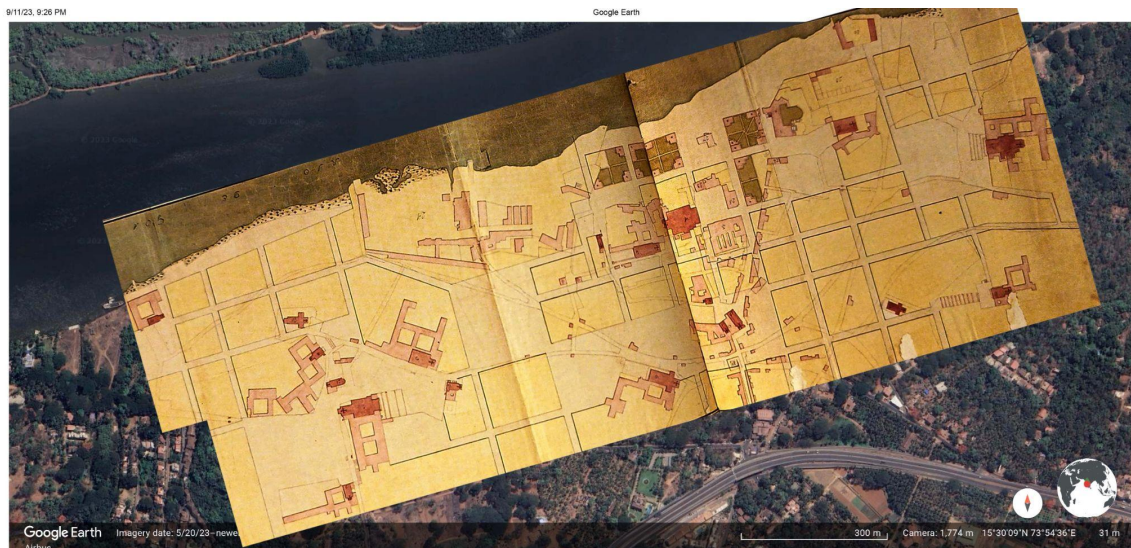
Figure 28 : Superimposition of Project for the City of Goa by José de Morais Antas Machado, Chief Infantry Sergeant, serving as an engineer in 1775". (Lisbon : GEAEM, 1775 onto Google Satellite Image, 2023)

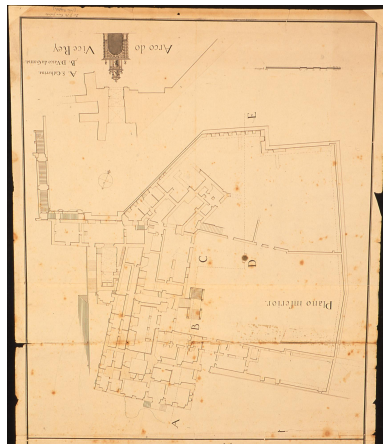
Figure 31: ‘Survey Drawings of Palácio dos Vice-Reis em Goa, Índia’. J.B. Vieira Godinho [Assin.], c.1770. Tinta-da-china com aguada. Ms.1185x433 cm (Biblioteca da Sociedade de Geografia de Lisboa, Des. 6-e-5)

This survey focuses on the official residence of the Viceroy of India in Goa, featuring elevations and floor plans of the ground and noble floors. The building stands out as an imposing three-story structure.

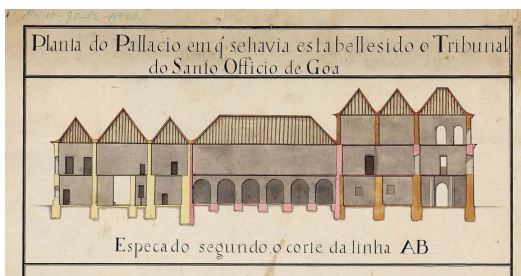
Figure 37: Survey Drawings of the Palace of Inquisition. João Baptista Vieira Godinho (assin.) Goa, c.1779. *Desenho a pena aguarelado com* 1950x376 mm Lisboa, GEAEM-1222/2^a-24 A-111

This survey was conducted in connection with the abolition of the Inquisition starting in 1774 and the building's potential rehabilitation for the Court of Appeal. The choice of Panjim as the new capital led to the idea being abandoned and demolished in 1820, along with the Palácio da Fortaleza dos Vice Reis. (Carita, 1996).

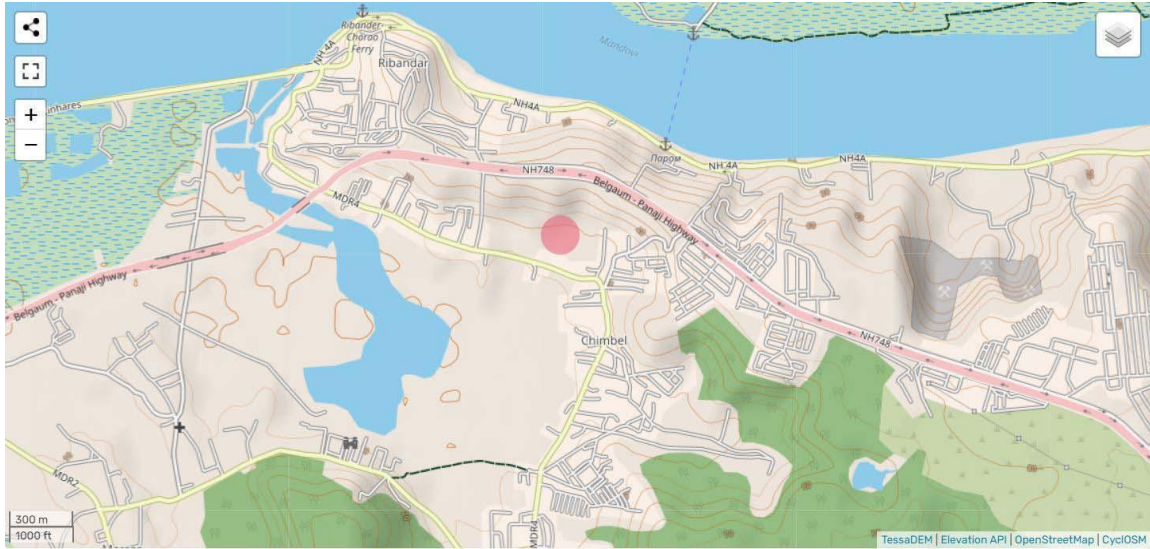
Figure 48 : Contour map of the village of Chimbél with the site of the church and convent of Our Lady of Mount Carmel marked. Also seen in the map is the newly constructed NH746 Panjim-Belgum highway. (Generated from Open street map, 2023)

NATURAL PHYSICAL FEATURES: Following the contours marked in Fig. 48 below, the site slopes upwards to the north, but slopes downwards to the south, the site does collect drainage water from the slope to the north, it comes to a stop at the ruin, but then passes further south.

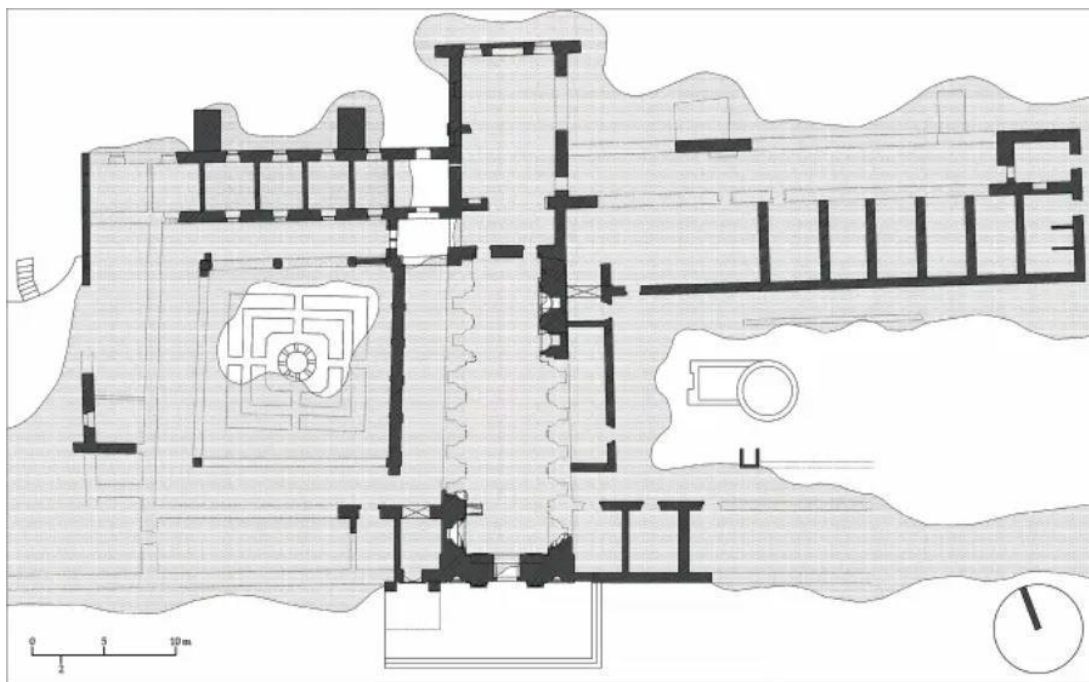
Figure 51: Plan of the Church and Convent of Our Lady of Mount Carmo. (survey coordinated by F. D. Velho & S. L. Mendiratta, 2017/ technical help by Siddesh Naik & Paresh Vengurlekar. Mendiratta, Velho 2004)

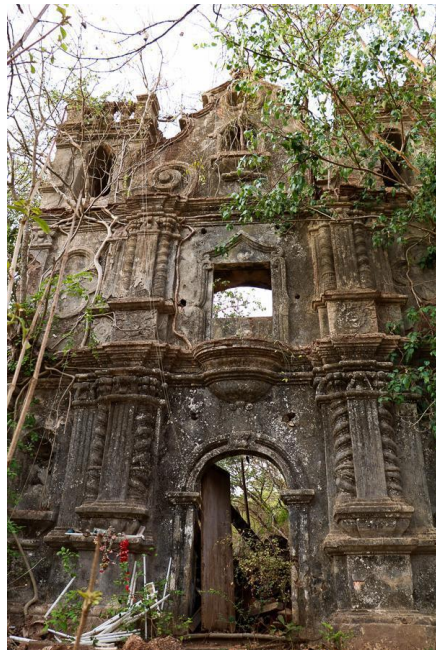
Figure 52: Façade of the Chapel. (Goa: Lester Silveira, 2019)

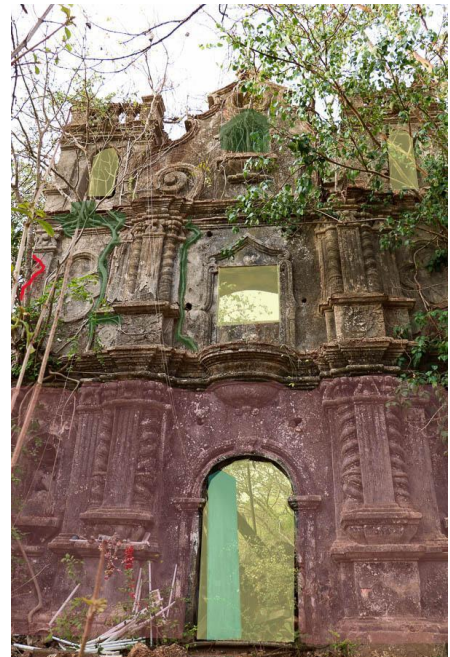
Figure 53: Diagnosis of Façade of the Chapel on Fig. 52

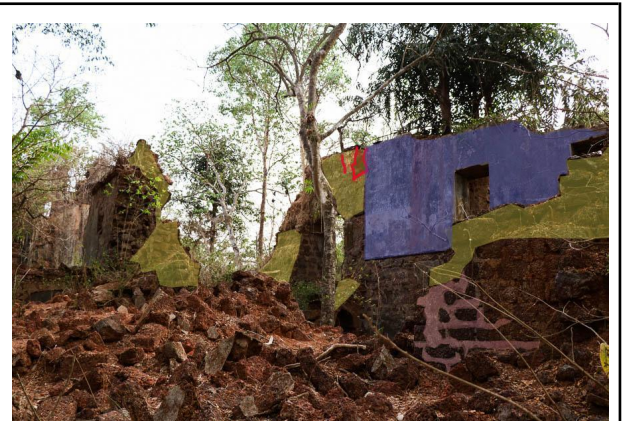
Figure 55: Diagnosis of walls that still stand based on Fig.54

The images above are marked after observing and diagnosing existing pathologies on the ruin. The 'key' to the pathologies identified along with a brief description is given below.

Upon identifying various pathologies, it becomes evident that the ruin is in dire need of conservation and treatment due to its abandonment, leaving it exposed to natural elements. The presence of fissures and linear cracks allows moisture to infiltrate the building, leading to coating discontinuities. Biological contamination, manifested through curled vegetation and black crusts, further exacerbates moisture retention in the substrate. While migration of ground moisture is not currently observed, this may be due to the absence of post-monsoon period images. Dissonant mortars, differing from those found on adjacent surfaces, are evident and may contribute to distinct pathologies, indicating previous restoration efforts.

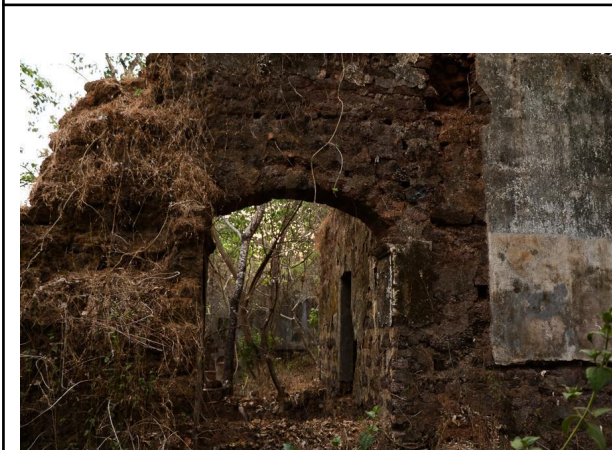
Figure 56 : Ruins of the Sacristy. (Goa: Lester Silvera, 2019)

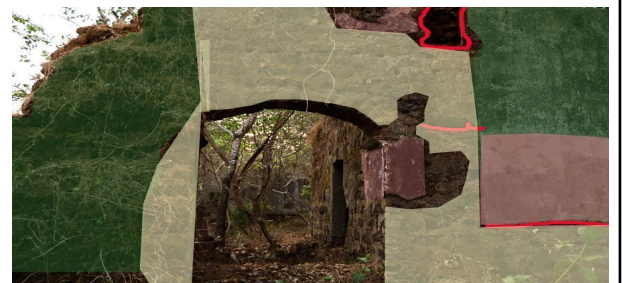
Figure 57: Diagnosis on the ruins of the Sacristy on Fig. 566

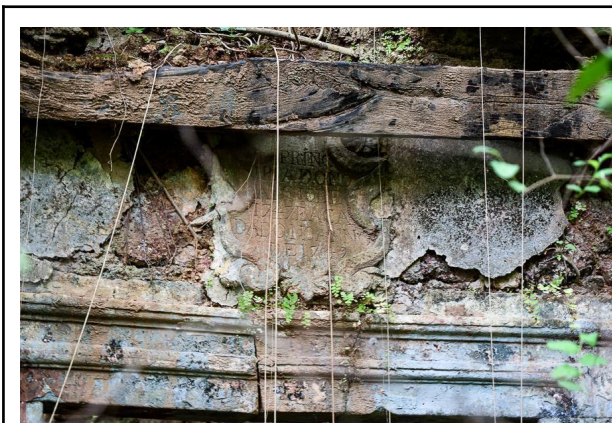
Figure 58: Descriptive basalt stone above the secondary doorway to the Chapel. (Goa: Lester Silvera, 2019)

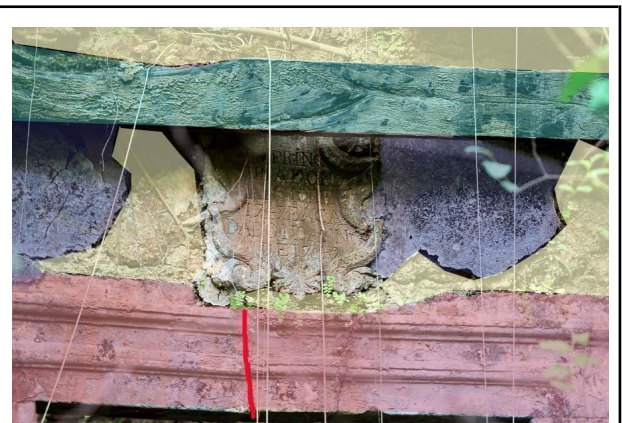
Figure 59: Diagnosis of basalt stone above the secondary doorway to the Chapel on Base Fig. 58

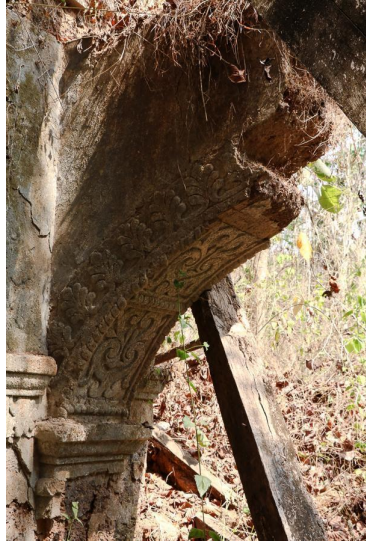
Figure 60 : Stucco patterns on what remains of the arch over the narthex. (Goa: Lester Silvera, 2019)

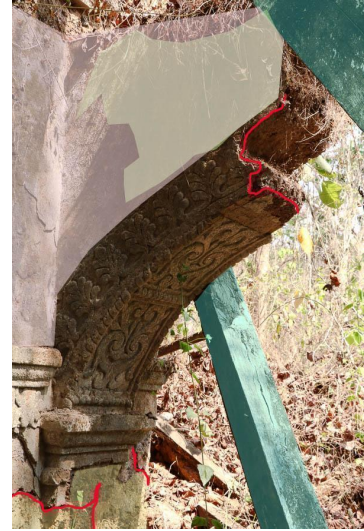
Figure 61 : Diagnosis on what remains of the arch over the narthex on Base Fig. 60

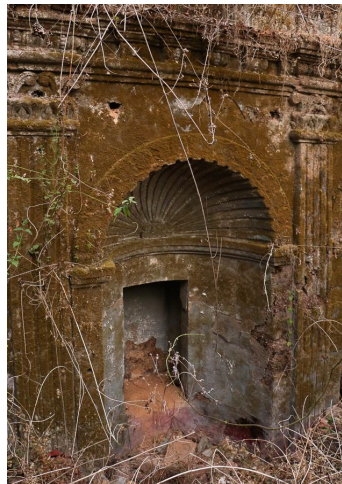
Figure 62: Ruins of an inverted shell niche that survives in the Chapel interior. (Goa: Lester Silvera, 2019)

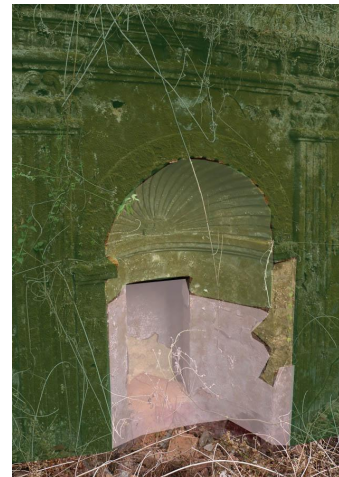
Figure 63: Diagnosis of ruins of an inverted shell niche that survives in the Chapel interior on Fig. 62

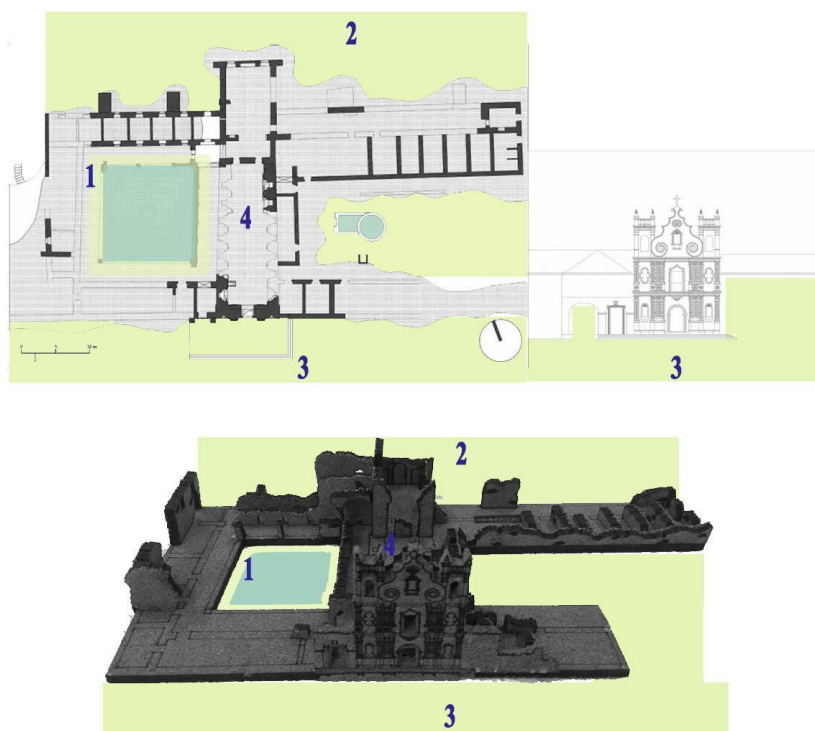
Figure 65 : Graphics showing zones of conservations and restoration and zones for revitalisation.

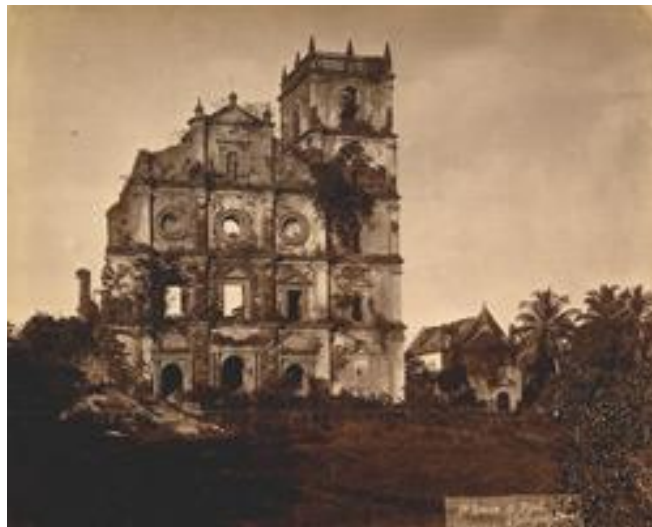
Figure 78 : Photograph of the ruins of Church and Convent of St Augustine (Goa : Souza & Paul, 1880)

church sacristy, among other areas. The Augustinian convent was located south of the church building and arranged around two cloisters separated by the chapter room and also a small patio. The cloister closest to the church, called the superior, is slightly smaller than the inferior or novitiate cloister. The convent's rooms were distributed on three floors. There were four chapels, cells for novices and friars, a library, two refectories, a kitchen, infirmary, pharmacy, parlour, chapter room, provincial chapter room and the church's sacristy, among other support spaces and access areas. Located just to the building's west were the laterite quarries, lime kilns and other convent support infrastructures. A service patio was likewise located at the south end of the complex, with various annexes used for the purpose of maintaining and supplying the convent. This was where the aforementioned elevated passageway led to the College of Our Lady of Popolo. The convent's enclosure began on the north side of the convent, with orchards and wells in this area. Besides the architecture, this sumptuous monastery also contained a notable collection inventoried when it closed in 1835. (Pereira, Mendiratta, HPPIP) A photograph of the ruins seen in Fig. 78 taken by Souza&Paul in 1880 is an important record of the church façade before it collapsed.

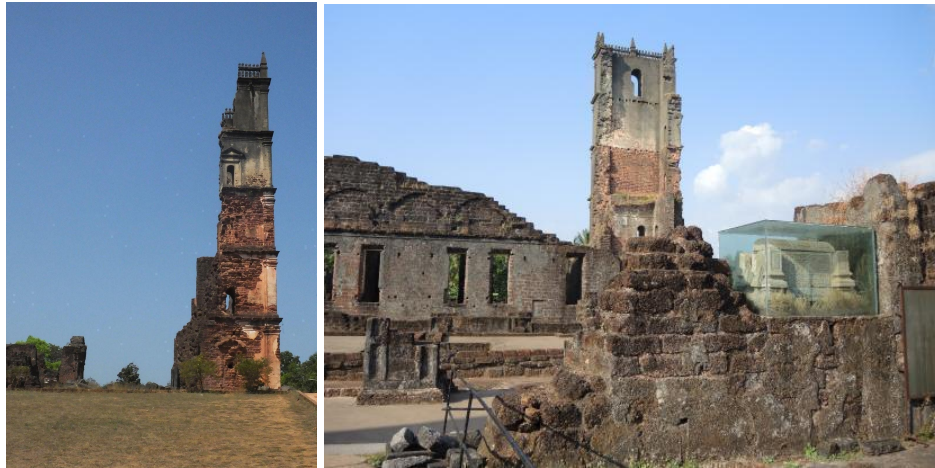
Figure 79 : Remains of the complex of the Convent of St Augustine. (Goa, 2019)

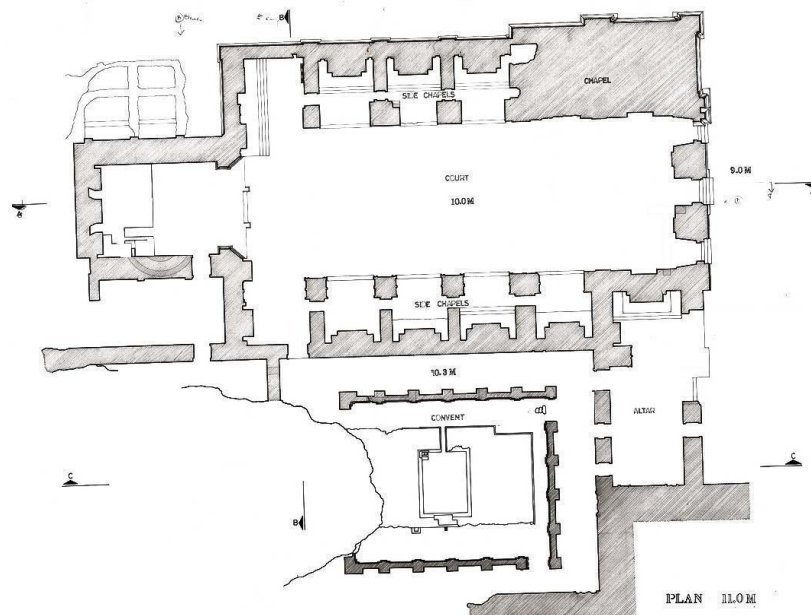
Figure 80 : Plan of the Church of Our Lady of Grace adjoining the Convent of the Augustinian order, Goa. (Ahmedabad : CEPT University Archives, 1933)

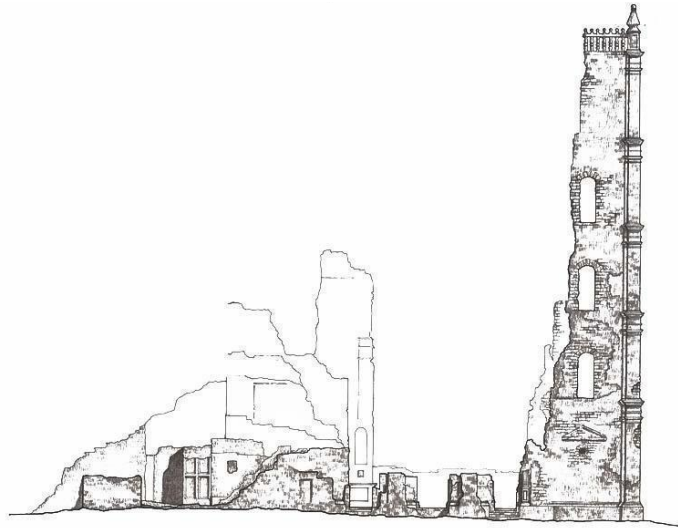
Figure 81 : Front elevation of the Church of Our Lady of Grace, adjoining the Convent of the Augustinian order, Goa. (Ahmedabad : CEPT University Archives, 1933)

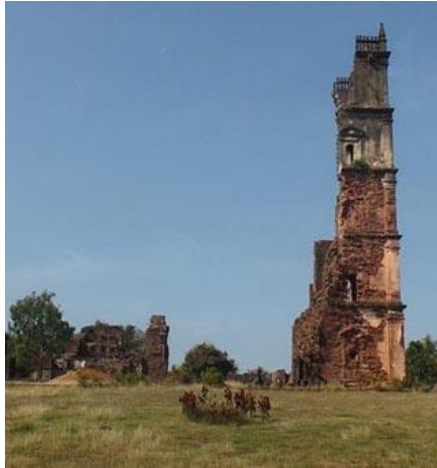
Figure 84: Façade of the Church. (Google Street View Imagery, 2022)

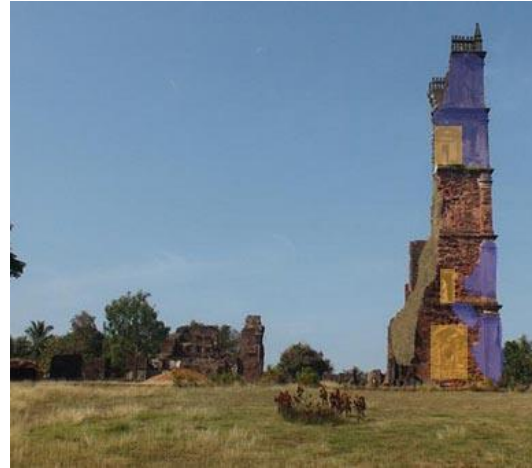
Figure 85 : Diagnosis on façade of the Church on Base Fig. 84

This section focuses on identifying structural pathologies through spot images taken from different parts of the ruins. The diagnosis involves marking and identifying various pathologies in these images. Subsequently, a critical analysis report is provided to communicate the site's conservation status.

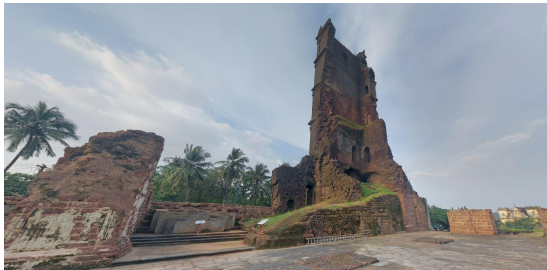
Figure 86: View of the remains of the bell tower and one of the aisle chapels from the Nave of the Church. (Google Street View Imagery, 2022)

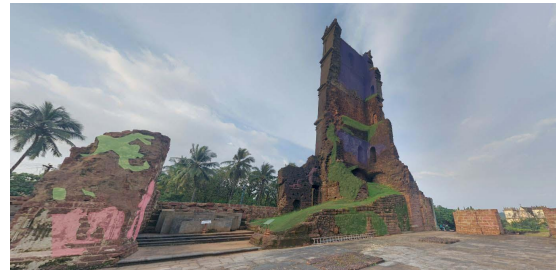
Figure 87: Diagnosis on the remains of the bell tower and one of the aisle chapels on Base Fig. 86

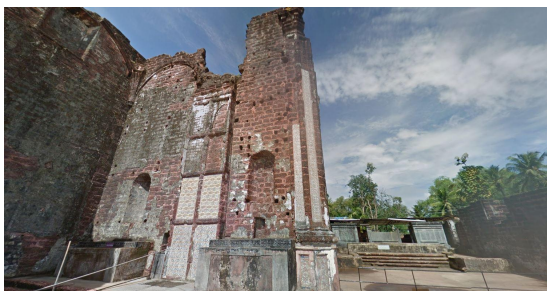
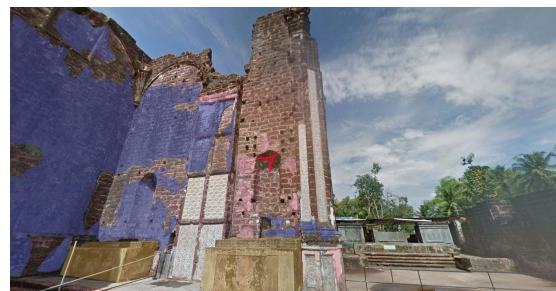
Figure 89: Diagnosis on the remains on the left of the transept of the Church on Base Fig.88.

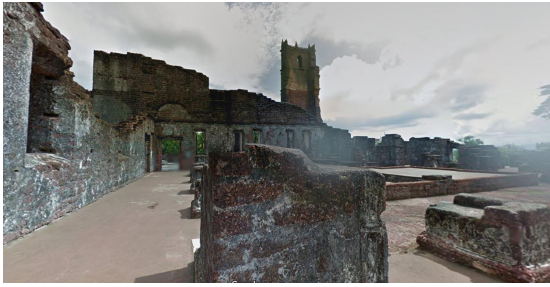
<p>Figure 90: View of the remains of the first cloister of the Convent. (Google Street View Imagery, 2022)</p>

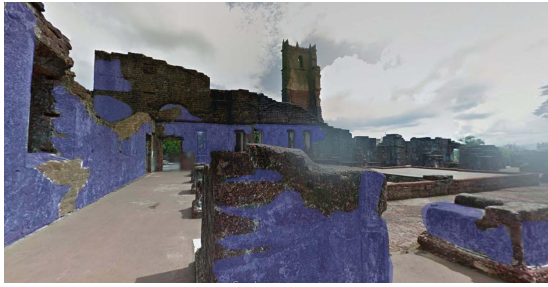
<p>Figure 91: Diagnosis on the remains of the first cloister of the Convent on Base Fig. 90</p>

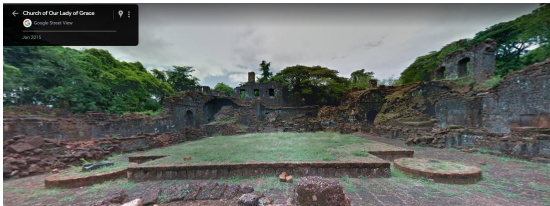
<p>Figure 92: View of the remains of the second cloister of the Convent. (Google Street View Imagery, 2022)</p>

<p>Figure 93: Diagnosis on the remains of the second cloister of the Convent on Base Fig. 92</p>

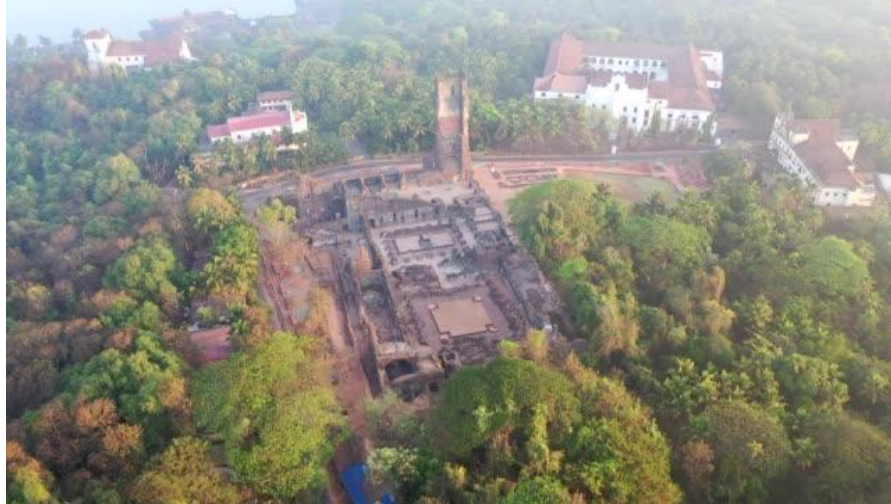
Figure 94: Drone image of the ruins of the church of Our lady of Grace adjoining the Augustinian Convent that sits atop Monte Santo in Old Goa. The remains of the 46 metre high four storied bell tower that was once a part of the façade of the church is still standing. The view shows the scale of the ruins in comparison to the neighbouring structures seen To its north, the Chapel of St. Anthony and the 'Convent of Santa Monica' can be found, presently housing the 'Museum of Christian Art'. Further northwest stands the 'Church of Our Lady of the Rosary', also located on the 'Holy Hill'. On the eastern side of the site, another road delineates its boundary, followed by the 'Church and Convent of St. John of John'. It is notable that the volume of the sumptuous monastery has left a volumetric void on the hill.

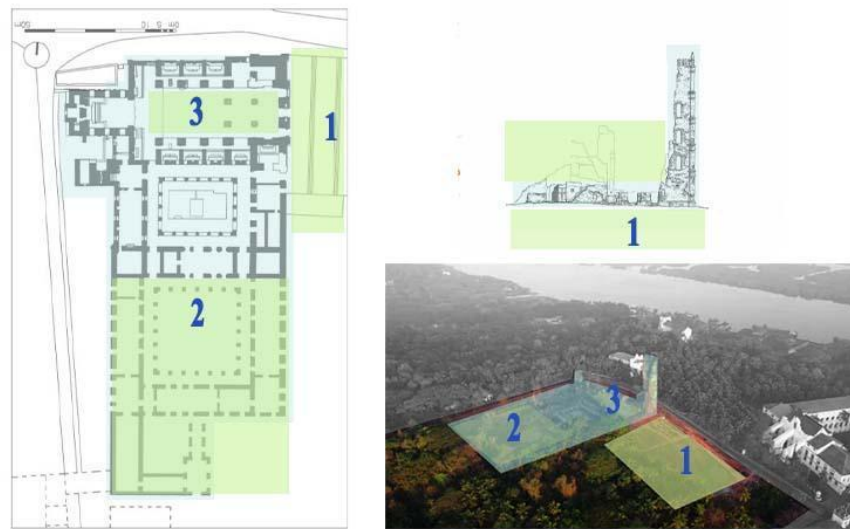
Figure 95 : Graphics showing zones of conservations and restoration and zones for revitalisation.

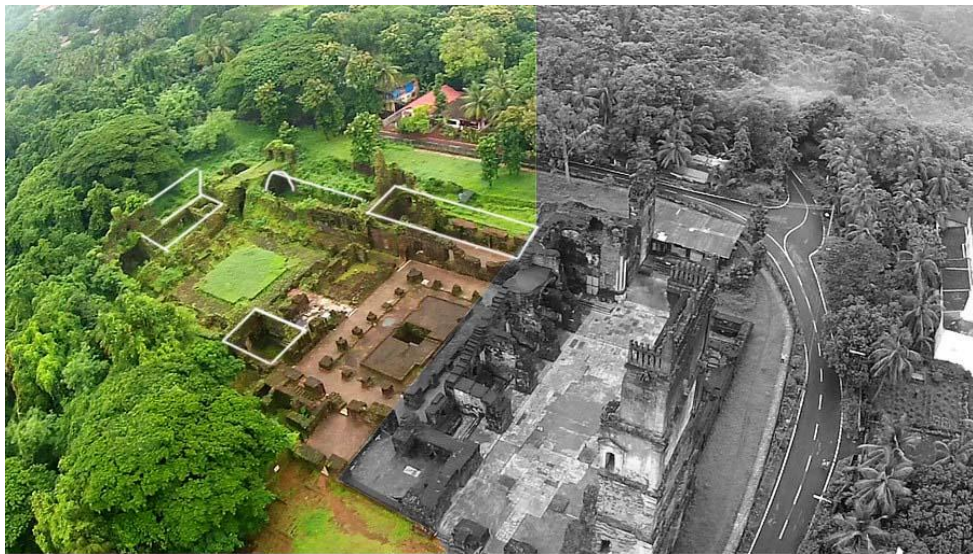
**Figure 101 : Zones marked out within the Convent of St. Augustine to recreate the lost volumes and allowing
vegetation to grow over the installation as a volumetric guide.**

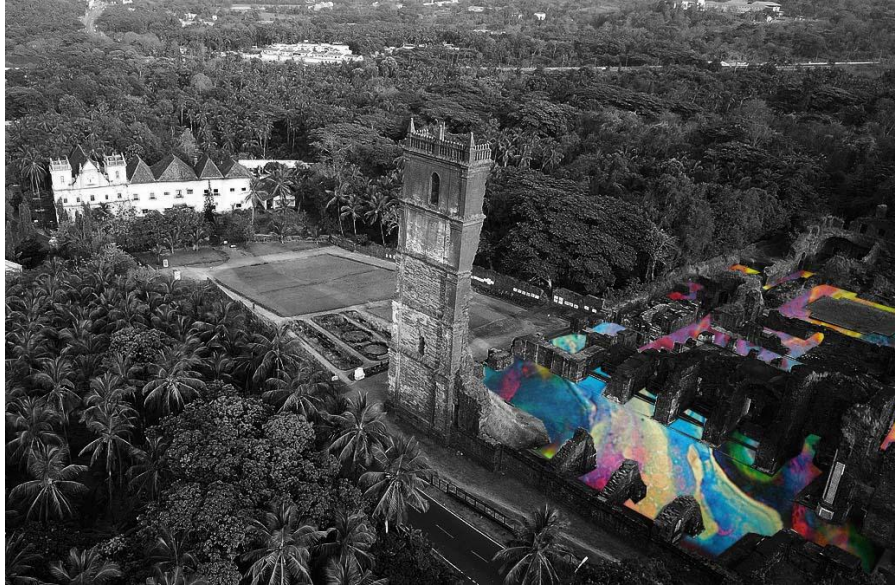
Figure 103 : Proposal mockup featuring the superimposition of a light projection show onto the floor of the ruins.

Since the floor of the ruins is the largest seamless surface available, a light projection spectacle can be casted onto the floor of the ruins. A proposal mockup of light show spectacles are seen in Fig. 103 and Fig. 104. These shows will do no harm to the existing ruins, as they do not involve mounting or erection of structures within the site. It could also introduce night visits to the site, which could broaden the schedule of events and hence the remuneration generated.

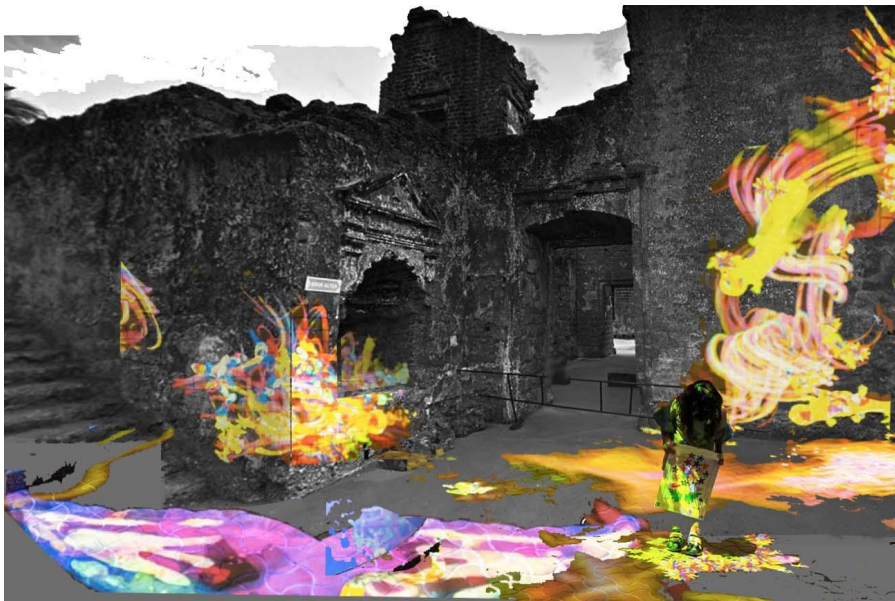
Figure 104 : Proposal mockup featuring the superimposition of a light projection show onto the walls of the ruins.
