Geological engineering problems associated with tunnel construction in karst rock masses: The case of Gavarres tunnel (Spain)

S. Alija [a,1], F.J. Torrijo [b,*], M. Quinta-Ferreira [c,1]

ABSTRACT

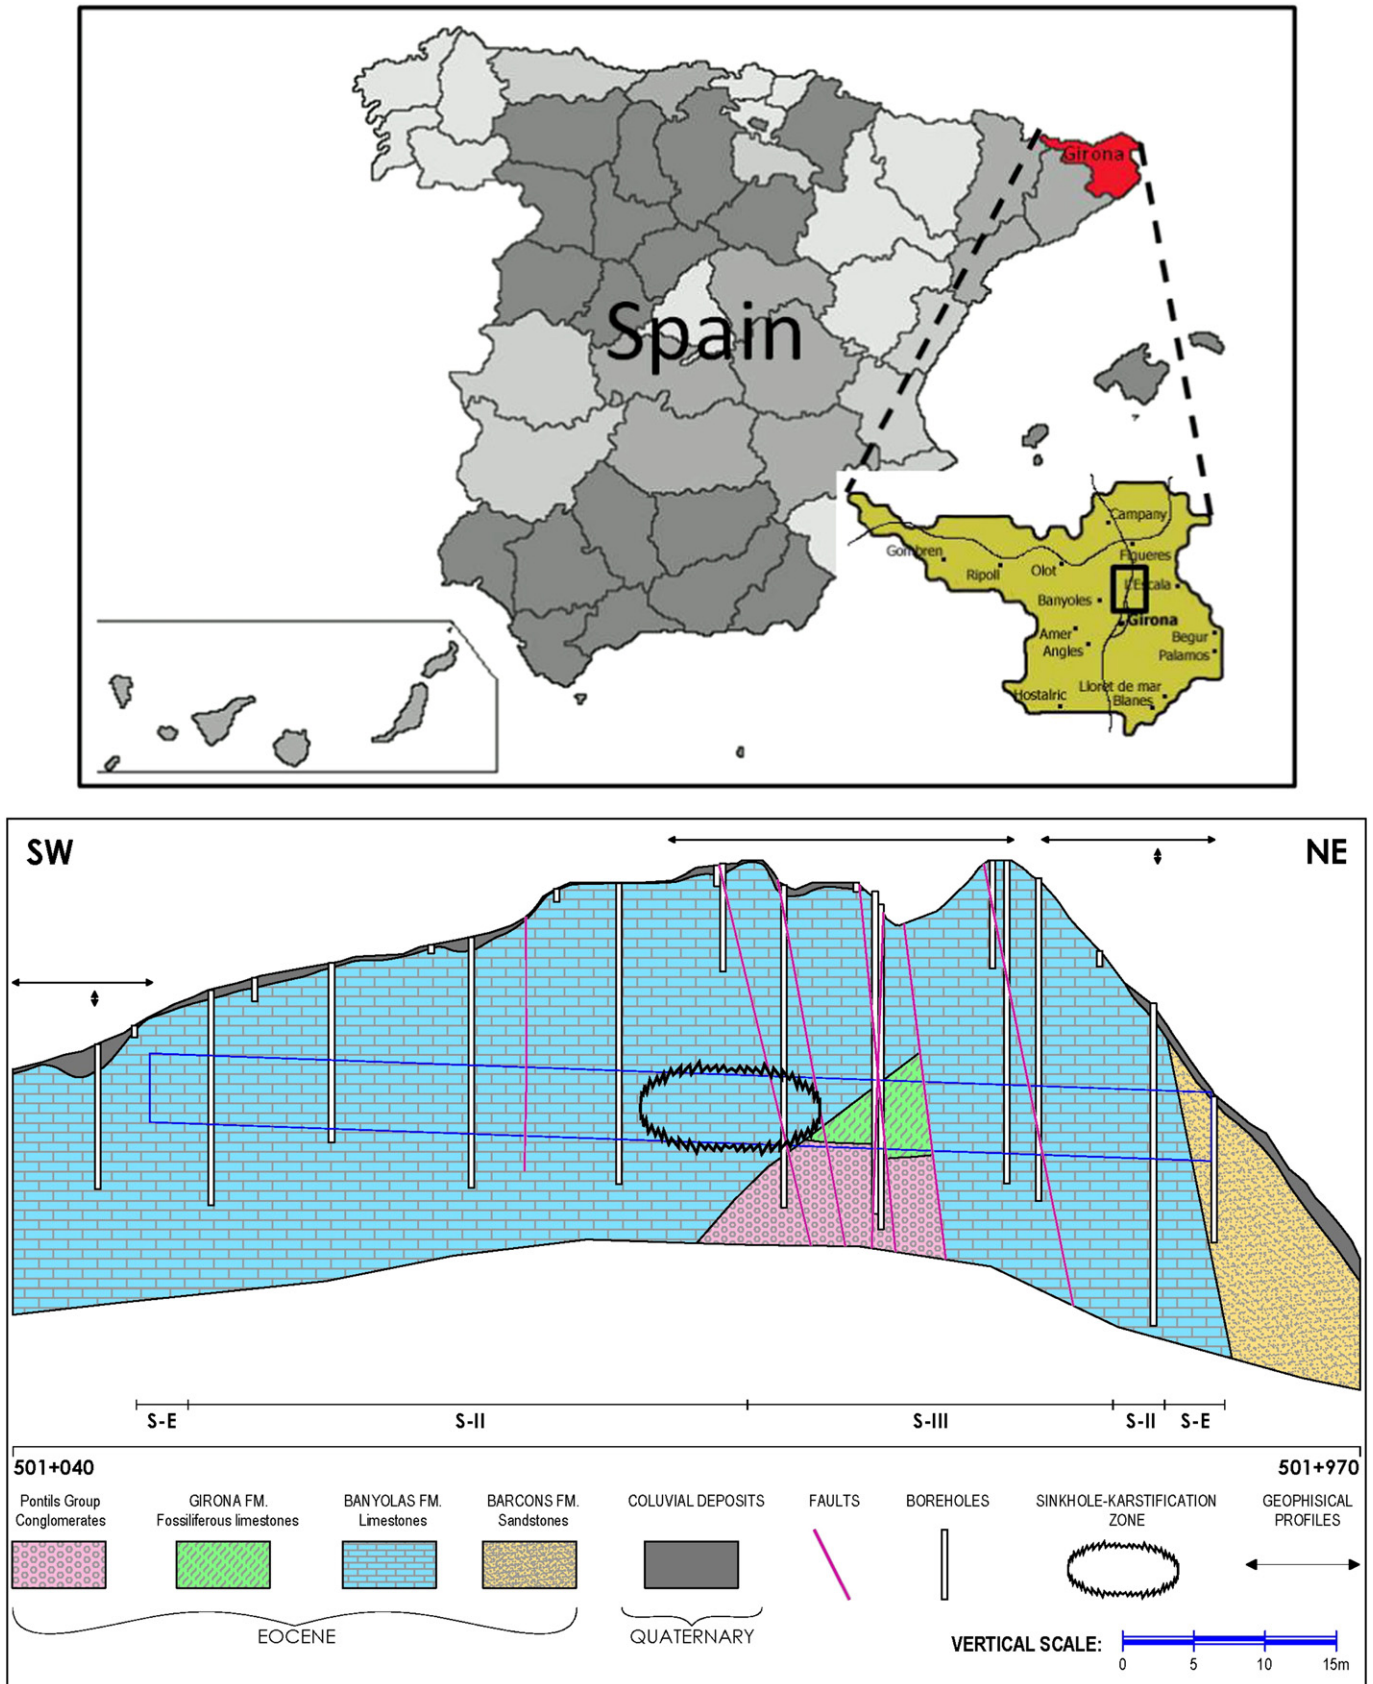
Fig. 1. Location map and geology profile along the Gavarres tunnel.

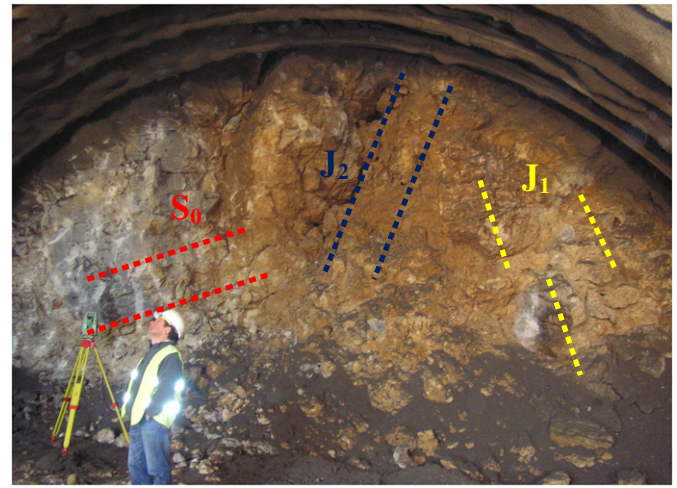
Fig. 2. Tunnel-working face view of section 19 with details of the stratification (S_0) and joints (J_1, J_2). Marl and limestone blocks, some broken, in a clay matrix.

Two families of joints were identified (Figure 2):
  - J_1: with an average orientation of 213/71, spaced about 30 cm, with some continuity and, when filled, it is with clay material.
  - J_2: with an average orientation of 124/70, spaced from 20 to 60 cm, very rough and usually closed.

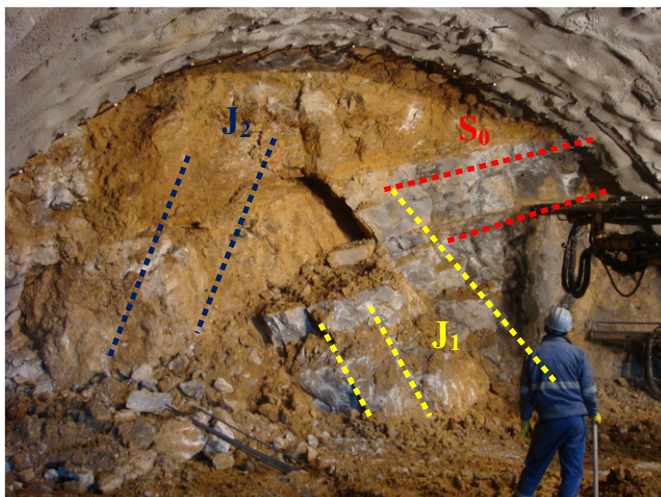
• *Zone 2* (*sections 38–91*). Corresponds to 53 m with moderate karstification. Several instabilities occurred, composed of highly fractured marl–limestone rock fragments embedded in a clay matrix. The weathering grade of this zone ranges from III to IV (Figure 3).

Fig. 3. Tunnel-working faces with weathering degree III in Zone 2 (section 61). Highly fractured marl–limestone rock fragments embedded in a clay matrix.
