Minimal Invasive Diagnostic Capabilities and Effectiveness of CFRP-Patches Repairs in Long-Term Operated Metals

Abstract: The paper deals with the subject of diagnostics and the quick repairs of long-term operated metallic materials. Special attention was paid to historical materials, where the structure (e.g., puddle iron) is different from modern structural steels. In such materials, the processes of microstructural degradation occur as a result of several decades of exposure, which could overpass 100 years. In some cases, their intensity can be potentially catastrophic. For this reason, the search for minimally invasive diagnostic methods is ongoing. In this paper, corrosion and fracture toughness tests were conducted, and the results of these studies were presented for two material states: post-operated and normalized (as a state “restoring” virgin state). Moreover, through the use of modern numerical methods, composite crack-resistant patches have been designed to reduce the stress intensity factors under cyclic loads. As a result, fatigue lifetime was extended (propagation phase) by more than 300%.

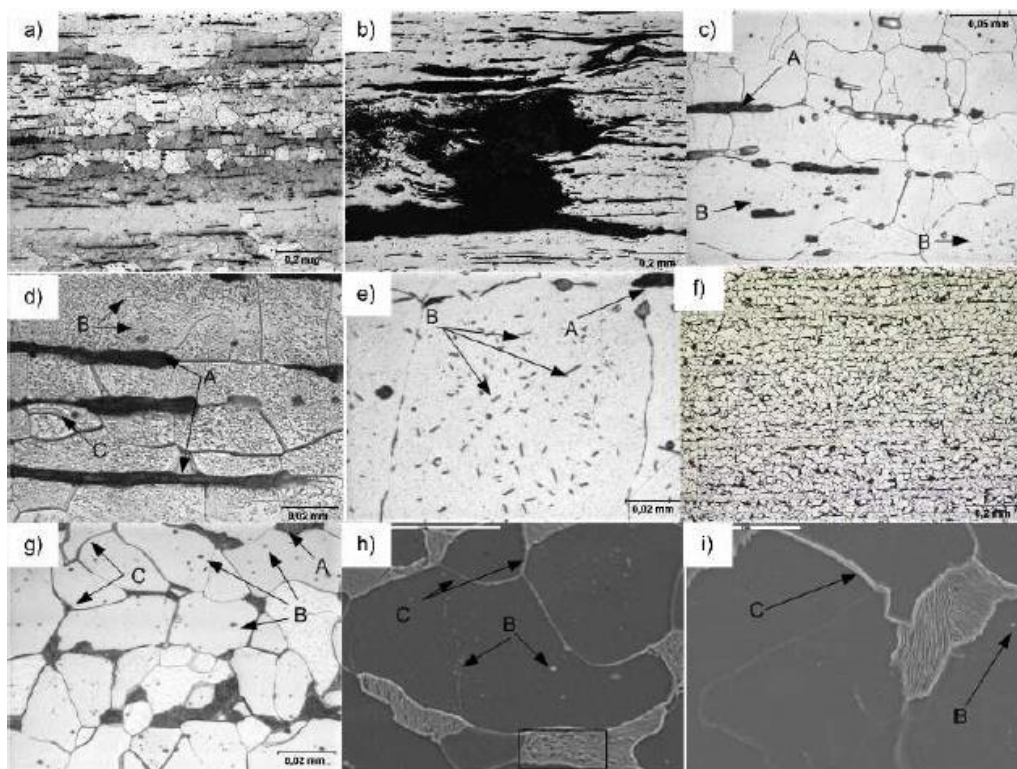
Figure 1. A typical microstructure of the long term-operated late 19th and early 20th century steels (described in the text). (a) typical microstructure of puddle iron, (b) enlarged non-metallic inclusion in puddle iron, (c) magnified microstructure of puddle iron, (d) magnified microstructure of puddle iron with microstructural degradation symptoms, (e) enlarged ferrite grain with degradation symptoms—puddle iron, (f) typical microstructure of early 20th century mild steel, (g) enlarged ferrite-pearlite microstructure of early 20th century mild steel, (h) SEM (Scanning Electron Microscope) image of early 20th century mild steel misstructure with small precipitations inside ferrite grains and degraded pearlites areas, (i) SEM (Scanning Electron Microscope) image of early 20th century mild steel misstructure without degradation symptoms.

In order to illustrate the structure types and features indicating the degradation progress, all mentioned symptoms are documented in Figure 1, where the microstructures of steel from the Pomorski Środkowy and Północny Bridges located in Wrocław, Poland (Środkowy bridge erected in 1861–puddle iron, Północny bridge erected in 1930–mild steel) are shown. Figure 1a–d shows the typical microstructure of 19th-century puddle iron with numerous slags and nonmetallic inclusions (A) with brittle precipitations inside the ferrite grains (B) and a thick envelope of Fe_3C_{III} on the grain boundaries (C). The enlarged ferrite grains with degradation symptoms, brittle precipitations inside ferrite grains, are noticeable in Figure 1d. Due to the lack of a contemporary equivalent of the material from the 19th century, the normalization process is used as a heat treatment procedure simulating the original state of the material. However, if the degradation processes are very advanced, normalization does not remove all of the degradation products. This is a clear sign that the old material has been disposed of and this example is shown in Figure 1e.

The structural steels from the early 20th century (shown in Figure 1f–h) have a typical ferritic-pearlitic (A–pearlite areas) microstructure that is close to that of modern mild steels with small amounts of the degradation processes manifested in (B) brittle precipitations inside ferrite grains and degenerated pearlite areas (marked by frame). However, in the case of the presented early 20th-century mild steel, after normalization, the degradation symptoms disappeared (see Figure 1i). This type of structure leads to strain localization and makes the problem of fracture site prediction in the material more complex [6].

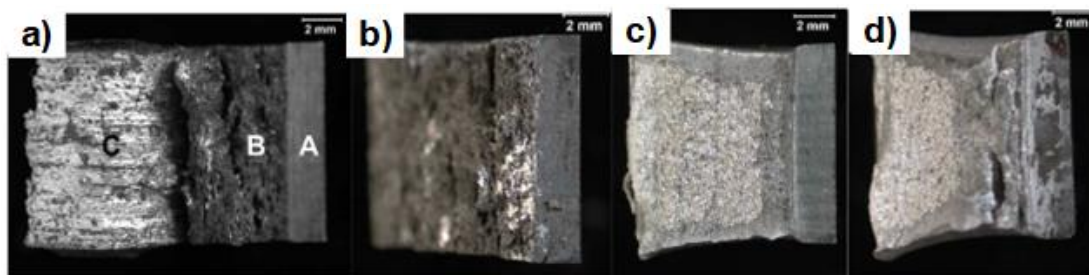
Figure 2. Fracture surfaces of the specimens after the Charpy impact test (+20 °C): (a) puddle iron in post-operated state (A–notch zone, B–crack propagation area, C–the plastic zone from the bottom part of the Charpy specimen), (b) puddle iron after heat treatment (normalized), (c) early 20th-century mild steel, post-operated state, (d) early 20th century mild steel, normalized state.

The presented microstructural features in old metallic materials also lead to significant changes in the fracture mechanisms visible in fractograms. Figure 2 illustrates the fracture surfaces of the specimens after Charpy testing for puddle iron and early 20th-century mild steel (the same materials as used for metallographic analysis from Figure 1).

As shown in Figure 2, the differences in ductility were noticeable for both long-term operated materials. As reported in several papers devoted to the degradation of long-term operated materials, usually during maintenance service, two crucial issues have been raised [3–9]:

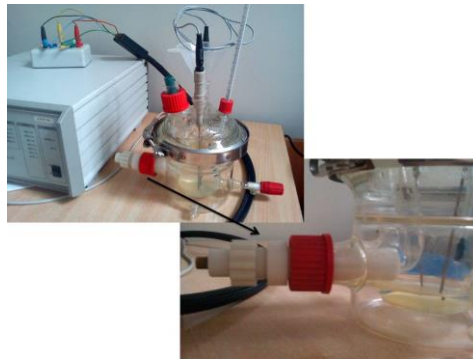
Figure 4. The electrochemical test stand used in the experimental campaign.

way were tested in a three-electrode polarization measuring system. The fully automated test stand (Figure 4) consisted of a measuring vessel, the ATLAS 0531–Electrochemical UNIT & IMPEDANCE ANALYSER (ATLAS 0531 ELEKTROCHEMICAL UNIT & IMPEDANCE ANALYSER, Atlas-Sollich, Gdansk, Poland) potentiostat, and the computer drivers. The counter electrode was made of austenitic stainless steel, while the reference electrode was used as the electrode, a saturated Ag/AgCl. During the open circuit, potential measuring polarization curves were registered.

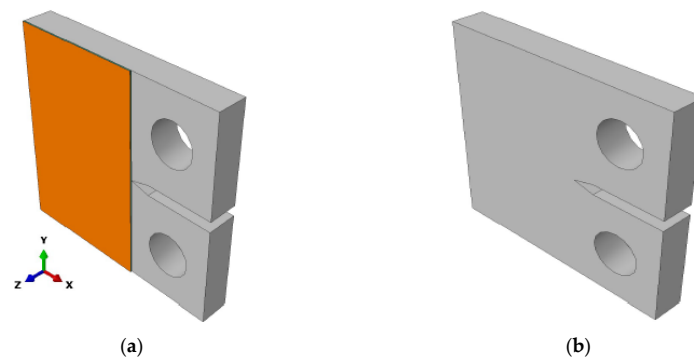
Figure 5. Numerical models: (a) Strengthened compact tension (CT) specimen; (b) Plain steel CT specimen.

The fatigue crack growth process is generally related to the severity of the stress distribution around the crack, which can be determined by the stress intensity factor. It is expected that using CFRP patches bonded to the material can contribute to decreasing the severity of the stresses around the crack tip, leading to an extension in fatigue life. Recent investigations have been performed in order to estimate the contribution of implementing the CFRP patch in CT specimens through numerical analysis. In recent considerations [14], different configurations of CFRP patches were studied (full-face and two strips) and numerical stress intensity factors were evaluated using X-FEM (eXtended Finite Element Method). However, in these studies, the adhesive was not modeled, and the interface between the CFRP and CT specimen was considered as perfectly tied, which means that there was no relative displacement in the interface. The crack in the CT specimens was imposed by node separation (X-FEM approach), and SIFs computed using the modified virtual crack closure technique (VCCT) for several imposed crack increments. In the present paper, numerical simulations were conducted to assess the values of the stress intensity factor for both strengthened and non-strengthened scenarios, as presented in Figure 5. The models were composed of a compact tension specimen with geometry

The metallic component was modeled with 3D finite elements with eight nodes, C3D8; the CFRP component was created using 3D shell elements with four nodes, S4; and the adhesive was modeled using 3D cohesive finite elements with eight nodes, COH3D8. Boundary conditions were set as pinned in the upper pin, $U_x = U_y = U_z = 0$, and as $U_x = U_z = 0$ for the lower pin. Loading was applied in the lower pin with a value equal to -7500 N in the y -direction. Boundary conditions and loads (Figure 6) were applied in reference nodes that are linked to the holes' surfaces by rigid links (kinematic coupling).

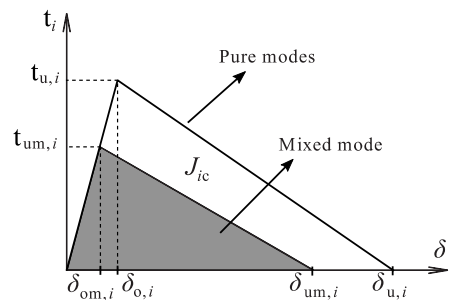
Figure 7. Bilinear cohesive zone model for pure modes (I and II) and mixed-mode (I + II).

For the adhesive component, the material law was defined with a cohesive mixed-mode damage model, as presented in Figure 7. It is characterized by a linear relation between stresses, t , and relative displacements, δ . The maximum value of stresses $t_{u,i}$ ($i = I, II$) defines the damage initiation and the

energy release rate, J_{ic} , is the parameter that gives the complete failure. In the case of mixed-mode behavior, damage initiation is based on the following quadratic stress criterion:

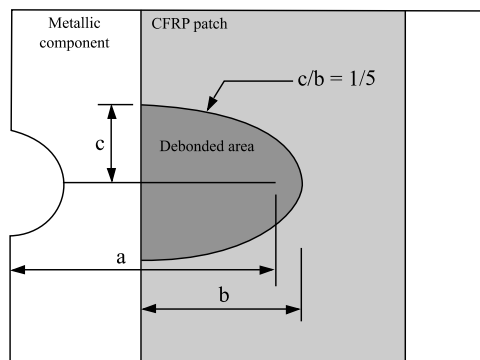
Figure 8. Definition of the debonded area.

Recent studies have shown that as fatigue crack grows on a substract, a debonded area is created between the substract and reinforcement [20]. The definition of this region is presented in Figure 8. The parameter b is obtained by Equation (3), where a refers to the total crack length, a_0 is the distance between the loading axis and the CFRP patch (12.5 mm), and r_p is the plastic zone ahead of the crack tip, which can be calculated from Equation (4).

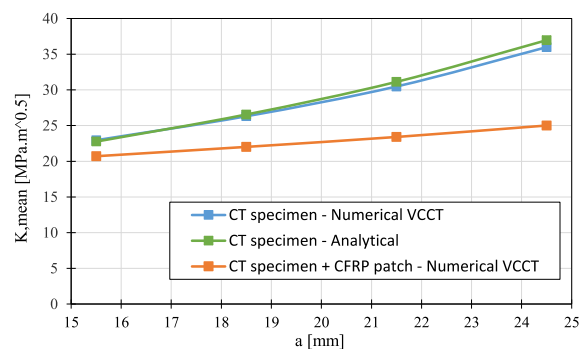
Figure 11. Comparison of final stress intensity factors.

Another important aspect that can be concluded from these graphics is that the difference between the stress intensity factors of strengthened and non-strengthened solutions increases for higher values of crack length. In fact, as presented in Table 4, the reduction on the stress intensity factor increased from 9% for a crack length equal to 15.5 mm to 32.3% for a crack length equal to 24.5 mm. In fact, the reduction of stress intensity factor is marginal for short cracks because the stiffness of the steel plate is much higher than that of the CFRP strips. However, the effectiveness of the patch reinforcement is maximized for long cracks because the patch covers a larger amount of the crack and its plastic zone. On average, the use of the CFRP patch led to a reduction in the stress intensity factor by 21%. Figure 11 and Table 4 present the evolution of the stress intensity factor with the crack length. It is shown that the numerical computation of stress intensity factors is in line with the analytical values and the difference varied between 0.9 and 2.7%.

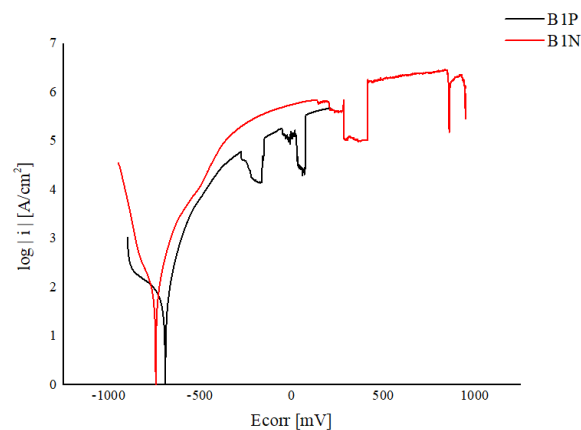
Figure 13. Polarization curves with the results of electrochemical tests for the B1P and B1N samples, where B1P is a post-operated state and B1N is a specimen after normalization.

A higher corrosive resistance for samples with normalized conditions was also observed on the obtained polarization curves (Figure 13).

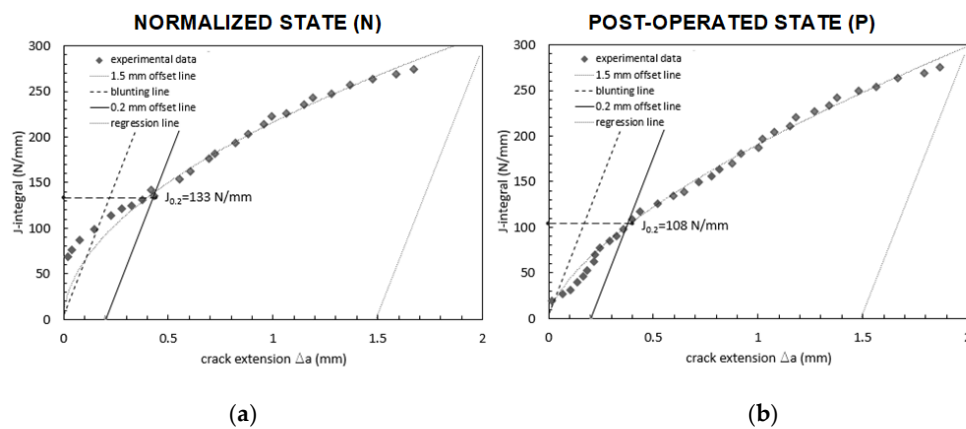
Figure 14. J-R curves for puddle iron after normalization heat treatment (a) and in the post-operated state (b).

According to the ASTM E1820 [10] recommendations, the J-R curves were drawn in Figure 14 for material in a post operated state and after heat treatment-normalization. The values of engineering J-integral $J_{0.2}$ were also determined. In Figure 14, there are marked horizontal lines corresponding with the J integral for the crack onset of 0.2 mm. However, because the thickness of 19th-century structural elements does not usually exceed 18 mm (in our case 10 mm), the plane strain condition cannot be achieved. In the presented results, the critical J_C values can be treated only (!) as a substitute (conditional) material resistant to cracking. The analysis of the experimental data showed that in the normalized state, the integral value of J_c was estimated on level $J_c = 104$ N/mm, and in the post-operated state at $J_c = 87$ N/mm. Comparing it with modern mild, low carbon steels, these values were far below the critical J integral, for example, S235/355 grade steel is $J_{IC} = 320$ – 360 N/mm. By also analyzing the archival data [22–25] for a wide group of degraded materials (including pipeline steels), it is very likely that the applied corrosion testing method should find a non-invasive application in the detection of degradation damage. This shift in polarity curves and the change in the value of electrochemical

Figure 14 clearly demonstrates the higher fracture resistance for the normalized state than for the post-operated state. After normalization, the critical J_c parameter increased by almost 20% and $J_{0.2}$ was -23% compared to the post-operated state.

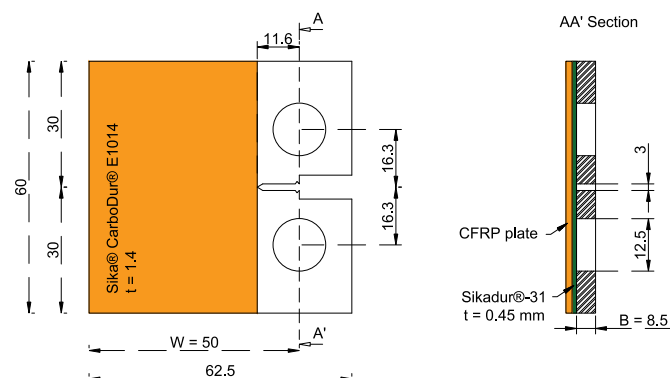
Figure 15. Geometry of CT specimens strengthened with the CFRP patch (all dimensions in mm).

The experimental campaign followed a numerical analysis of SIF and the influence of the CFRP patch on the SIF reduction. The geometry of CT specimens was defined as in the previous part, by W (width) = 50 mm and B (thickness) = 8.5 mm, as presented in Figure 15. The notch was created using electrical discharge machining. A preliminary FCG (Fatigue Crack Growth Rate) test produced the pre-crack under ΔK control with a maximum value of $15 \text{ MPa}\cdot\text{m}^{0.5}$. To evaluate the influence of the mean stress effect, for non-strengthened specimens, different values of the stress ratio were used: 0.05, 0.1, and 0.7. During the tests of the fully metallic specimens, the crack length was monitored using the compliance method prescribed in the standard. The crack opening displacement and the applied force were also recorded in order to assess the effective stress intensity factor. Strengthened CT specimens were tested with the geometry and components described in Figure 15. The CFRP patch was glued in one face of the specimen with the fibers oriented perpendicular to the crack growth direction (parallel to the load application line). These tests were conducted under constant amplitude loading with a maximum value of 7500 N and a frequency of 10 Hz.

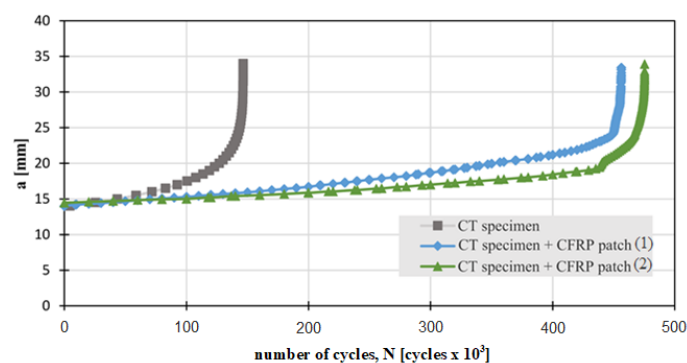
Figure 17. Crack growth evolution for strengthened and non-strengthened solutions ($R = 0.1$ and $F_{max} = 7500$ N).

In the case of the CT specimens strengthened with CFRP patches, the crack length was monitored using a microscope in the face with no patch. Figure 17 presents the evolution of the crack growth throughout the test performed under $R = 0.1$ and $F_{max} = 7500$ N. Comparing the data obtained from the FCG tests on strengthened specimens with the a-N curve defined by the material parameters determined with FCG tests on non-strengthened CT specimens, it is possible to state that the implementation of a CFRP patch led to a fatigue life extension of 318%.
