Second International Symposium on Risk Analysis and Safety of Complex Structures and Components (IRAS 2023)

Failure mechanisms of GRFP after long term exposure to seawater

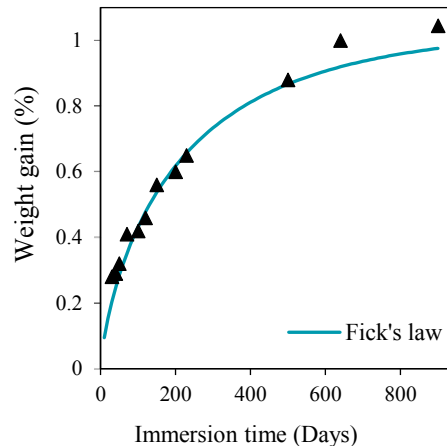
Figure 1. Water absorption curve of tested GFRP laminate and fitted Fick's law used in the numerical simulations, from Vidinha et al. (2022).

The weight gain was modelled using a Fickian diffusion model and the procedure presented in Vidinha et al., (2022). The comparison between the predicted weight gain resulting from the numerical simulations and the experimental measurements is depicted in Figure 1. Overall, the proposed function closely approximates the experimental results, regardless of the immersion time. Notably, the absolute maximum of discrepancies illustrated in Figure 1 was observed at 640 days but was below 8.8%. However, the differences are insignificant for immersion periods shorter than 500 days, and there is a strong agreement between the data points and Fick's law.

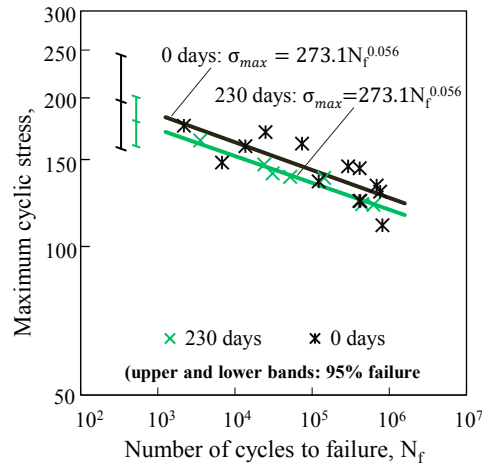
Figure 2. Comparison of the S-N curves for different immersion times (0 days, 230 days, and 910 days) under uniaxial cyclic loading (R = 0.1).

Tension fatigue tests ($R = 0.1$) were conducted at a constant load amplitude. The S-N diagram was the primary tool used for analysing the results of the fatigue tests. The test results were used to obtain the stress-life (S-N) curves for samples immersed 230 days in seawater and for samples not immersed. The failure criterion used in this study was the complete separation of the specimens. Figure 2 displays the S-N curves for maximum stress (σ_{\max}) versus number of cycles to failure (N_f) obtained from the fatigue tests conducted at immersion times of 0 days and 230 days. The curves are presented on log-log scales. The mean curves obtained through linear regression and using the least square method for a 50% failure probability are represented by solid straight lines. The corresponding 95% confidence bands, determined in accordance with the ASTM E739 standard, are shown on the left-hand side as upper and lower limits. In general, there is some scatter in the results, but a satisfactory correlation is observed.

Regarding the cause of the fatigue failure, low-cycle fatigue failure is generally distinguished by stress dominance, and the failure of the structure is primarily caused by fiber breakage. On the other hand, high cycle fatigue failure is characterized by various forms of damage accumulation, including microcracks, delamination, and fiber-matrix debonding, Padmaraj et al. (2021). By examining the S-N curves, it is visible that the fatigue performance of the immersed specimens (230 days) is noticeably diminished in comparison to the control group (0 days) for the same level of applied stress. Additionally, it is noteworthy that the slopes of all three S-N curves remain almost constant. This observation indicates that the failure mechanisms are not significantly altered by exposure to seawater; rather, the damage progresses more rapidly with increased immersion time. When subjected to a maximum cyclic stress of

143 MPa, which was the average stress for the tested range, the fatigue life of the 230-day samples was approximately 66% of that of the control samples, which reaffirms the importance of considering the impact of seawater exposure during the initial design stages of composite marine structures.

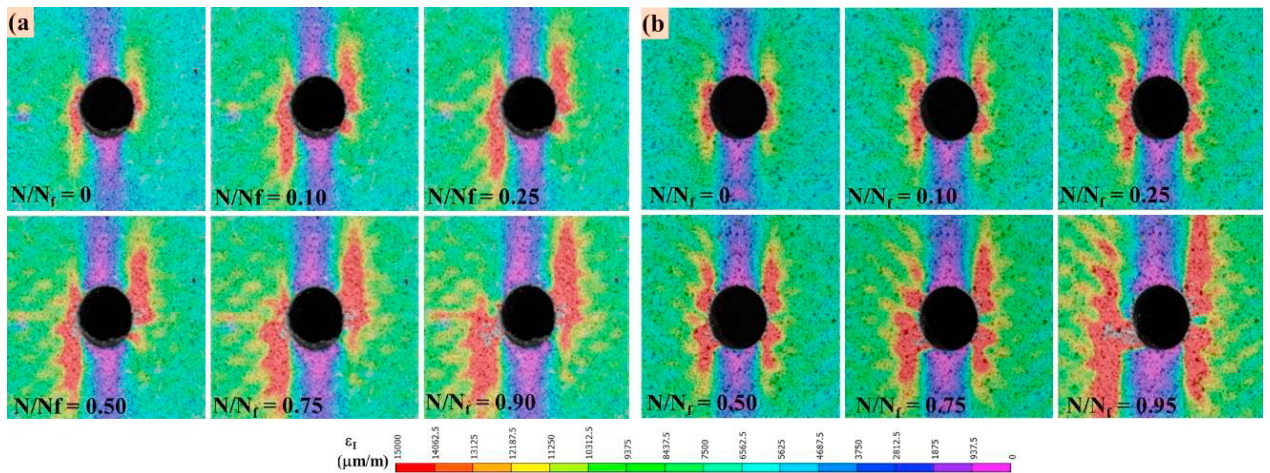
Figure 3. Evolution of the first principal strain field (ϵ_1) near the hole with the dimensionless life (N/N_f) for: (a) 0 days of immersion; and (b) 230 days of immersion. The images were captured at the maximum applied stress of each cycle.

The degradation process caused by fatigue loading in the tested laminate was also accessed by using digital image correlation. Figure 3 shows the first principal strain fields (ϵ_1) near the notched region at various dimensionless lives (N/N_f) for the maximum applied stress of the loading cycle for a samples not immersed in seawater (Fig. 3(a)) and immersed in seawater for 230 days (Fig. 3(b)).

As the number of loading cycles increases, higher values of the first principal strain are localized in two diametrically opposite regions around the hole. These regions identify axial splits that originate from the hole and extend towards the longitudinal extremities of the specimen. This behaviour is in line with the findings reported by Aidi et al. (2015) for laminates with central notches subjected to fatigue loading.
