XII Conference on Transport Engineering, CIT 2016, 7-9 June 2016, Valencia, Spain

Regulatory median parking: a case study on Recanto das Emas Avenue, Brasília, DF, Brazil

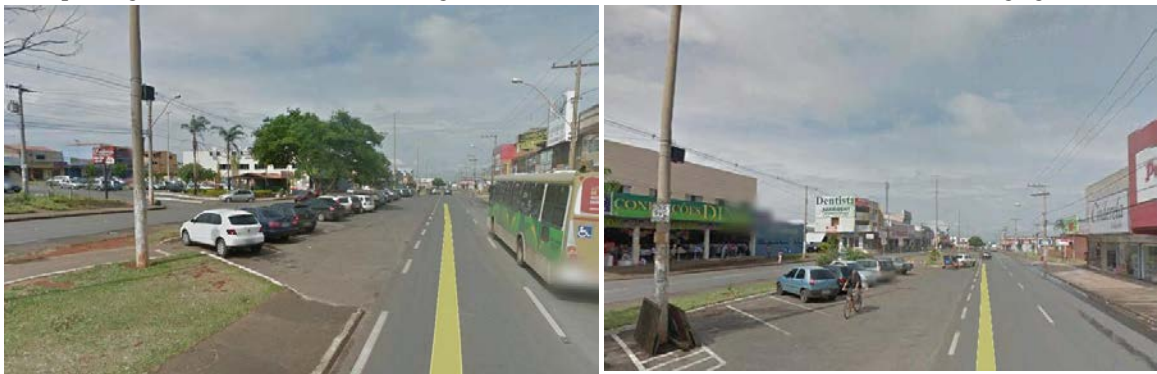
In addition to the median parking areas put into effect in 2007, another significant change to the avenue landscape was the construction of a two-way, 2.2m-wide median bike lane in 2011. The median is approximately 12 m wide, the sidewalk is 2 m wide, and the bike lane is 2,2 m wide, with the remaining area covered by vegetation (grass). Median parking areas offer drivers, in addition to the actual parking place, a 5 m area for maneuver with no physical barrier, an infringement of Brazilian traffic legislation. The bike lane is interrupted in the maneuvering area, leaving bikers of all ages traveling in both directions to face motorized vehicles in the left lane (to be used by high-speed vehicles) or vehicles entering the parking areas. Figures 1a and 1b show, respectively, the initial section of one of the median parking areas (with a vehicle blocking the bike line) and its end section (with a biker traveling against traffic).

Fig. 1. (a) Initial section of a median parking area; (b) End section of a median parking area.

Specifically in regard to Recanto das Emas Avenue, the bike lane implemented in 2011, four years after the parking areas were put in place, exhibits serious pavement discontinuities which force bikers traveling in both directions to share road space with motorized vehicles in the opposite flow. Given the fact that the bike lane ends in front of a parking space, bikers have to get off their bikes in order to continue their route, therefore hindering mobility. Resolution number 514/2014 of the National Traffic Council (CONTRAN, 2014), which establishes the National Traffic Policy, includes among its guidelines the development of public transport and non-motorized systems (section 5, subsection III, clause “c”).

This study examined the impact of median parking areas along Recanto das Emas Avenue on road safety. From a regulatory standpoint, we verified the absence of a physical flow divider measuring at least one meter in width (law infringement) as well as the conflict with the bike lane at the initial and end sections of the parking areas (implemented before the bike lane). The increase in the number of fatal and non-fatal (injuries) accidents (97% and 68%, respectively) was mostly caused by pedestrian run-overs and collisions between vehicles, and we believe that the nature of these accidents suffered a direct influence from the way median parking was implemented in the region. The lack of a local parking policy must be stressed, in addition to the need for a more effective assessment of the functional and hierarchical features of Recanto das Emas Avenue in view of the implementation of parking spaces. In summary, findings extracted from these analyses have assisted other traffic projects in the Federal District, mainly the one concerning median parking on Paranoá Avenue.
